# AIR TRANSPORTATION SAFETY INVESTIGATION REPORT A23W0158

## CONTROLLED FLIGHT INTO TERRAIN

Air Tindi Ltd.  
De Havilland Inc. DHC-6 Twin Otter Series 300, C-GMAS  
Diavik Aerodrome (CDK2), Northwest Territories, 7 NM SE  
27 December 2023

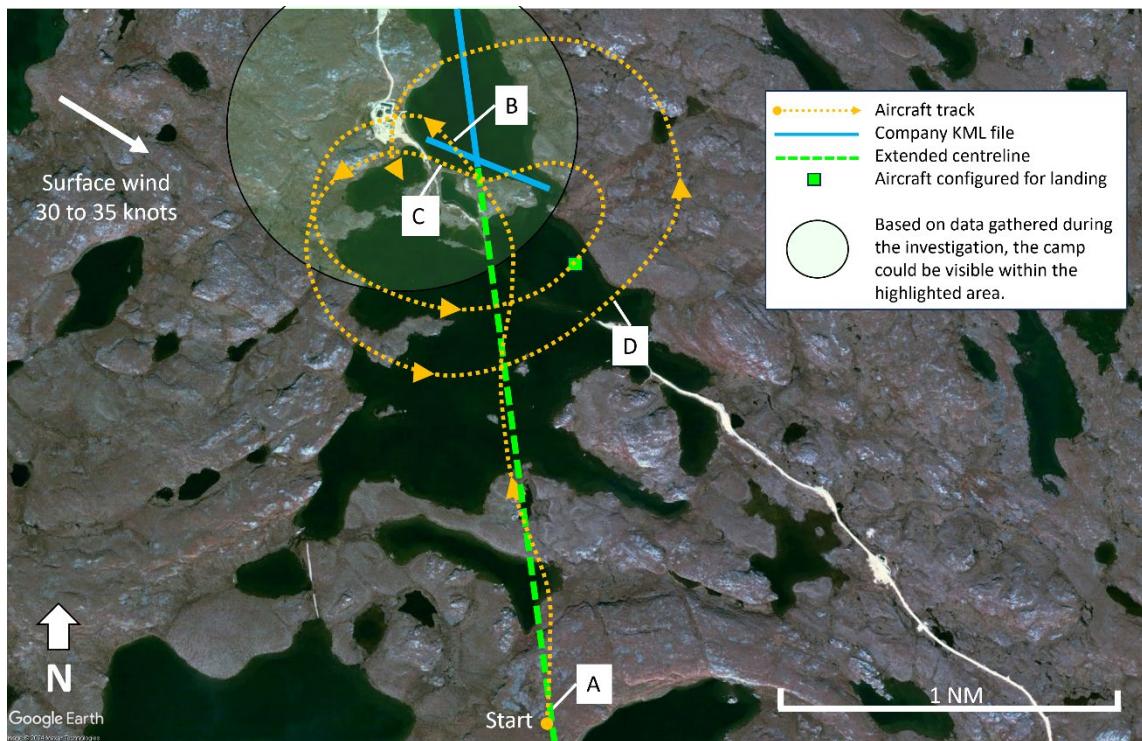
Figure 2. Area map showing Air Tindi's Lac de Gras visual approach defined in the Keyhole Markup Language file and the occurrence aircraft's track on the 1st approach, inspection pass, and subsequent go-around (Source: Google Earth, with TSB annotations)

Event	Time (hhmm:ss)	Height (feet AGL)	Ground speed (knots)	Event description
A	1228:07	215	92	Intercepted approach course
B	1229:25	250	70	Overflew the road camp
C	1230:56	50	55	Conducted a go-around
D	1231:59	495	123	Left-hand orbit of the desired landing surface

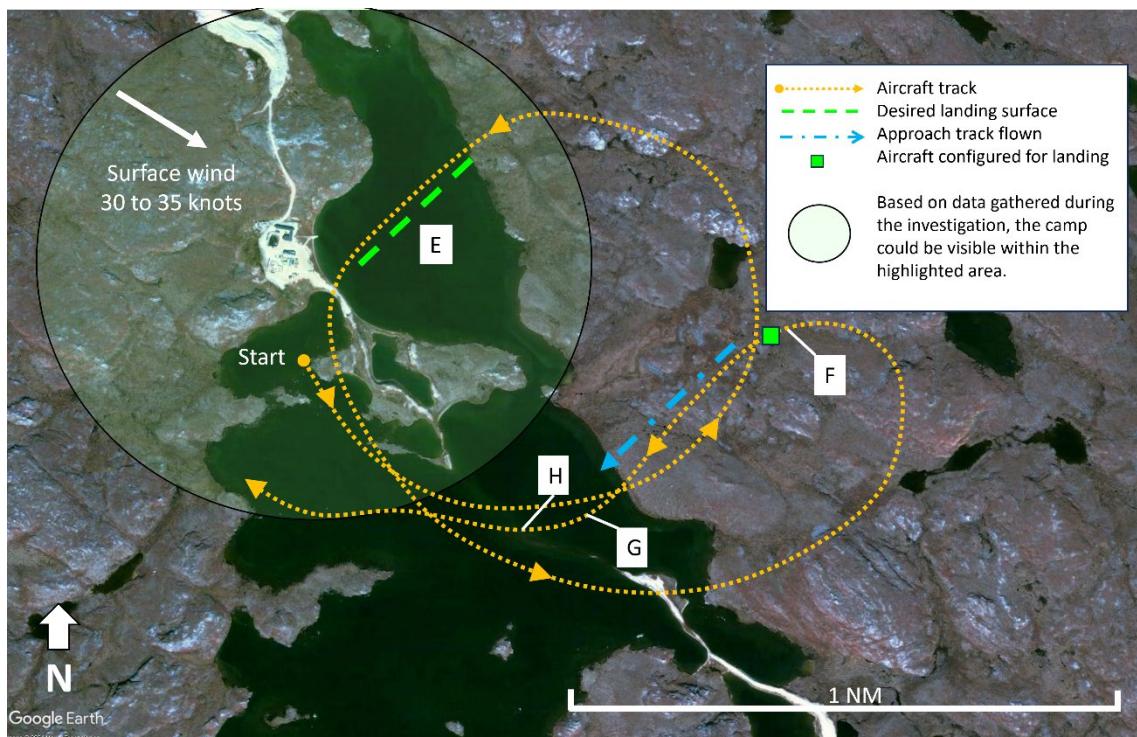
Figure 3. Area map showing the occurrence aircraft's track on the 2nd approach (Source: Google Earth, with TSB annotations)

the PM determined the aircraft was not aligned with the desired landing surface, and a go-around was initiated (G on Figure 3). During the go-around, at approximately 120 feet AGL, the flight crew entered instrument meteorological conditions (IMC)<sup>12</sup> and were unable to determine their position visually (H on Figure 3) (Table 2).

Event	Time (hhmm:ss)	Height (feet AGL)	Ground speed (knots)	Event description
E	1234:32	245	76	Determined new desired landing surface and approach heading
F	1235:53	155	75	Rolled out on heading 220°M
G	1236:12	50	57	Initiated a go-around
H	1236:20	120	54	Entered IMC

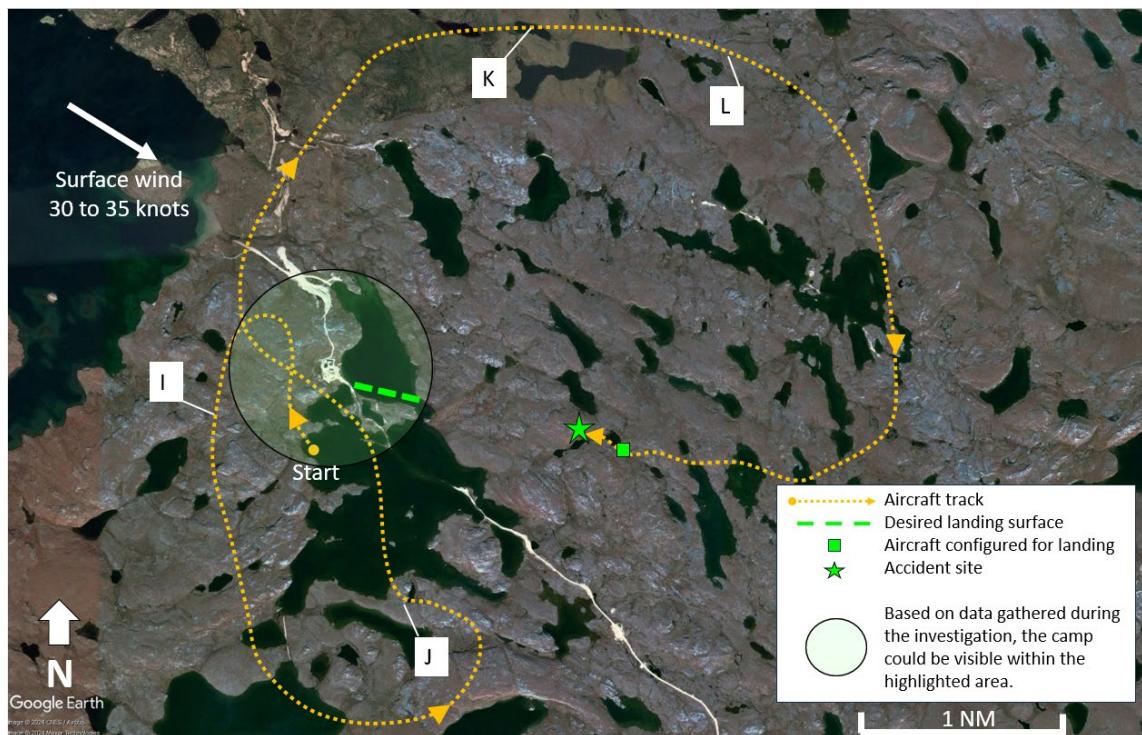
Figure 4. Area map showing the occurrence aircraft's track on the 3rd and 4th approaches (Source: Google Earth, with TSB annotations)

After the go-around, the aircraft began to drift upwards, steadily gaining altitude, and entered a right-hand downwind 2 NM to the north of the road camp (K on Figure 4). At 1241, the PF indicated on an EFB that he intended to fly a modified right-hand circuit and approach the road camp on a westerly heading, and the PM proceeded to build a 4th improvised approach into the EFB. On the downwind leg, the aircraft inadvertently climbed to approximately 1000 feet AGL (L on Figure 4). At the time of the 4th approach, the visibility was approximately  $\frac{1}{2}$  SM. During the base leg, the aircraft began descending (Table 3).

Event	Time (hhmm:ss)	Height (feet AGL)	Ground speed (knots)	Event description
I	1237:43	280	96	Left-hand circuit for northbound approach
J	1239:40	155	62	Intercepted desired northbound approach track
K	1242:01	700	124	Right-hand downwind for westbound approach
L	1242:41	1000	130	Inadvertent climb to 1000 feet AGL

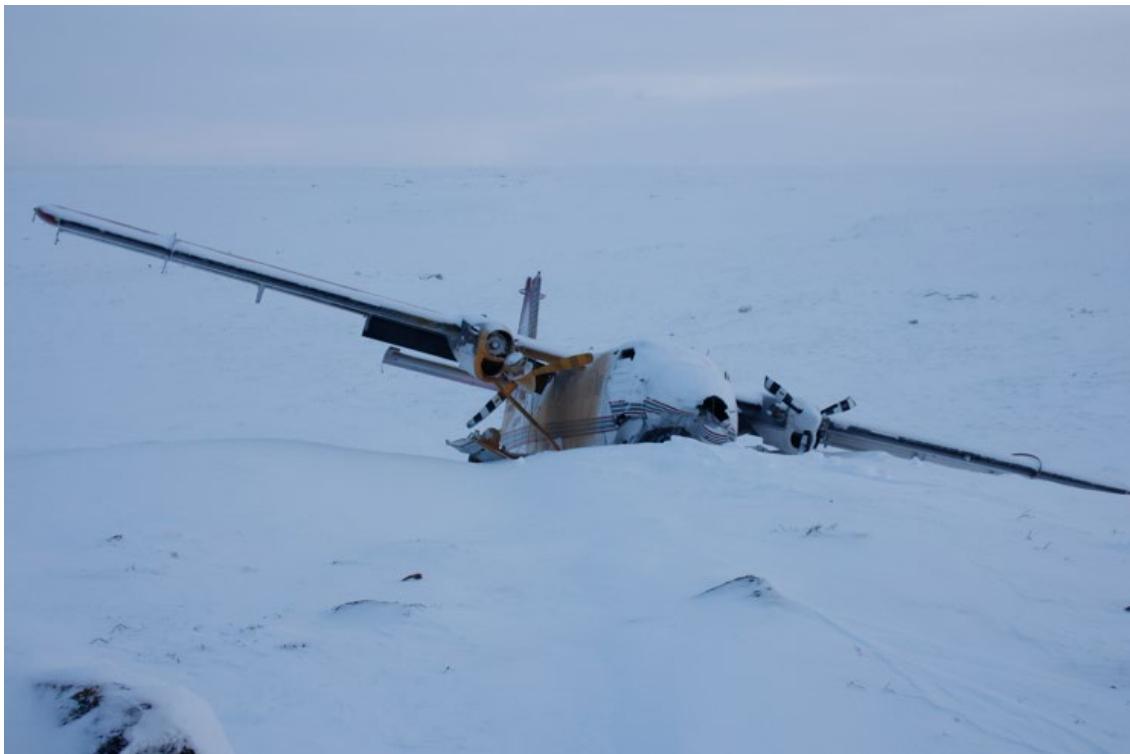
Figure 5. Occurrence wreckage (Source: Air Tindi Ltd.)

considerable damage to the underside of the fuselage; both main landing gears collapsed and the nose gear compressed into the fuselage. The right-hand engine separated at the power turbine, with the hub and propeller left loosely attached.
