RAIL TRANSPORTATION SAFETY INVESTIGATION REPORT R24Q0089

MAIN-TRACK DERAILMENT

Quebec North Shore and Labrador Railway
Ore train BAL-481-F
Mile 25.4, Wacouna Subdivision
Near Saumon Station, Quebec
03 November 2024

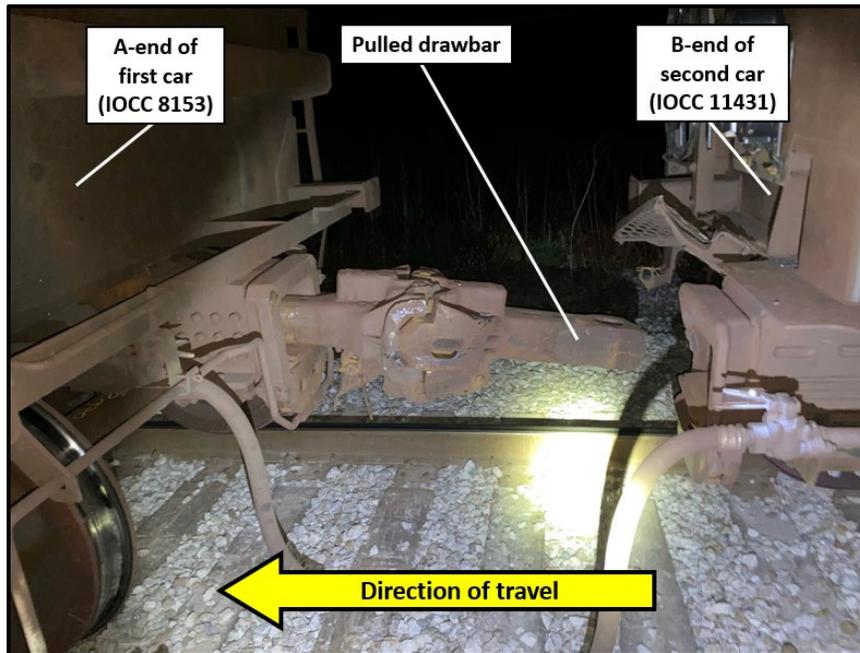
The A-end of the 1st car (IOCC 8153) derailed, and the car remained coupled to the head-end locomotives. The drawbar on the 2nd car (IOCC 11431) had dislodged from the draft sill but remained coupled to the 1st car (Figure 2).

Figure 2. Pulled drawbar between the 1st and 2nd cars (Source: Quebec North Shore and Labrador Railway, with TSB annotations)

The failure of the yoke caused it to move excessively in the draft sill. The yoke pin then moved beyond the carrier plate, causing it to fall onto the track. Because the drawbar was no longer connected to the yoke, it dislodged from the draft sill. The car, now detached from the rest of the train, became at risk of separating when the couplers would be stretched.

The drawbar at the B-end of the 2nd car became dislodged after the yoke broke, causing the yoke pin to move beyond the carrier plate. The pin then fell onto the track, causing the train to become uncoupled and susceptible to separation.

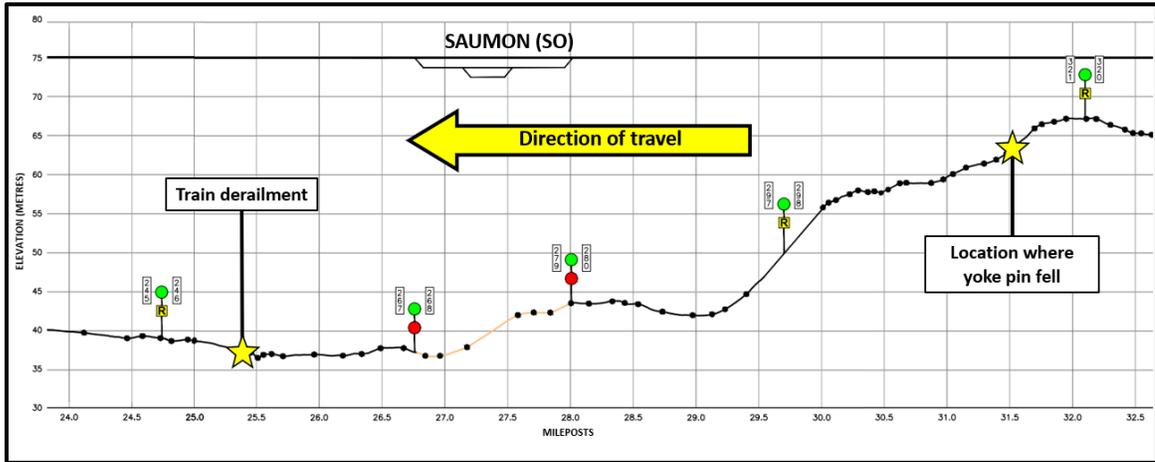
The pin connecting the drawbar to the yoke from car IOCC 11431 was found in the vicinity of Mile 31.5 (Figure 3) and showed no signs of damage or wear.

Figure 3. Locations where the yoke pin fell and where the train derailed, with railway track profile (Source: Quebec North Shore and Labrador Railway, with TSB annotations)

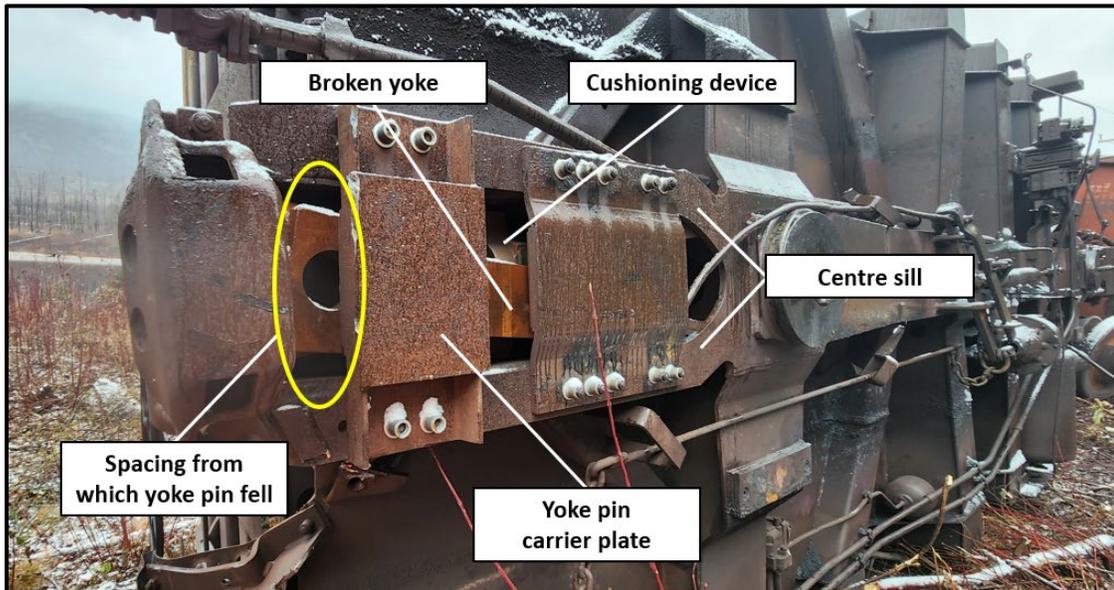
After the occurrence, most of the derailed cars were moved off the railway right-of-way so that regular service could be restored as quickly as possible. Car IOCC 11431 ended up on its side, allowing TSB investigators to get a closer look at the main components of the coupler at its B-end (Figure 4).

Figure 4. Car IOCC 11431 on its side after being moved off the tracks, showing the centre sill, the cushioning device, the yoke pin carrier plate, the broken yoke, and the spacing from which the yoke pin fell (Source: TSB)

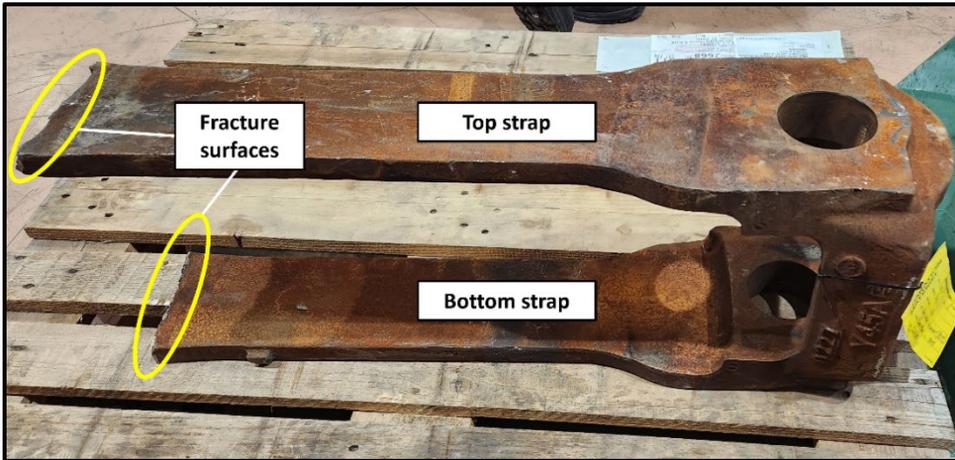
The coupler at the B-end of car IOCC 11431 was examined and it was determined that the yoke had broken near its rear part, at the end of the cushioning device (Figure 5).

Figure 5. Broken yoke, showing the fracture surfaces on the top and bottom straps (Source: TSB)

Visual examination of the yoke involved in this occurrence revealed that the 2 straps failed through brittle fracture near their rear part.¹⁴

Laboratory analysis concluded that the yoke had sustained a brittle fracture due to overload in 2 locations near the rear of its 2 straps, in an area subject to high stresses. The initial fracture occurred in the top strap, which was closest to the underside of the car body. This strap had porosity¹⁶ attributable to shrinkage that was not visible on the outer surface of the cast part. Following this initial fracture, because all the tensile forces on the yoke were concentrated on the bottom strap, the latter was unable to withstand the sudden overload and also failed. At this location, the applied stresses exceeded the material's tensile strength, which was reduced due to internal porosity that had formed during casting of the part.

The yoke in this occurrence sustained a brittle fracture due to overloading in an area subject to high stresses, where internal porosity was present. That porosity, which was not apparent on the surface of the cast part, could not be identified during the visual inspection of the yoke after manufacture. As a result, the tensile strength of this part of the yoke was reduced below the minimum strength required by Association of American Railroads (AAR) specifications. The yoke was therefore more susceptible to failure when subjected to the normal in-train forces.

The yoke had internal porosity in a high-stress area. That porosity, which likely formed when the part was cast, reduced the tensile strength of this section of the yoke, causing it to fail in service.

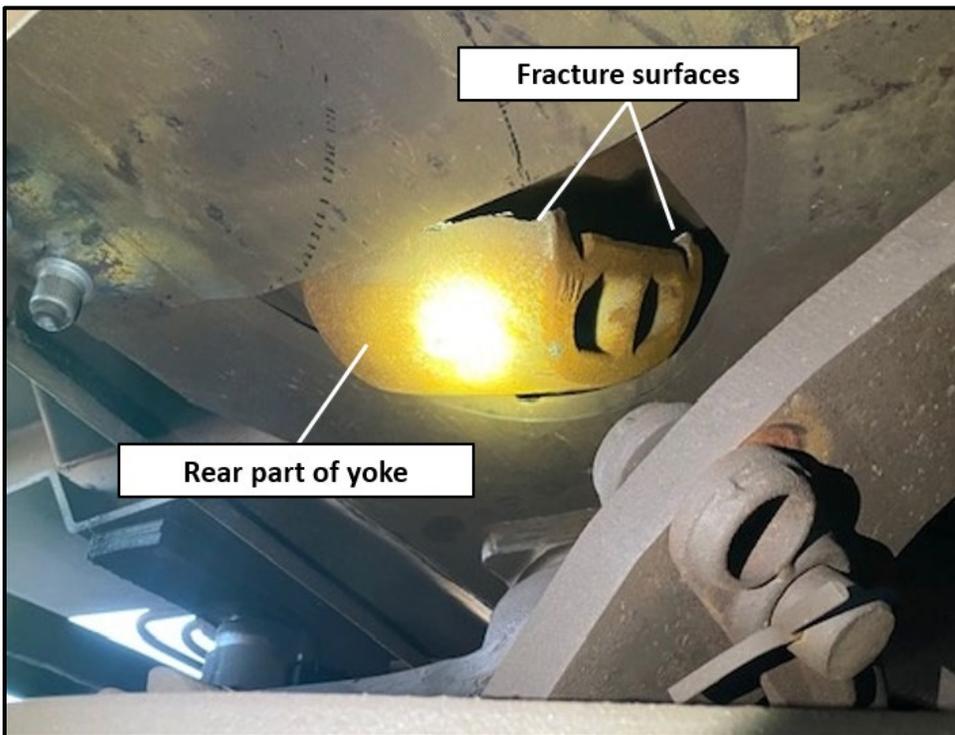
The rear part of the broken yoke remained attached to the car (Figure 6).

Figure 6. Rear part of the broken yoke, as it was positioned inside the draft sill after the derailment, showing the fracture surfaces (Source: Quebec North Shore and Labrador Railway, with TSB annotations)

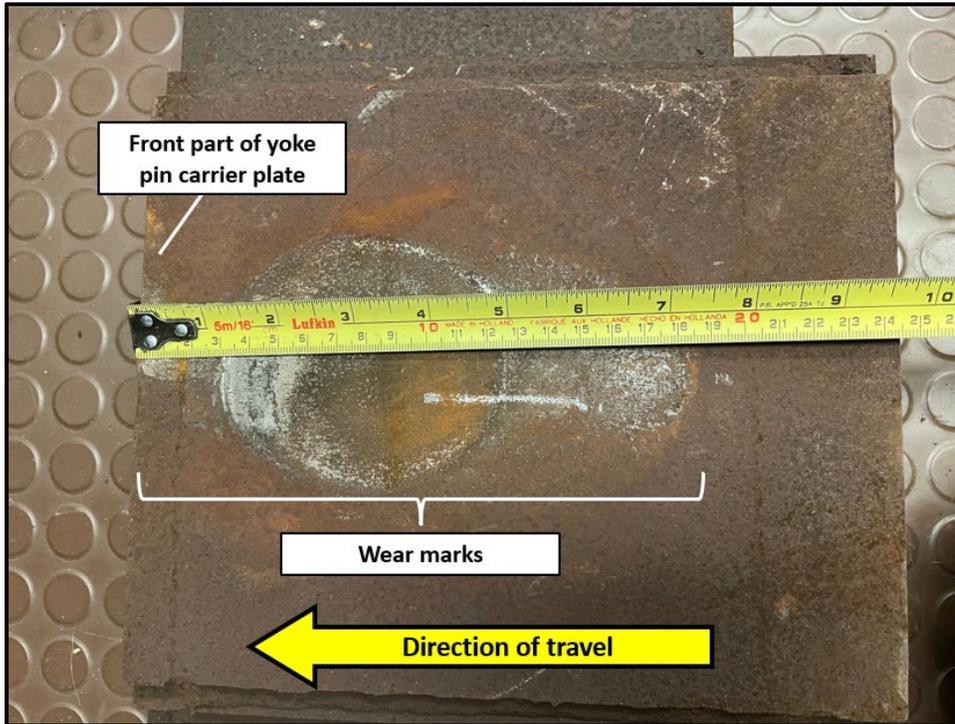
When the TSB investigators examined the car, the carrier plate that holds the yoke pin was removed so that the contact surface of the plate could be observed. The plate showed signs of wear extending to its front end (Figure 8).

Figure 8. Carrier plate holding the yoke pin showing wear marks extending to its front part (Source: TSB)
