# AIR TRANSPORTATION SAFETY INVESTIGATION REPORT A23P0136

## LIGHTNING STRIKE AND LOSS OF CONTROL

Helijet International Inc.  
Sikorsky S-76C++ (helicopter), C-GXHJ  
Sidney, British Columbia, 10 NM NE  
24 October 2023

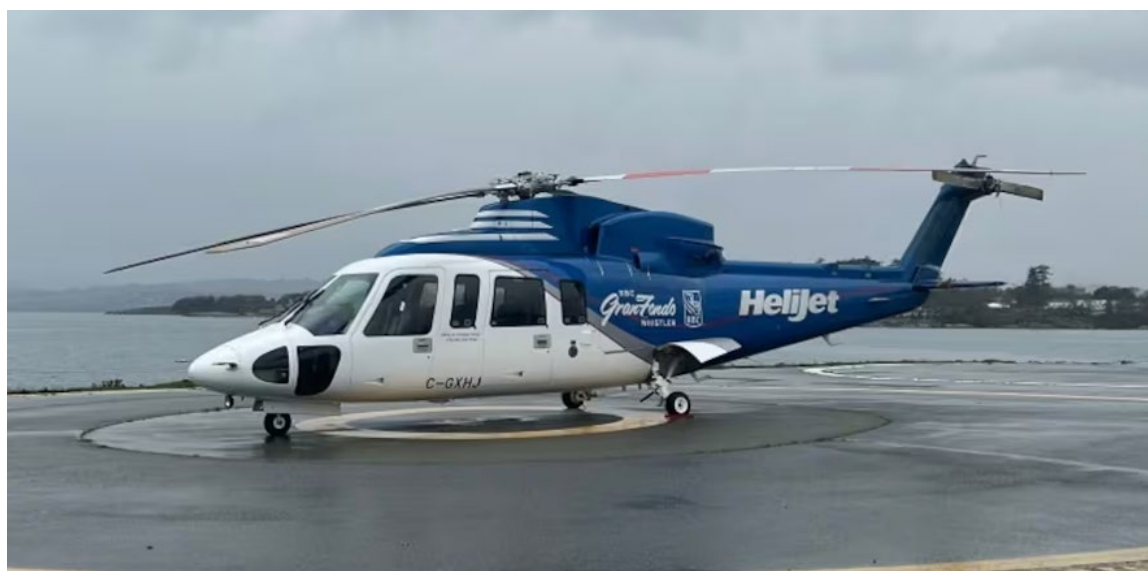
The helicopter was substantially damaged. One tail rotor blade assembly separated from the helicopter in flight and contacted 3 main rotor blades, the left horizontal stabilizer, the left side of the tail boom, and the left engine cowl.

Figure 2. Occurrence helicopter at Victoria Harbour (Camel Point) Heliport (CBF7), following the occurrence (Source: CTV News)

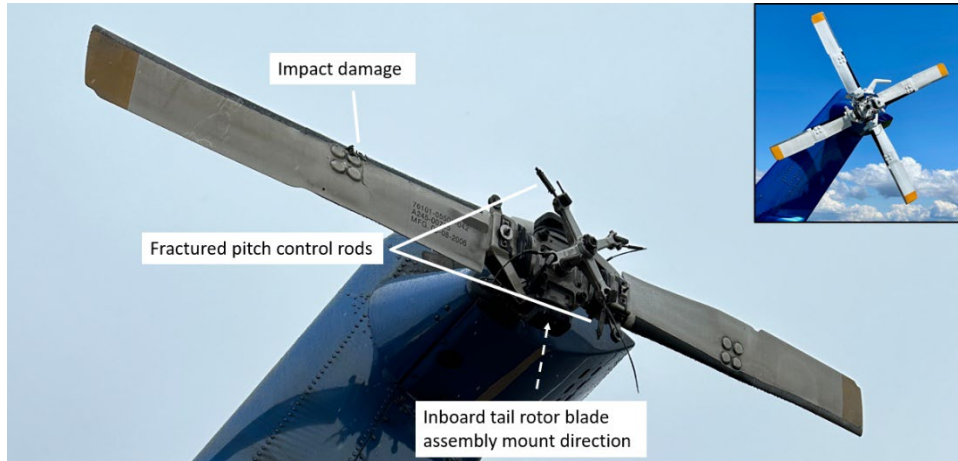
The inboard tail rotor blade assembly had separated from the helicopter, and the spar centring plug was all that remained with the helicopter. For each of the separated rotor blades, the pitch control rod end assembly had fractured in overload at the blade attachment point and the bonding jumper was broken during separation (Figure 8). The opposite end of the pitch control rods remained attached to the helicopter and 1 bearing surface had damage that was consistent with flashover.

Figure 8. Main image: The tail rotor system on the occurrence helicopter following the lightning strike, showing the missing inboard tail rotor blade assembly and the resulting damage from its separation. Inset: The repaired occurrence helicopter tail rotor for reference as a complete assembly. (Source of the main image: Helijet International Inc., with TSB annotations. Source of inset: Helijet International Inc.)

The outboard tail rotor blade assembly remained attached to the tail rotor output shaft by the outboard retaining plate. One tail rotor blade had impact damage to the leading edge near the tail rotor blade fasteners. The same rotor blade had minor pitting on the leading edge approximately  $\frac{3}{4}$  inch from the tip, which is consistent with lightning attachment. The other rotor blade of the assembly was not damaged.

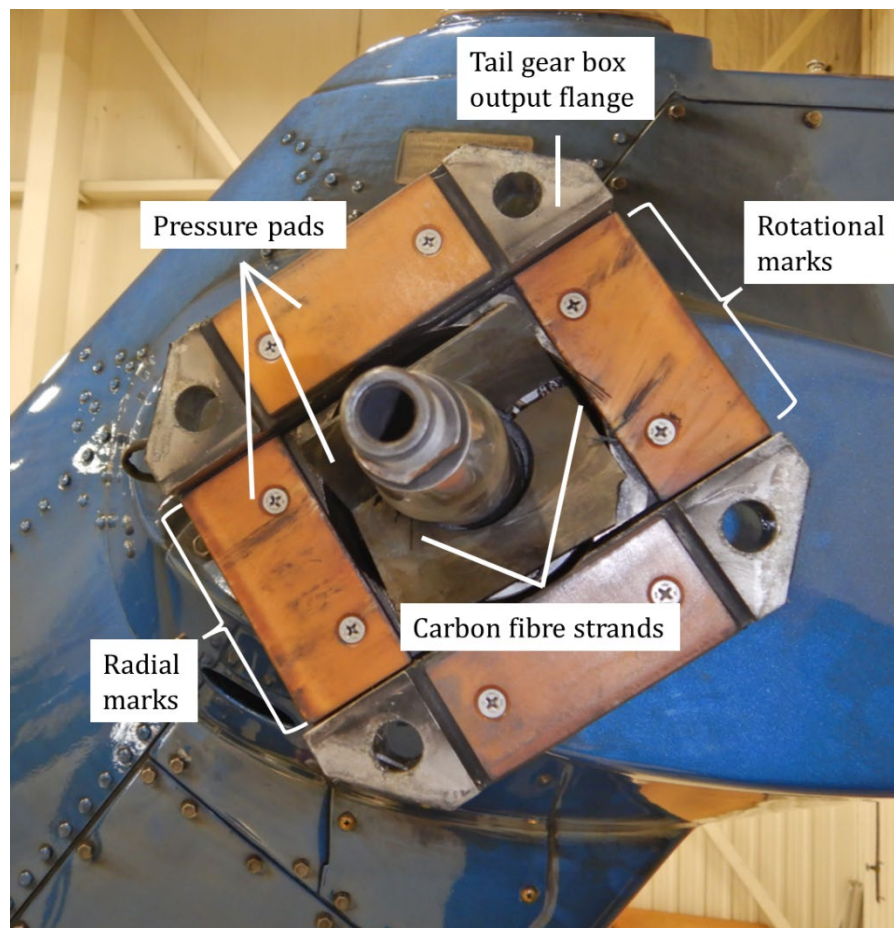
The pressure pads on the tail gear box output flange had radial and rotational marks where the inboard tail rotor blade assembly was mounted (Figure 9). One pressure pad had carbon fibre strands embedded in the pad. In addition, the pressure pad surrounding the pitch control shaft was broken in half with carbon fibre strands present.

Figure 9. Occurrence helicopter tail gear box output flange highlighting the remaining carbon fibre strands and the marks on the pressure pads where the inboard tail rotor blade assembly was mounted (Source: TSB)

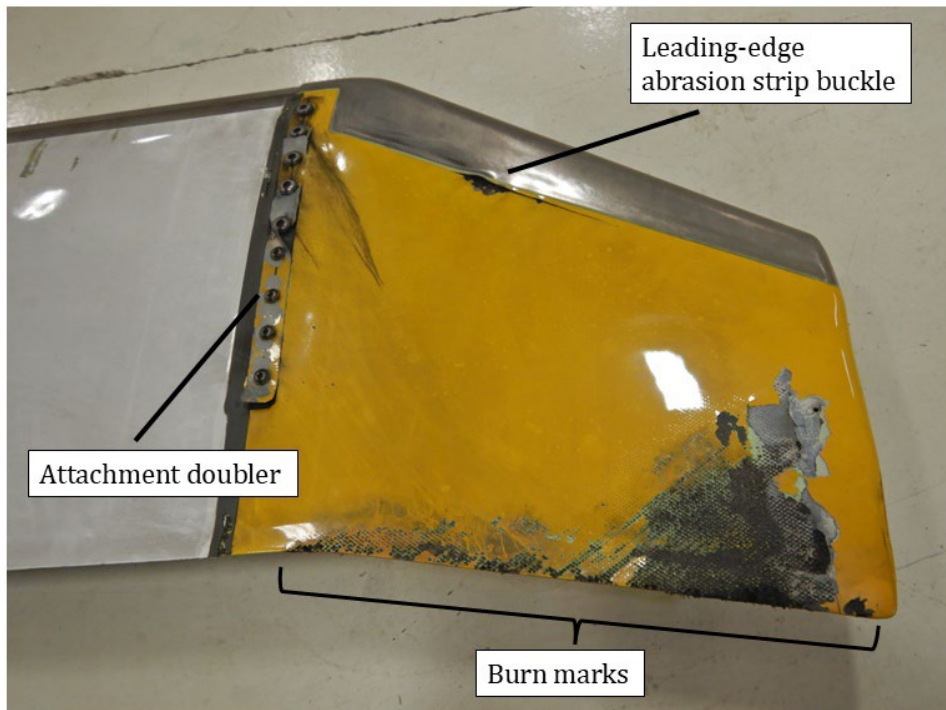
The occurrence helicopter's blue main rotor blade had burn marks on both sides of the tip cap that exposed the underlying Kevlar skin. The tip cap's leading-edge abrasion strip had buckled slightly on the upper (Figure 10) and lower aft edge as well as on the lower aft edge at the overlapping outboard seam, which is consistent with lightning attachment. The tip cap attachment doubler had buckled on the upper and lower skins.

Figure 10. Top side of the blue main rotor blade tip cap with damage from lightning attachment (Source: TSB)

In addition, the blue main rotor blade's upper and lower skin had burn marks down the length of the blade that were characterized by paint blisters in a mesh pattern, which is consistent with the arc root dispersion of the wire fabric.<sup>43</sup> At approximately 98 inches from the blade root, the lower skin had minor paint chips and abrasion marks likely from a glancing impact with an object.

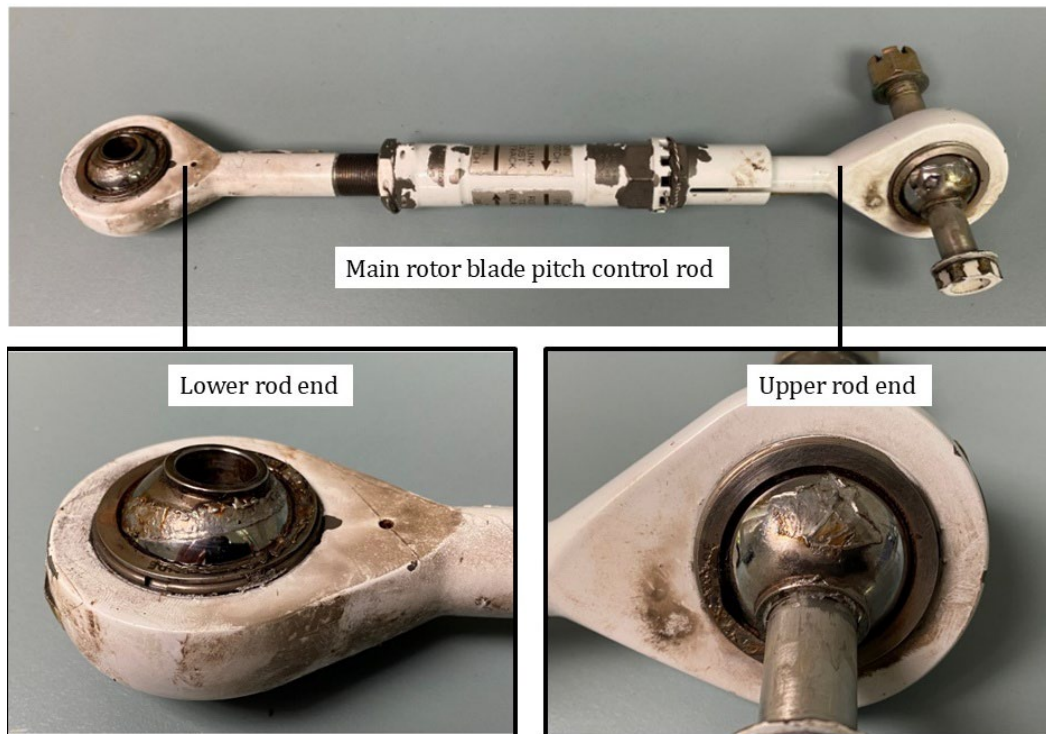
The blue main rotor blade damper, pitch control rod, and bonding jumper exhibited damage from the lightning strike. The damper inboard and outboard spherical bearings had minor pitting, flaking, and discolouration. The pitch control rod upper and lower spherical bearings and bearing races had significant discolouration with melted material over a portion of the bearing and bearing races (Figure 11).

Figure 11. Occurrence helicopter's blue main rotor blade pitch control rod with the spherical bearing damage highlighted (Source: TSB)

The pitch control rod attachment points at the blade spindle and the swashplate also had indications of flashover.
