OPERATIONAL SERVICES BRANCH  
**ENGINEERING LABORATORY REPORT**

LP141/2013

Lac-Mégantic Video Analysis

Montreal, Maine & Atlantic Railway, Train MMA-002

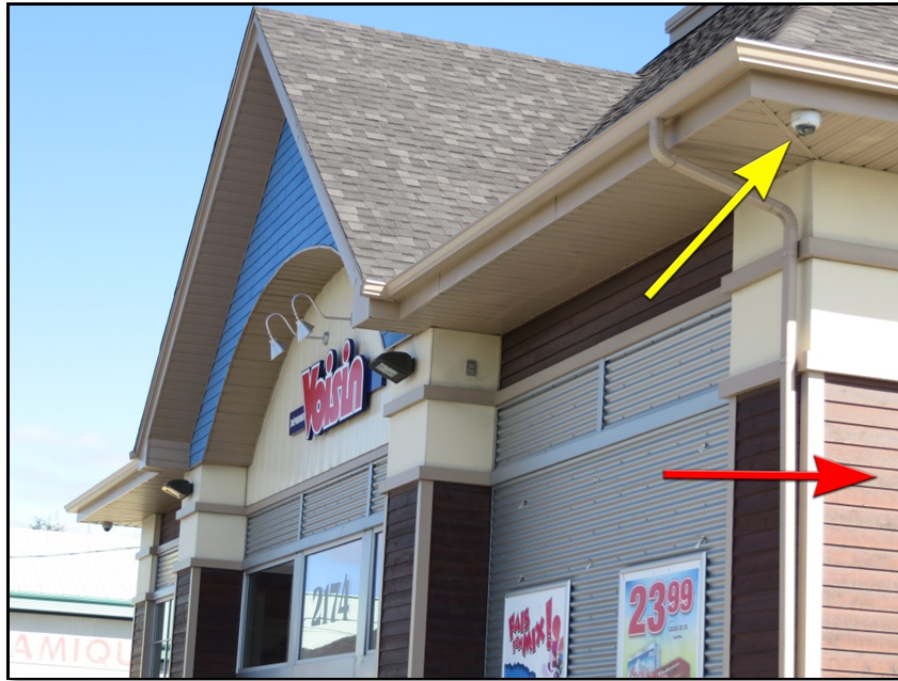
- 2.1 The security camera was mounted under the eave on the southeast corner of the Dépanneur Voisin/Ultramar gas station at 2174 Route 161, Nantes, Quebec (Figure 1). The level crossing at Highway 161 can be seen in the image (Figure 2) and is located about 109 meters away from the camera. The camera's central lens axis was pointed approximately 87 degrees from north (Figure 3).

Figure 1: Security camera on the Dépanneur Voisin/Ultramar gas station (yellow arrow). Red arrow points to the direction of the railway crossing over Highway 161.

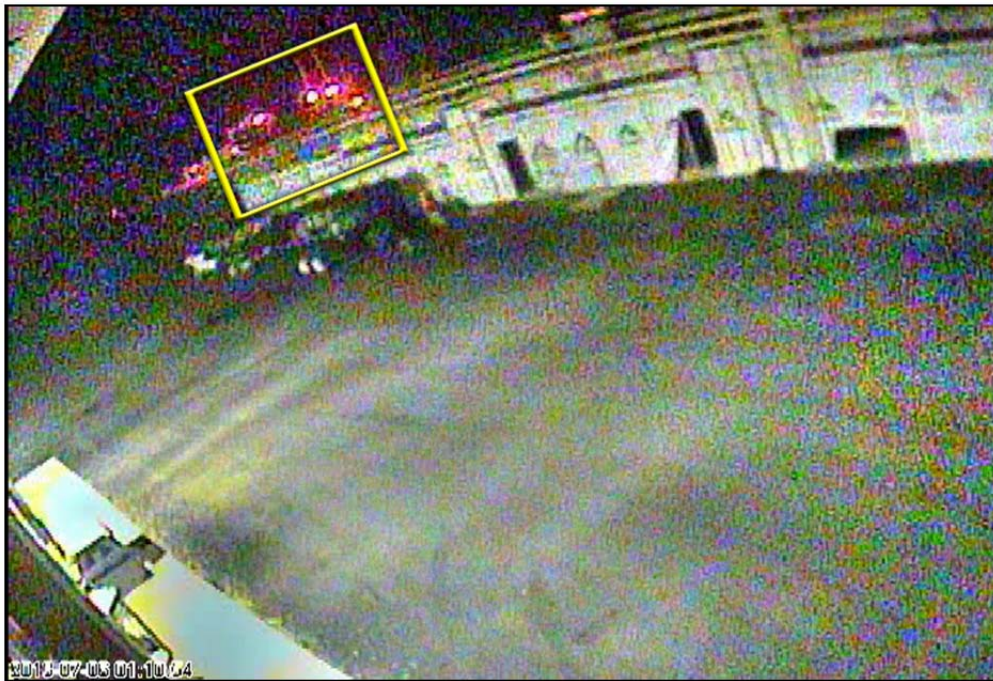
- 2.4 In the video sequence, the level crossing signal lights can be seen activated at 1:10:52 am on 6 July 2013. The lead locomotive – MMA 5017 crosses highway 161 27 seconds later at 1:11:19 am . The train is travelling at a converging angle of 26 degrees to the GeoVision's cameras lens axis (Figure 3).

Figure 2: Still image captured at 1:10:52 am. Shows activation of the crossing lights (yellow box) before freight train MMA 002 passes by.

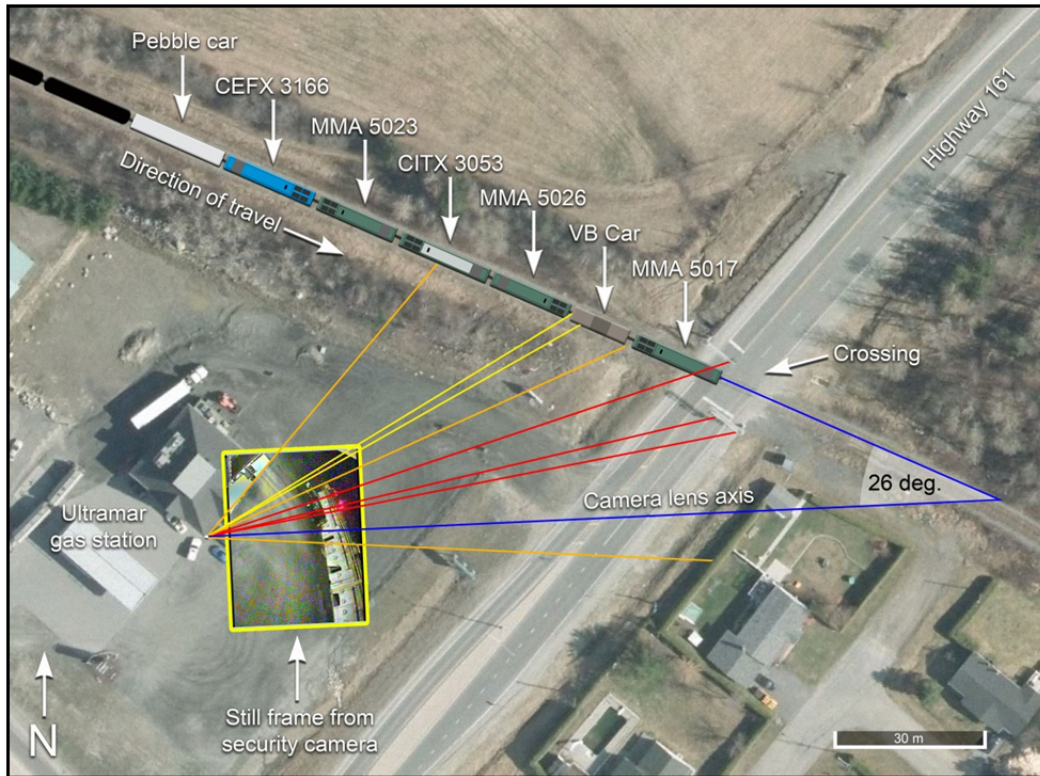
Figure 3: Still image positioned over an aerial photograph. The red lines are pointing to the signal lights. The orange lines point to ground objects and the yellow lines are pointing to lights emanating from the VB car. The angle between the camera lens axis and the tracks is 26 degrees.

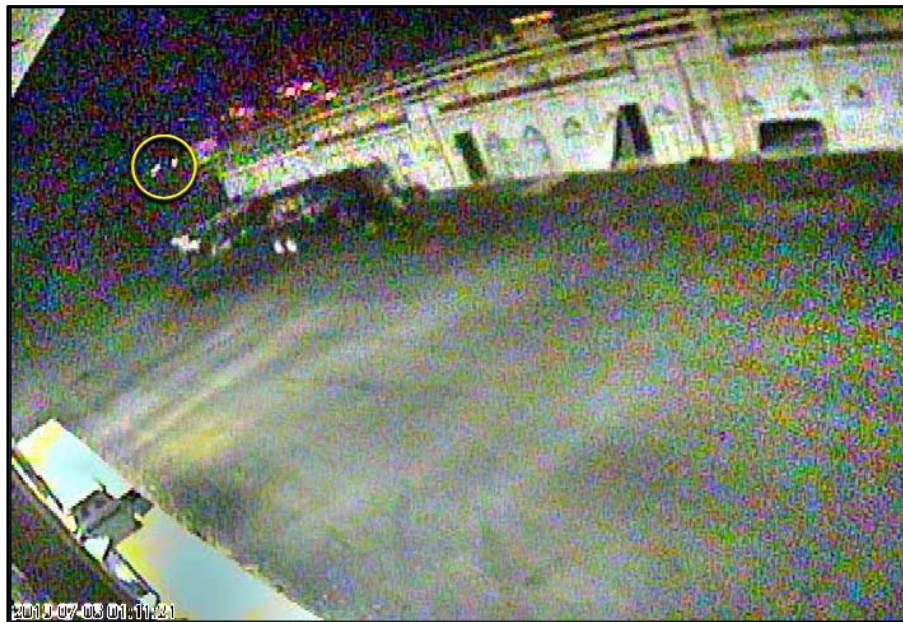
- 2.6.1 The video sequence revealed unknown light sources (Figure 4) as train MMA 002 crossed Highway 161. Initially the unknown light sources were thought to be sparking or heating of the brake shoes, evidence of applied brakes. Further examination revealed a total of 3 light sources – a single light followed by two next to each other. After careful examination of the video, the light sources were observed to be too high in the video frame to be considered as part of the brakes or wheels of the locomotives or cars (Figure 5). With the train travelling at a converging angle of 26 degrees to the camera's lens axis (Figure 3), the side and rear windows of the VB car would have been exposed to the security camera as the train passed by.

Figure 4: Unknown light source passing from left to right with train MMA 002 at 1:11:21 am (yellow circle).

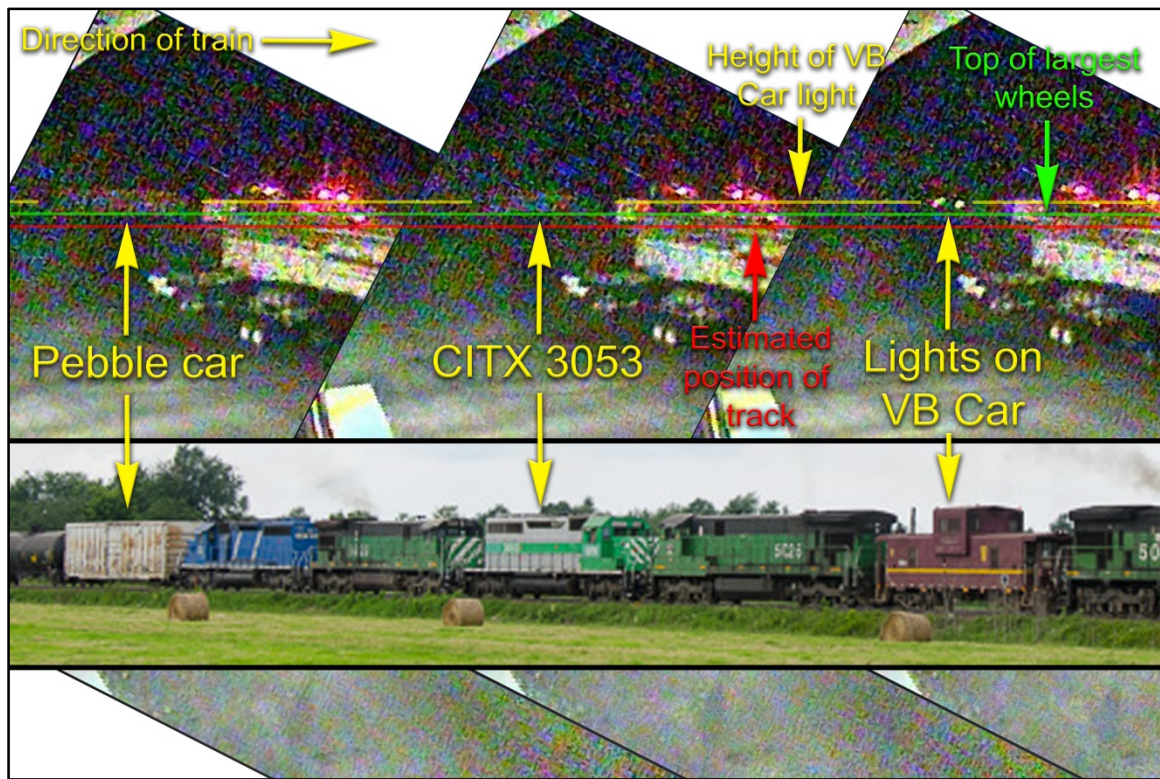
Figure 5: The unknown light source when positioned relative to the Pebble car and locomotive CITX 3053. The lights are approximately mid height of the VB car and above wheel height.

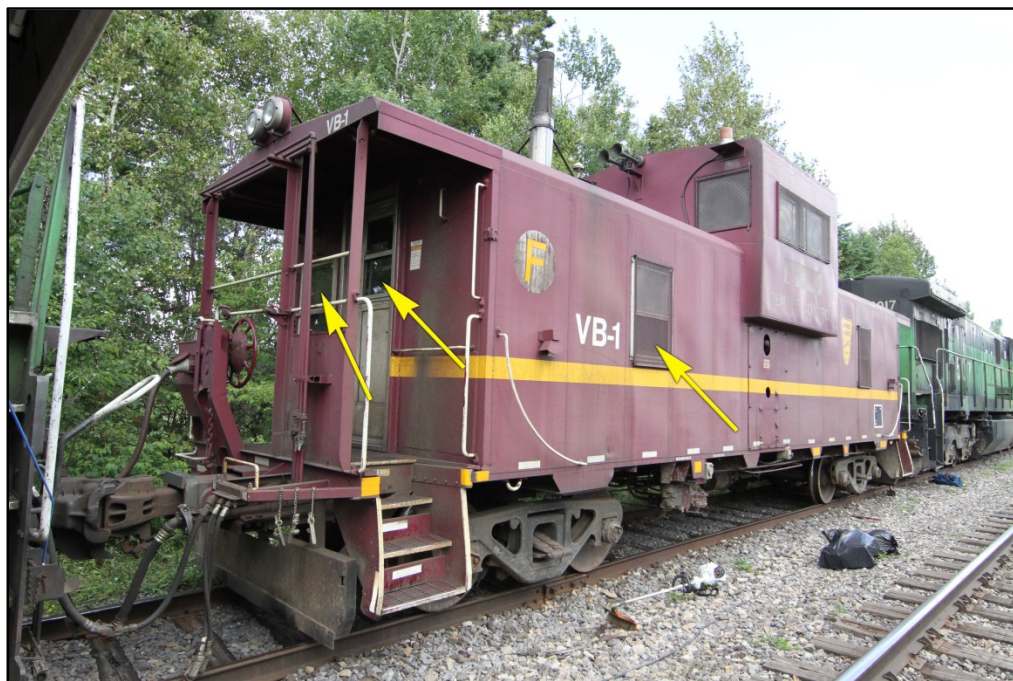
- 2.6.2 Further investigation revealed that the light sources were interior lights left on in the rear of the VB car. The lights were emanating through the 3 windows in the rear and side of the passing VB car (Figure 6). Two or more interior lights in the rear of the VB car may have been left switched on (Figure 7) prior to the train rolling down the grade from Nantes.

Figure 6: The 3 areas of illumination observed in the security camera video.

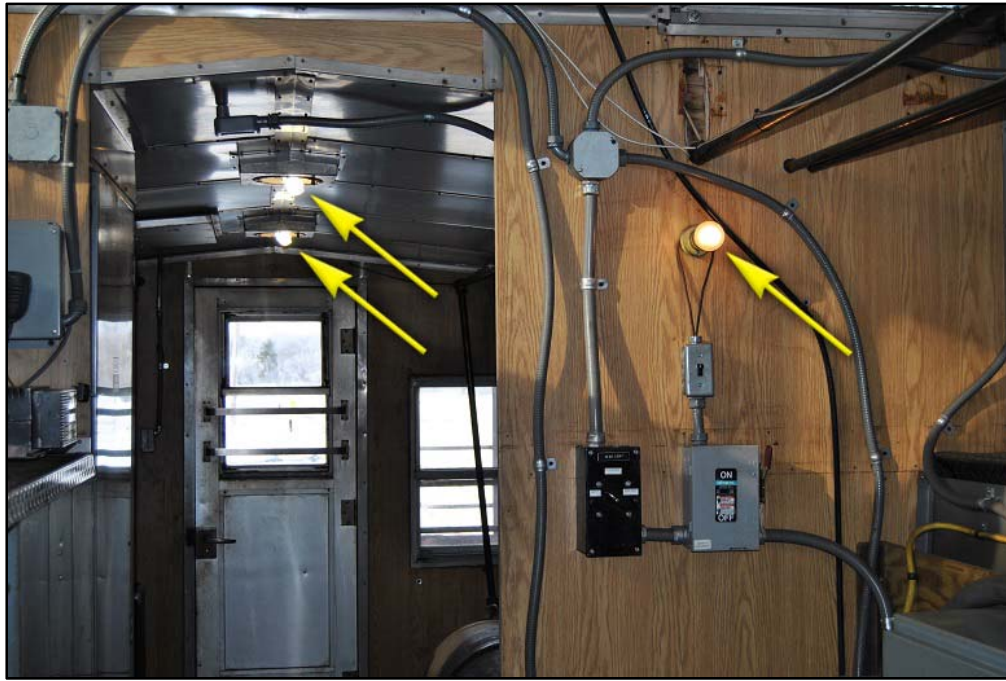
- 2.6.3 Although there was no electrical power in the locomotives themselves, the VB car has its own independent battery system which could power its interior lights.

Figure 7: Inside view of the rear of the VB car showing position of light bulbs and rear windows.
