OPERATIONAL SERVICES BRANCH  
**ENGINEERING LABORATORY REPORT**

LP152/2013

Examination of Box Car Wheel Set

Montreal, Maine & Atlantic Railway, Train MMA-002

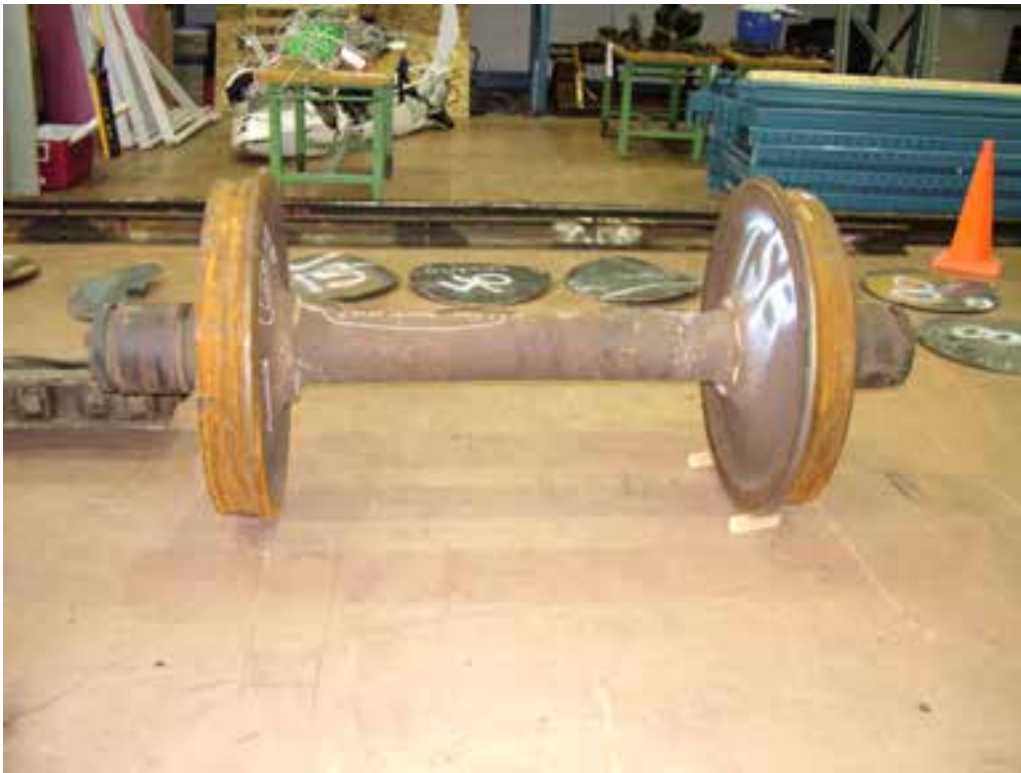
- 2.2 Figure 1 shows the wheel set as received. Both wheels were cleaned so an examination could be performed. The feature observed on the flange of wheel 83414 is shown in Figures 2 through 5. Close-up examination of the feature on the wheel flange revealed that there was a rub mark on either side of it and that its edges were rounded, with a worn appearance.

Figure 1: Photograph showing the wheel set as received

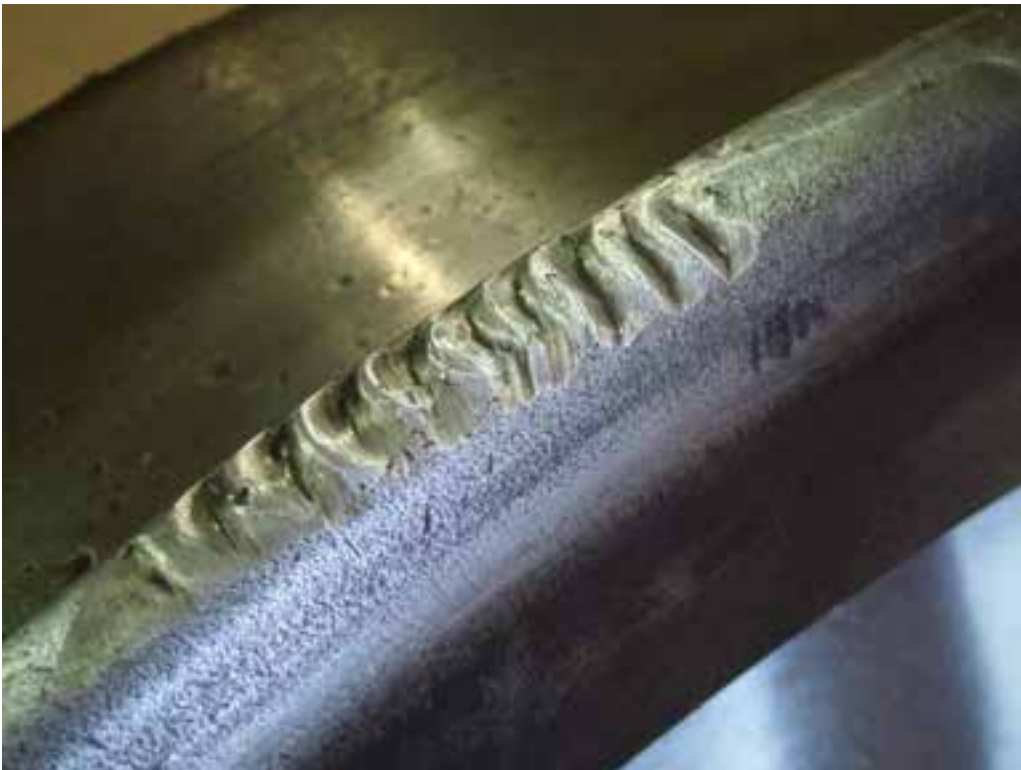
- 3.1 The features observed on the subject and mating wheels were most likely caused by mechanical damage as a result of contact with some foreign object. The rounded edges of the rub marks and their worn surfaces suggest that they were present on the wheel flange for some time and most likely pre-dated this derailment.
- 3.2 The 2 features observed on the wheel flanges may have been caused by the brake components; they are located very close to the wheel flange and might have contacted the wheel at some point. The other cause might have been contact with some equipment along the track and/or switch.
- 3.3 The microstructure of the wheel material in the feature areas did not show any changes associated with exposure to heat from processes such as welding or torch cutting.

Figure 2: Photograph showing the feature observed on the flange of wheel 83414

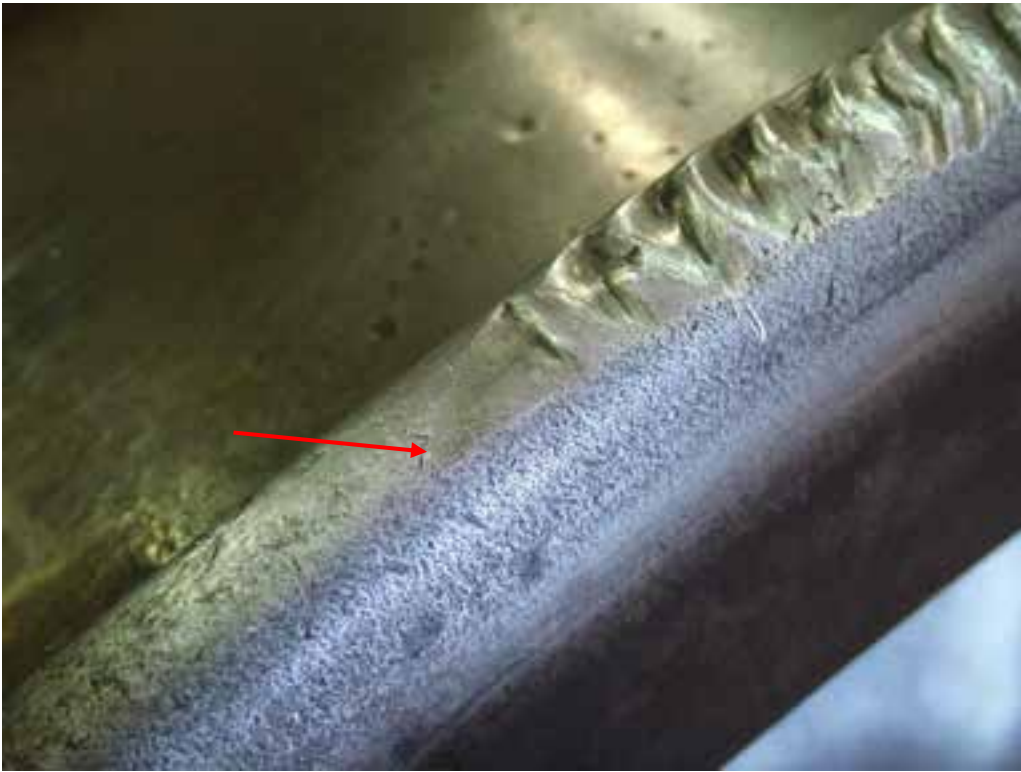
Figure 3: Photograph showing a portion of the feature on the flange of wheel 83414. The red arrow points to the end of the rub mark.

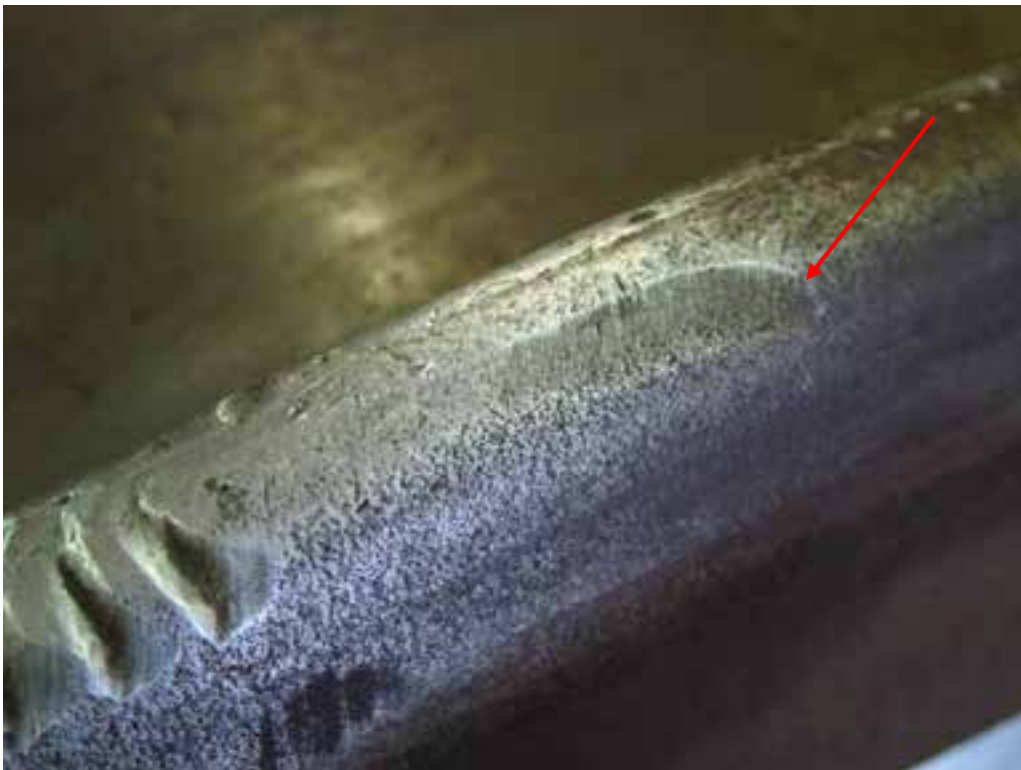
Figure 4: Photograph showing the rub mark at the end of the feature on the flange of wheel 83414 (red arrow)

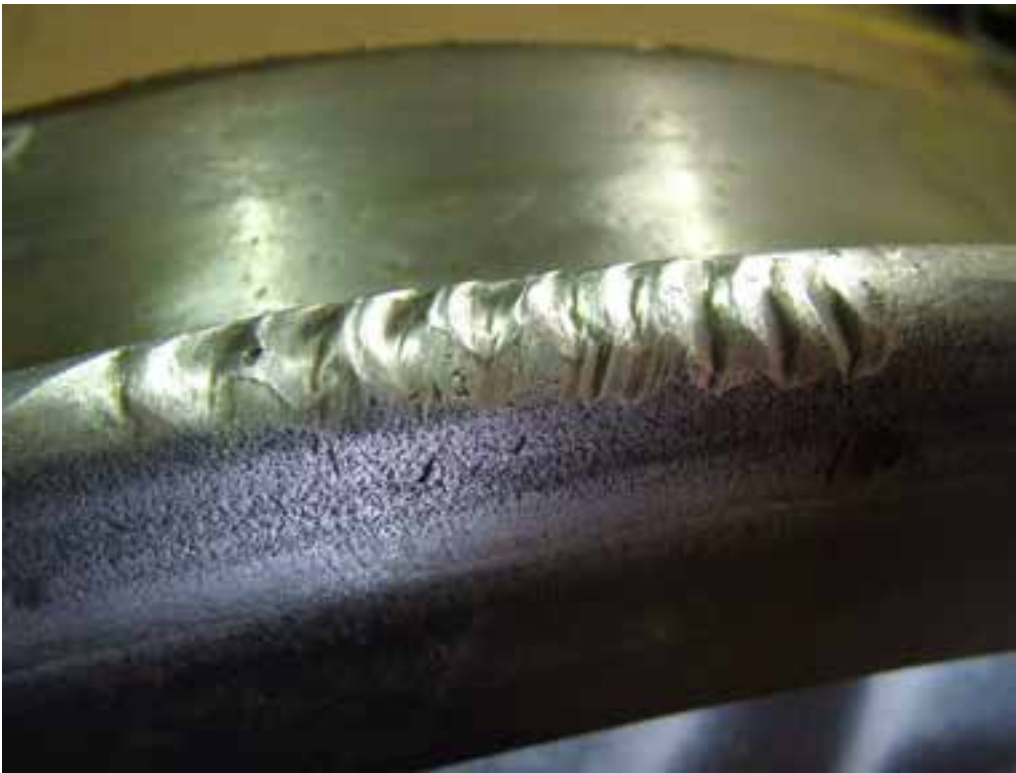
- 4.1 The feature on the subject wheel flange was caused by some type of mechanical damage. The feature had the appearance of being present on the wheel flange for some time and most likely pre-dated the occurrence.
- 4.2 The mating wheel had a similar type of feature on the wheel flange approximately 180 degrees from the feature on the subject wheel. This feature also appeared to have pre-dated the occurrence.
- 4.3 The wheel tread wear, flange wear and hollow tread wear were within the AAR specifications.
- 4.4 Both wheels met the AAR Class C wheel specifications for hardness. No discrepancies were noted with the subject wheel material which met the AAR requirements.
- 4.5 The metallurgical analysis of the wheel flanges indicated that there was no welding associated with these features.

Figure 5: Photograph showing the feature on the wheel flange. Note how the edges have a rounded appearance.

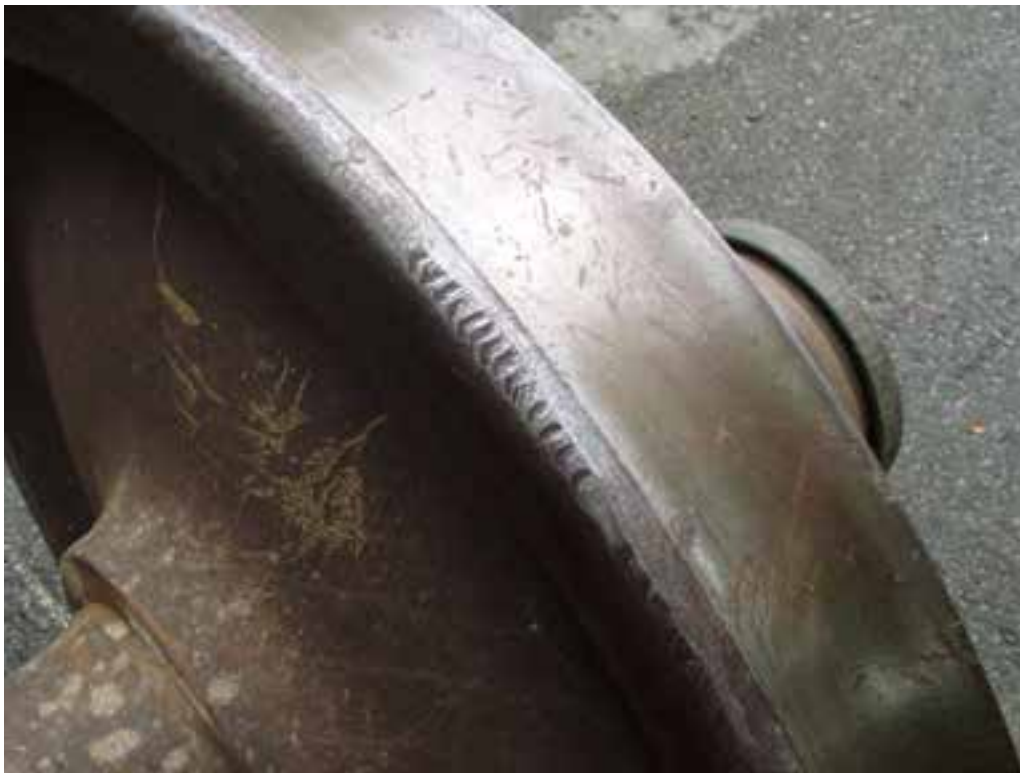
- 2.3 Examination of the mating wheel also revealed a similar feature on the wheel flange (Figures 6 and 7). This feature was located approximately 180 degrees from the feature on the subject wheel. Similar to the other wheel, the feature on this wheel had worn edges and an overall worn appearance.

Figure 6: Photograph showing the feature observed on the mating wheel 80228

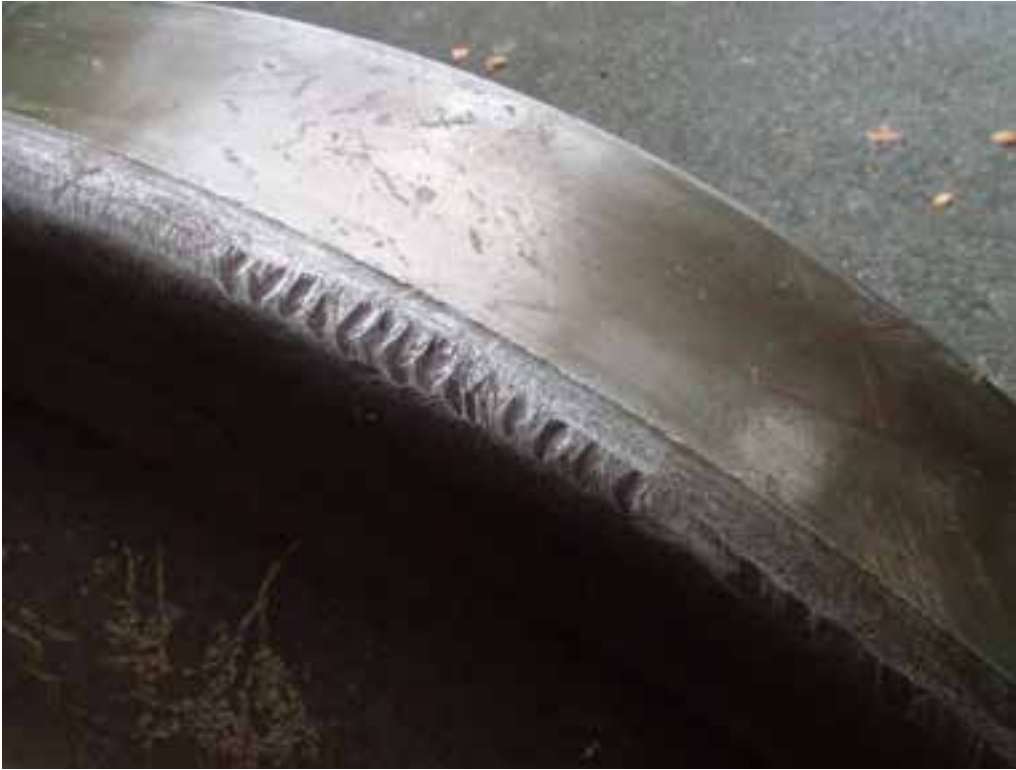
Figure 7: Photograph showing a closer view of the feature on the mating wheel 80228. Note how the edges have a rounded appearance similar to the feature on wheel 83414.

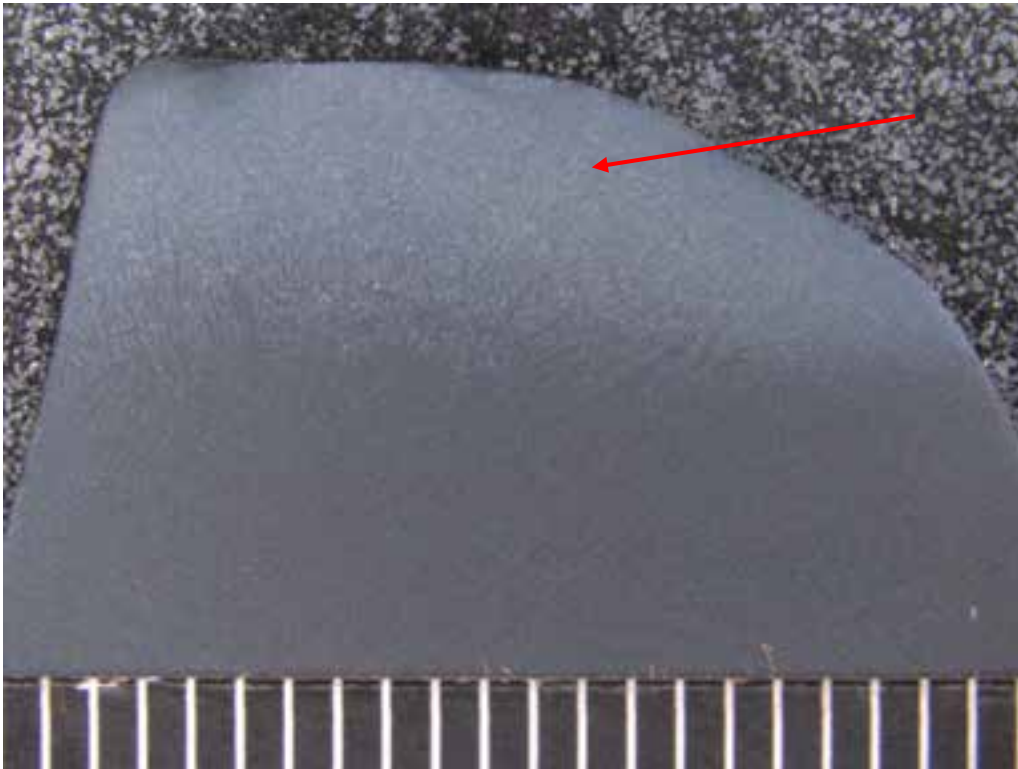
- 2.4 Three metallurgical sections were taken: the first through the middle of the subject wheel flange feature, the second at 90 degrees from the wheel flange feature, and the third from a random location on the wheel flange on the mating wheel. All sections were chemically etched in 2% nital solution. The metallurgical sections showed a zone of fine tempered martensite at the tip of the wheel flange and a core microstructure of ferrite–pearlite (Figures 8 to 13). No sign of welding was observed on the metallurgical section taken through the subject feature. The zone of fine tempered martensite at the tip of the wheel flange is most likely a result of the manufacturing process and would have no effect on the wheel operation or performance.

Figure 8: Photograph showing the metallurgical section taken through the feature on the wheel flange. The red arrow points to the zone of fine tempered martensite. (Nital etchant)

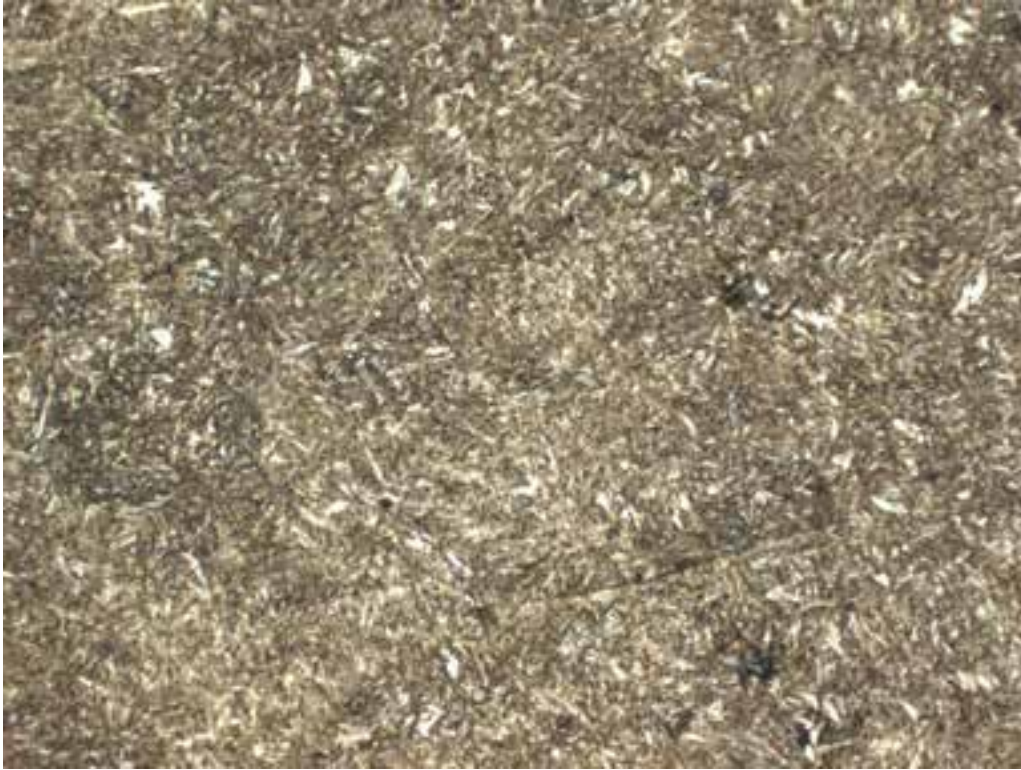
Figure 9: Micrograph showing the fine tempered martensite in the tip area of the wheel flange (Nital etchant, original magnification  $\times 200$ )

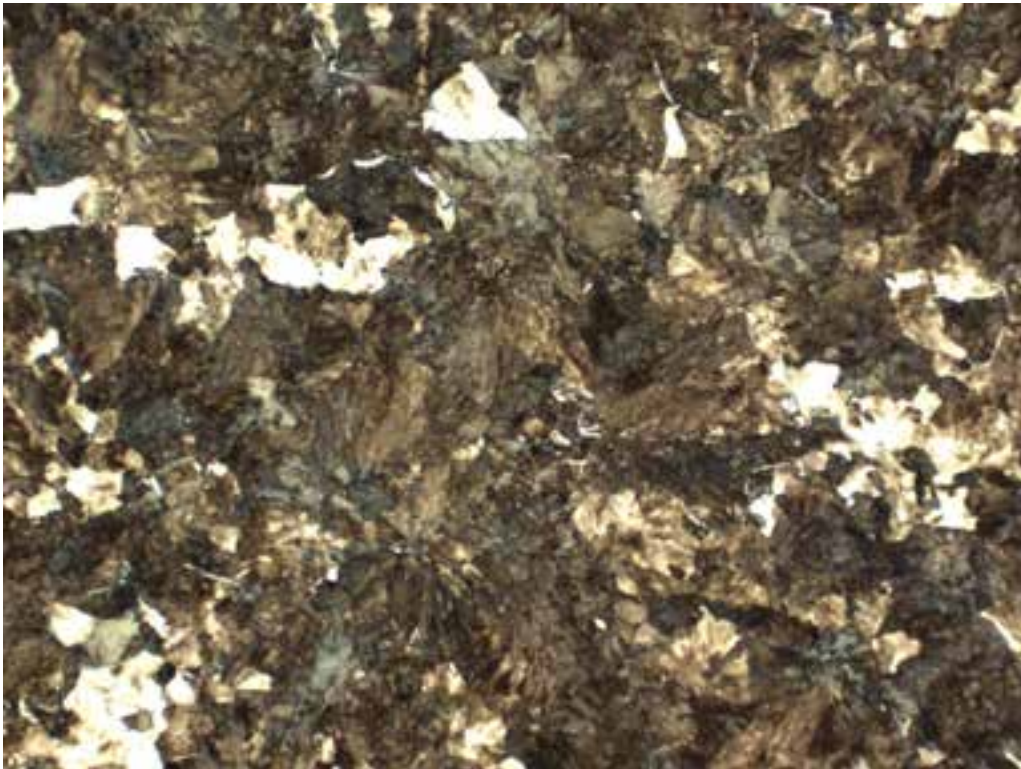
Figure 10: Micrograph showing the ferrite-pearlite microstructure in the wheel core (Nital etchant, original magnification  $\times 200$ )

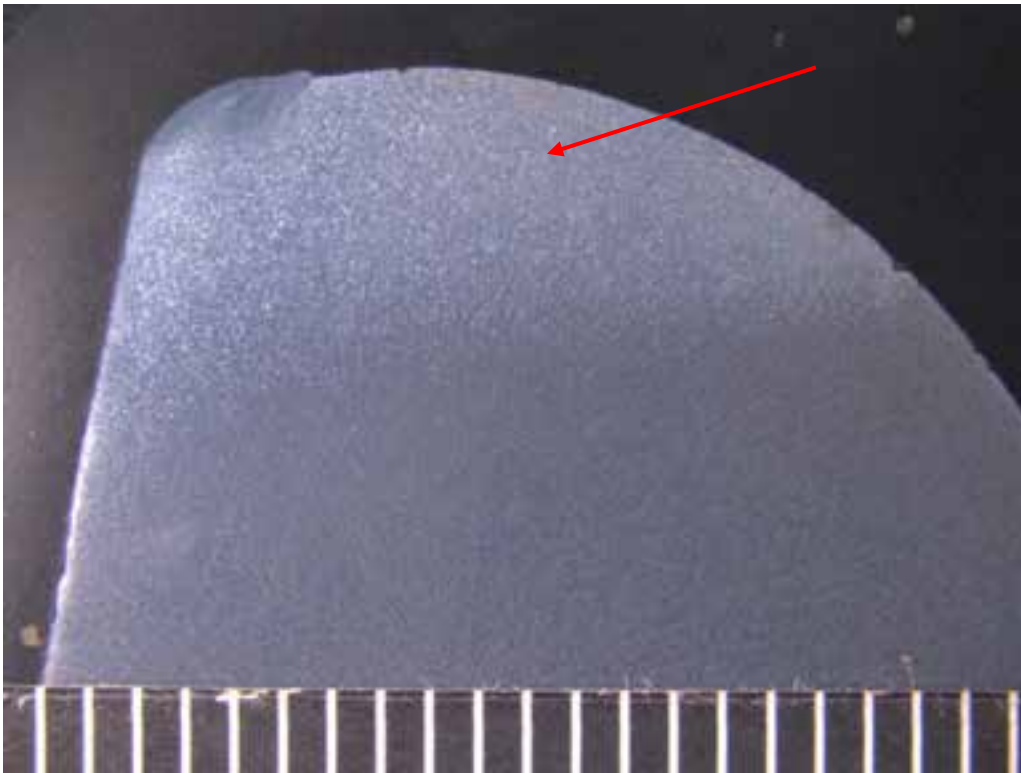
Figure 11: Photograph showing the metallurgical section taken from the subject wheel 90 degrees from the observed feature on the wheel flange. The red arrow points to the zone of fine tempered martensite. (Nital etchant)

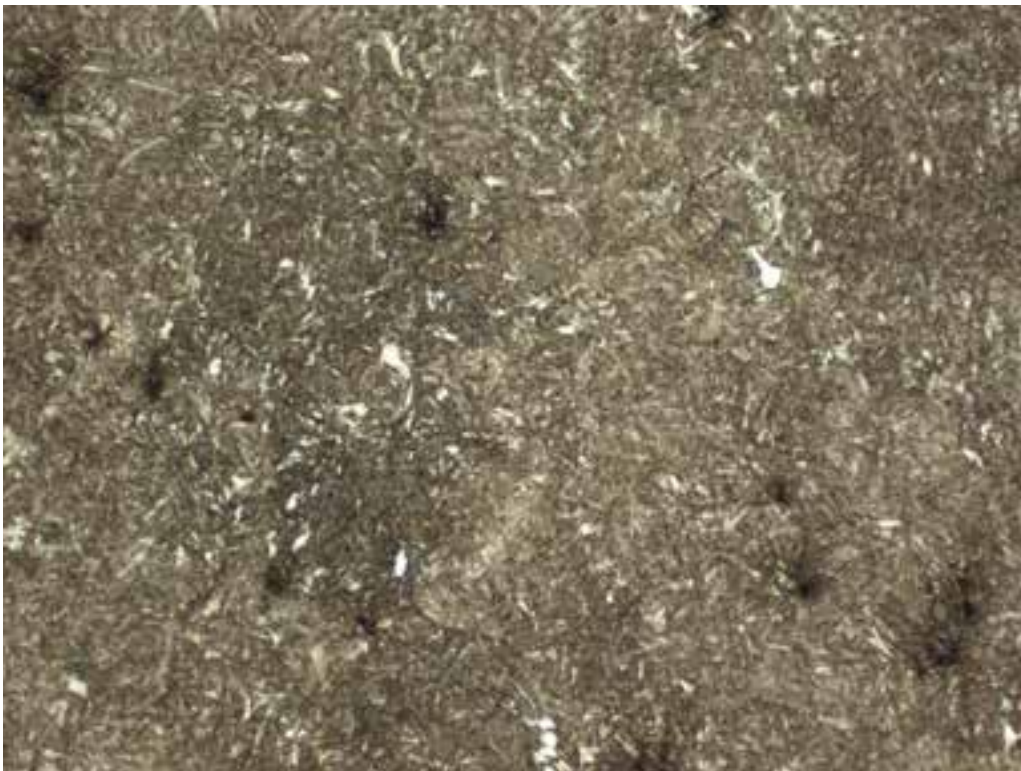
Figure 12: Micrograph showing the fine tempered martensite in the tip area of the wheel flange on the section taken at 90 degrees to the feature on the wheel flange. (Nital etchant, original magnification  $\times 200$ )

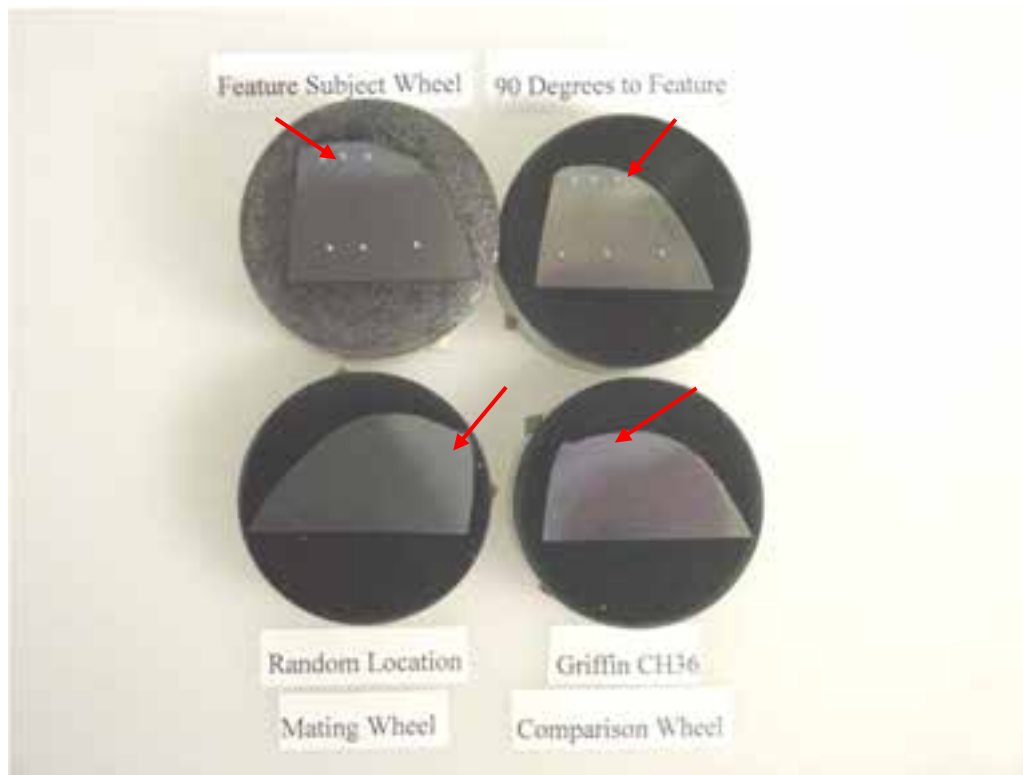
- 2.5 To confirm if this zone of fine tempered martensite at the tip of the wheel flange was an anomaly in this particular wheel set only, a comparison section was taken from another Griffin wheel located at the Engineering Laboratory. The wheel was type CH36, manufactured in March 2011, serial number 06568. Like the subject wheel, the tip of the wheel flange was composed of fine tempered martensite and the core microstructure was ferrite–pearlite. The 4 metallurgical sections are shown in Figure 13. The tip area of the wheel flange which has fine tempered martensite is clearly visible.

Figure 13: Photograph showing the 4 metallurgical sections taken of the wheel flanges. The arrows point to the zone of fine tempered martensite at the tip area of the wheel flange.

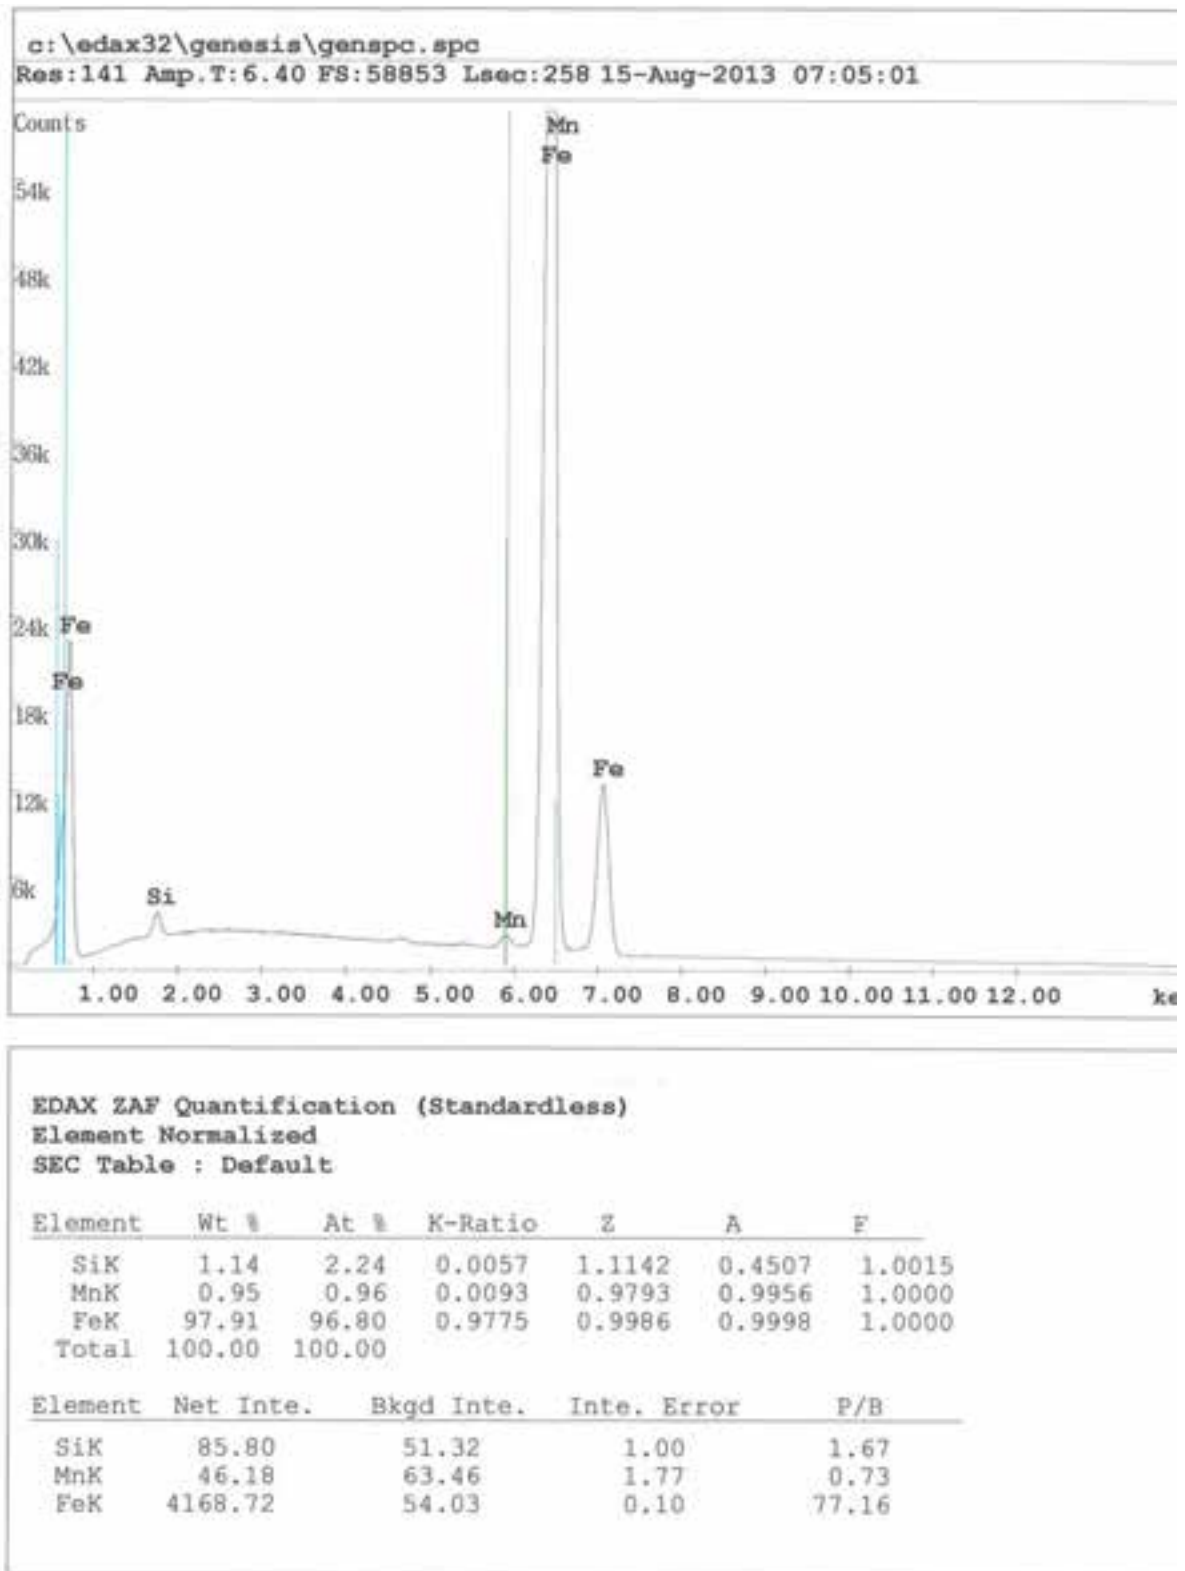
- hardness results of the core were within the AAR hardness specification for this class of wheel.
- 2.7 Energy dispersive spectroscopy (EDS) was performed on the metallurgical section taken from the subject wheel and the standard less results show the subject wheel gave manganese and silicon contents consistent with the AAR specification. The amount of carbon, phosphorus, and sulphur could not be measured. A representative spectrum is shown in Figure 14.
- 2.8 Wheel wear measurements were performed on both wheels and the results are shown in Table 4. Both wheels were within the serviceable limits specified by the AAR.

Figure 14: EDS spectrum and standard less analysis results for the subject wheel material showing the iron (Fe), manganese (Mn) and silicon (Si) peaks
