AVIATION INVESTIGATION REPORT

A00A0185

RUNWAY OVERRUN

FOKKER F-28 C-GKCR

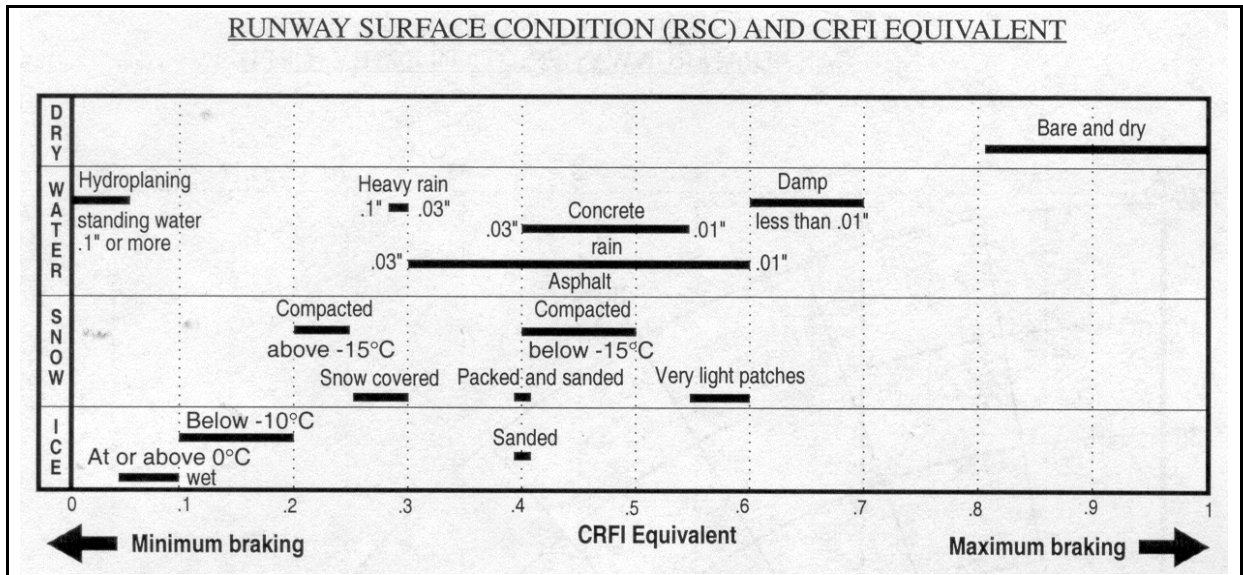
Charts in the Canadian Regional SOP manual allow crews to calculate landing distances for various weights and CRFI combinations. When a CRFI reading is not available, crews refer to the Runway Surface Condition and CRFI Equivalent chart found in the company SOP or in *A.I.P. Canada* (Figure 1). Using this chart, crews can choose a CRFI equivalent from among typical runway surface contaminants such as water, snow, or ice. This chart does not, however, have a CRFI equivalent for slush contamination.

The RSC for runway 09 reported to the crew about 10 minutes before arrival indicated that the runway centreline was 50% covered in thin slush. The CRFI equivalence chart does not give a value for runways that are partially or fully contaminated with slush. The crew, therefore, had no means of estimating a CRFI equivalence for the landing on runway 09. About 8 minutes before landing, the crew indicated to the FSS specialist that they had the option to land on either runway and requested that the vehicles be cleared from all runways. This suggests that the crew continued to believe that both runways would be usable for landing and that they were not aware that the slush contamination was accumulating on runway surfaces. Seven minutes before landing, the RSC reported to the crew for runway 15/33 indicated that the entire runway surface was covered in slush, eliminating 15/33 as a usable runway. This report could have served as an indication that slush was also accumulating rapidly on runway 09; however, this fact was not made clear to the crew.

1. The Canadian runway friction index equivalence chart does not indicate a value for runways contaminated with slush. Crews have no means of readily assessing the effects of slush on an aircraft's stopping performance.
2. Runway surface condition reports do not indicate if a contaminant, such as slush, is accumulating or the rate of such accumulation.

On 20 June 2002, a second advisory (A020014-1) was forwarded to TC suggesting that TC consider establishing CRFI equivalents for slush contamination.
