AVIATION INVESTIGATION REPORT

A00Q0043

INCORRECT ASSEMBLY OF AILERON CONTROL SYSTEM

CESSNA 172L C-FAXL

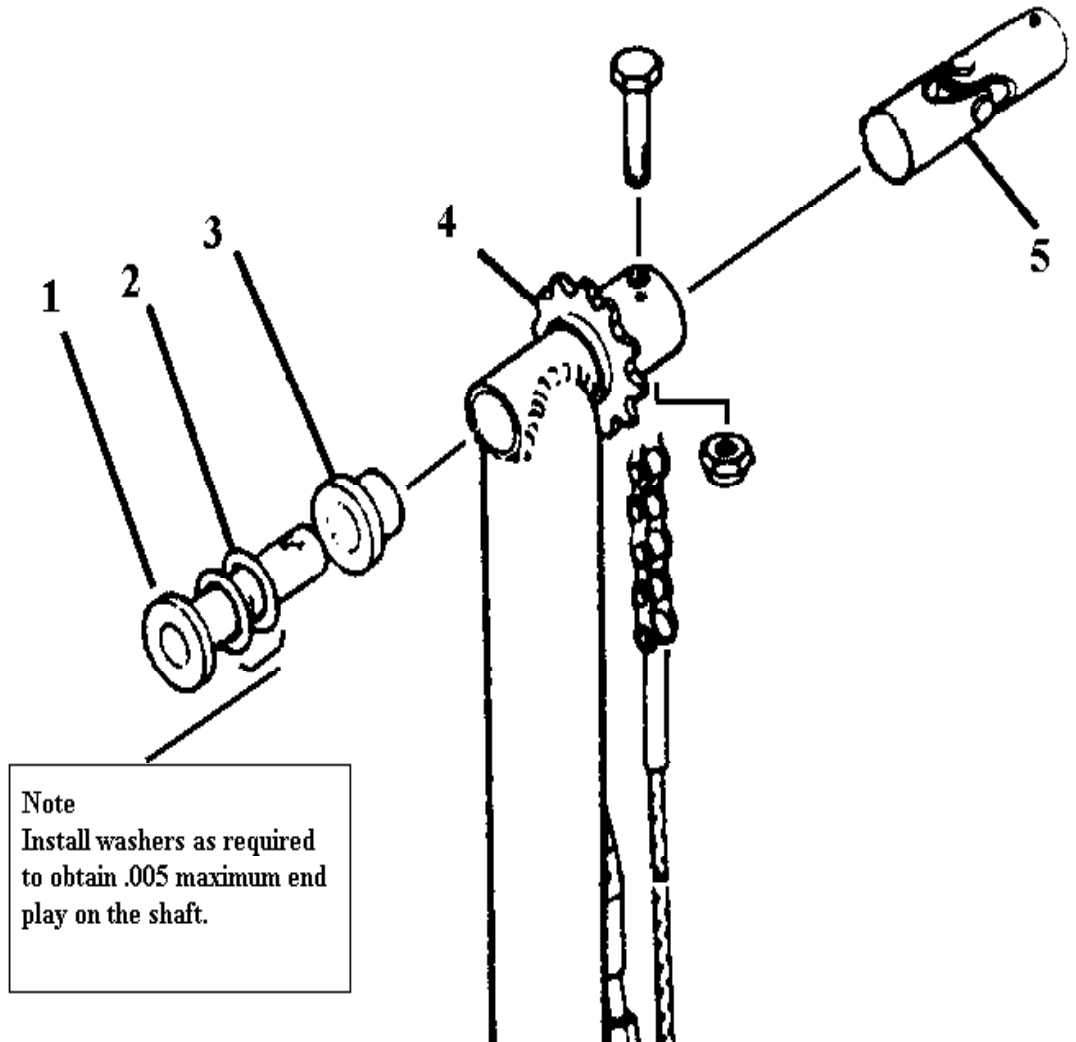
*Appendix A—Aileron Control System*

The work involved sliding the universal joint (part number [P/N] 0411257) into the sprocket (P/N 0511785-1), then pushing the shaft (P/N 0511788-1) into place and aligning it to install the bolt. The bolt would thus hold all the parts together. In the second occurrence, the maintenance manager had trouble aligning and inserting the universal joint in the sprocket. To ensure the integrity of the assembly, the manufacturer had added a note specifying that washers (P/N AN960-816L) were to be installed on the shaft to limit the distance between the shaft and the bearing (P/N S1004-43A) to 0.005 inch. (See Appendix A for a diagram of the aileron control system.) The Cessna 172 maintenance manual contains no specific instructions for removing and installing the universal joints. The manual describes, rather, the procedure for removing and installing the control as a whole. For a better view of the right-hand installation, the technician could have accessed all the parts by removing the card box, but he did not do so. The technician therefore had to work by feel in a more confined space.

The universal joint was held in place by the pressure exerted by the nut, even though the nut was not in the right place. Consequently, the abnormality could not be detected in the ground test of the controls. Removing the card box would have simplified access and would have helped to visually confirm the incorrect assembly. The time required to remove and replace the card box was a determining factor in this maintenance operation. The distance between the shaft and the bearing was nearly 0.500 inch, whereas it should have been 0.005 inch. Even an inspection by touch would have been able to detect this abnormality.
