AVIATION INVESTIGATION REPORT

A00Q0094

RUNWAY EXCURSION

BOEING 747-200 CN-RME

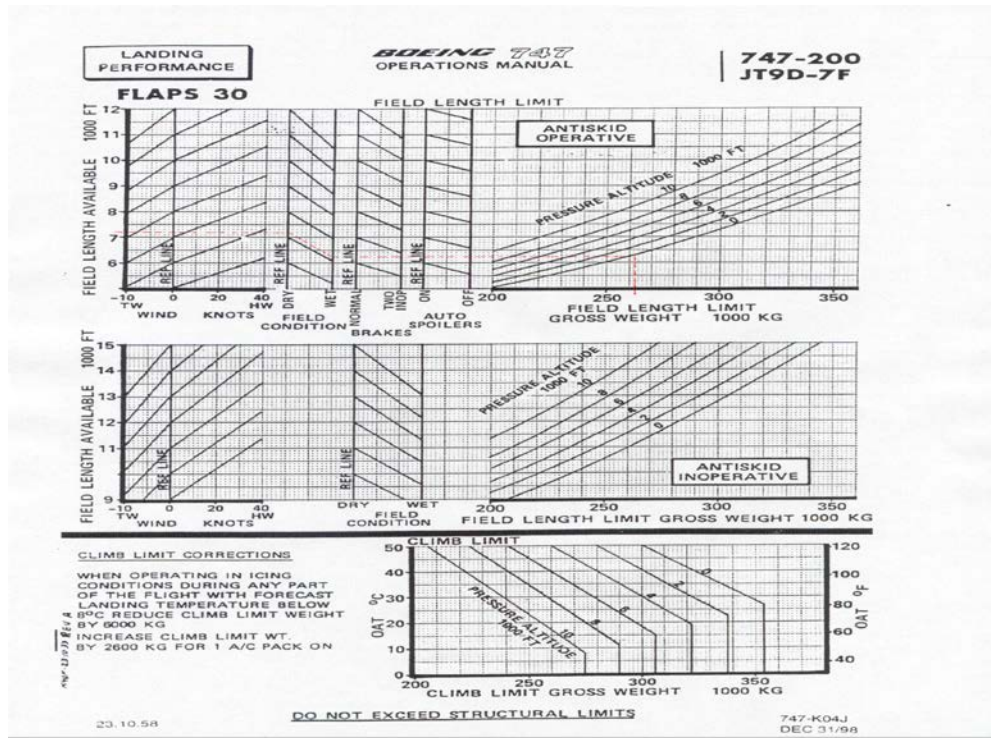
Appendix A—Landing Performance Diagram

Landing distance required 7200 feet

Wet runway

Aircraft landing weight 263 000 kg

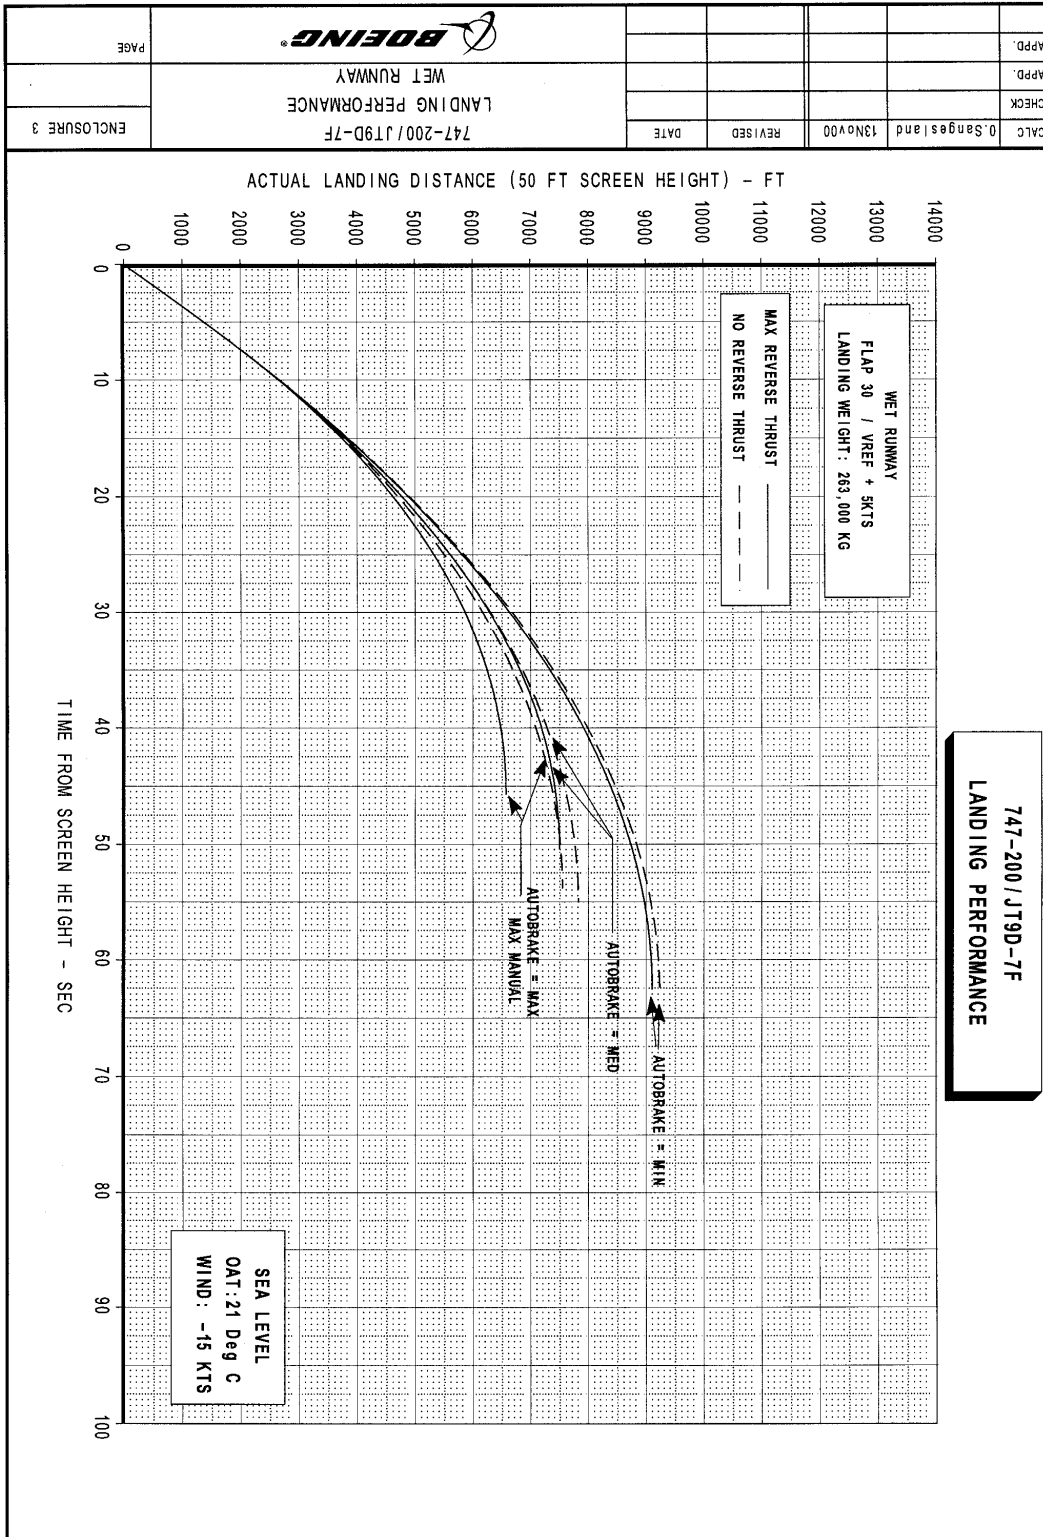
Appendix C—Landing Distances on Wet Runway: 15-knot Tailwind Component

Given the tailwind component a few seconds before touchdown and the wet runway, the flight crew was in a situation where it almost could not depart from the ideal landing profile. Even if braking had been carried out with the automatic system selected to medium, as recommended, and even if the approach speed had been maintained at $V_{ref} + 5$, the

aircraft needed about 7800 feet to come to a stop under these conditions, which left a margin of error of only 200 feet.
