AVIATION INVESTIGATION REPORT

A01P0126

LOSS OF SEPARATION

NAV CANADA

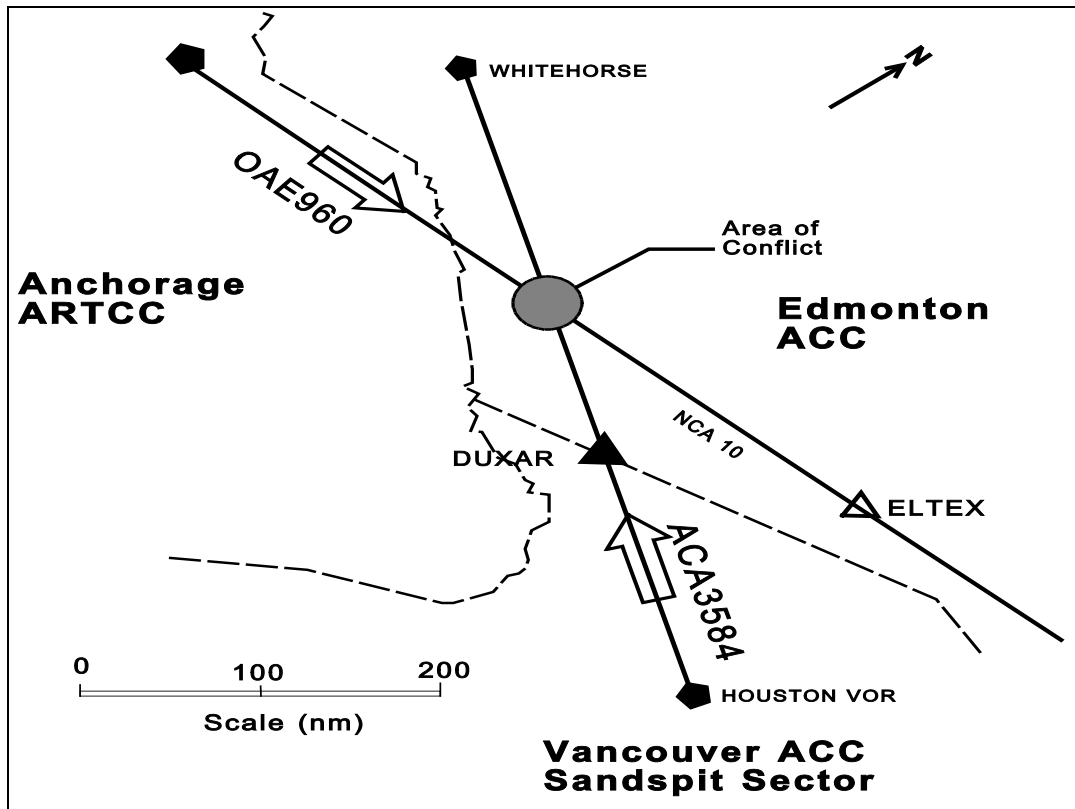
The B737 (ACA3584) was proceeding to Whitehorse via the Houston VOR (very high frequency omnidirectional radio range) and the DUXAR intersection at a cleared altitude of FL310. It crossed the Northern Control Area Route 10 (NCA 10) about 110 nautical miles (nm) northwest of the DUXAR intersection. This intersection is at the airspace boundary between the Vancouver and Edmonton ACCs. (See Figure 1.) Between the Houston VOR and DUXAR, the aircraft was under the control of the Sandspit sector of Vancouver ACC.
