**AVIATION INVESTIGATION REPORT
A01P0194**

COLLISION WITH TERRAIN

**WAHKASH CONTRACTING LTD.
DE HAVILLAND DHC-2 C-GVHT
MACKENZIE LAKE, BRITISH COLUMBIA, 4 nm NE
13 AUGUST 2001**

Report Number A01P0194

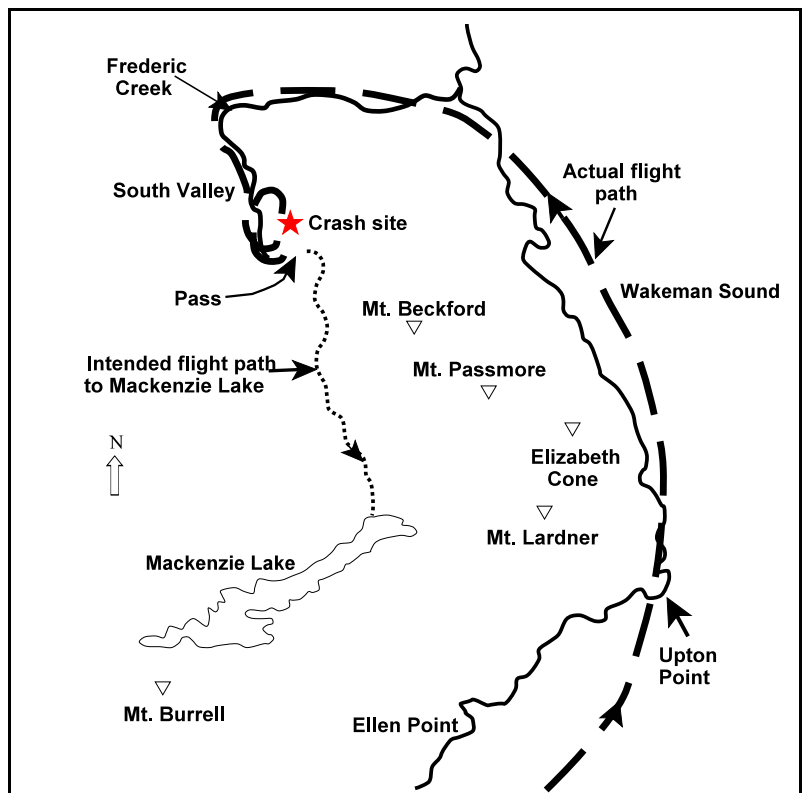
Figure 1 - C-GVHT's flight path

One of the managers of the camp, who was on a logging road in the south valley, advised the pilot to come to the Frederic Creek area because it was clear of cloud. The pilot then flew northeast to Wakeman Sound, where he advised that he could descend below the cloud to the Frederic Creek inlet. The aircraft flew west along Frederic Creek until turning left toward the pass in the south Frederic Creek valley. The pass crosses a north-south divide (saddle); the valley to the east of the divide turns south immediately and descends to Mackenzie Lake. (See Figure 1.)

The aircraft flew south toward the pass and made one circuit of the valley. After the circuit, the aircraft again flew toward the pass, then executed a sharp left turn about 10 seconds before the accident. The aircraft was flying away from the pass at impact. The last brief radio transmission from the pilot was at 1706, only seconds before impact.

During the second attempt, the turn radius was smaller and the ground speed slower than in the first circuit, allowing the aircraft to come closer to the pass. As a result, the aircraft was forced to turn in a more confined area.

The accident occurred after a left turn away from the pass, during the second attempt to get through the pass. During this attempt, the turn radius was smaller and the speed slower than in the first circuit, allowing the aircraft to come closer to the pass. It is therefore most likely that during the second attempt to investigate the pass, the pilot slowed the aircraft and, when he decided to abort flight through the pass, turned sharply to avoid the higher terrain on the north side. As a result, the pilot was forced to turn left in a more confined area and would have applied greater bank angle in the turn to avoid the steep terrain.

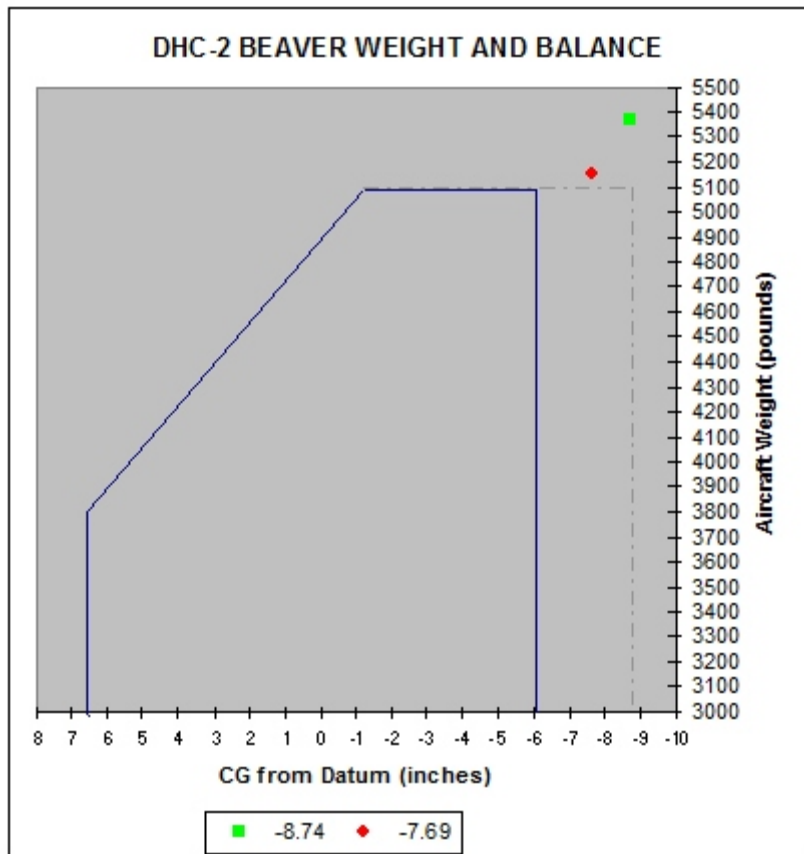
Figure 2: Weight and balance calculations for C-GVHT

The pilot loaded the aircraft at Campbell River himself, as was his practice. There is no information that the cargo or passengers were weighed before the flight. Weight and balance calculations by TSB, using actual weights of the occupants and cargo carried, show that, at take-off from Campbell River, the aircraft was 5364 pounds, with a CG of 8.7 inches aft of the datum—274 pounds over MAUW and 2.6 inches outside the aft CG limit. Calculations also showed that the aircraft was overloaded by approximately 59 pounds at the time of the accident and that the CG was 1.6 inches outside the aft limit. (See Figure 2. Note that this graph also shows the aft CG limit for the wheels configuration.)

The aircraft weight and balance were outside the approved and tested flight envelope, in an area where the stall characteristics of this aircraft are unproven. The aircraft weight exceeded the certificated MAUW, and the CG was outside the floatplane aft limit, the latter being a condition known to hasten the onset of stall, produce challenging aircraft attitude changes, and make recovery difficult. Furthermore, because incorrect values were used for the aircraft basic weight and passenger weight (errors of 275 and 185 pounds respectively), any weight and balance calculation would consistently have been approximately 450 pounds less than actual.
