AVIATION INVESTIGATION REPORT

A01Q0166

LOSS OF CONTROL AND COLLISION WITH WATER

DE HAVILLAND DHC-2 MK 1 C-GPUO

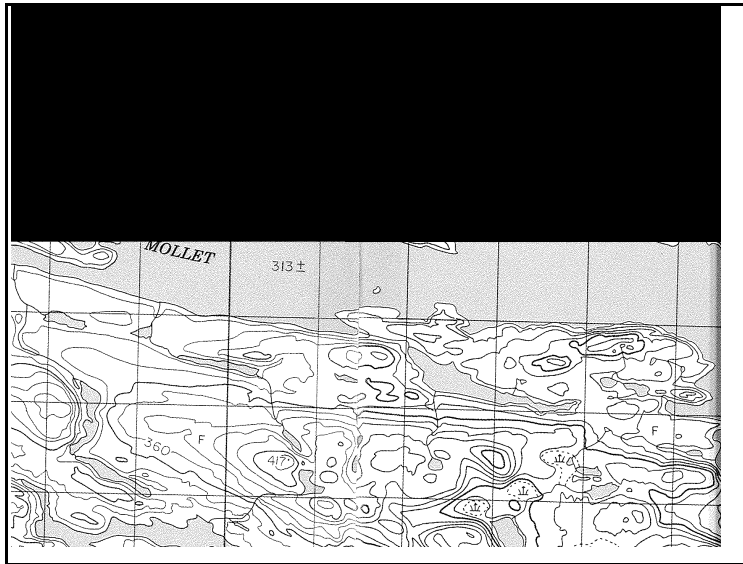
The outfitter is located on the north shore of Mollet Lake. The lake is 1 nm wide and is oriented east-west. The aircraft flew the downwind leg, proceeding east along the south shore of the lake. About 1 nm east of the outfitter, at an altitude of about 500 feet above ground level, the pilot made a left turn and proceeded north on the base leg. On approaching the north shore and the rising terrain immediately north of the lake, the aircraft was shaken and then turned right, taking it farther away from the outfitter. Meanwhile, witnesses heard an increase in engine noise. In the turn, the seaplane pitched nose-down and struck the surface of the lake, right wing first. The aircraft crashed 1 nm from the outfitter at about 1735.
