AVIATION INVESTIGATION REPORT

A02C0143

LOSS OF ENGINE POWER AND FORCED LANDING

BLUE WATER AVIATION SERVICES  
DE HAVILLAND DHC-2 MK1 BEAVER C-FEYQ  
SASAGINNIGAK LAKE, MANITOBA 10 NM S  
28 JUNE 2002

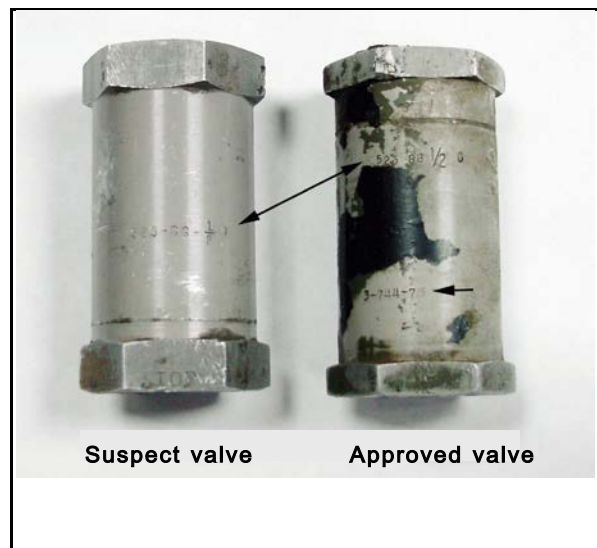
During the examination of the aircraft, two anomalies were noted in the fuel delivery system. The first anomaly involved one of the two inline fuel system check valves (see Figure 1). The check valves were stamped with the same body number (525 GG 1/2 D), but only one valve was stamped with the original component manufacturer's part number (P/N) 3-744-75. The valve without the original component manufacturer's P/N stamp appeared to be of a different design. The internal flapper door on this valve had a stiffer return spring and the flapper door was found to contact the internal wall of the valve, preventing the door from opening fully. This check valve was installed in the main fuel line between the inlet and outlet lines connected to the wobble pump.

Both valves were tested at the component manufacturer's facility in Irvine, California. The minimum flow requirement for the P/N 3-744-75 valve is 110 cubic centimeters per minute (cc/min) with a flow rate of 5 inches of solvent. The flow rate for the approved P/N 3-744-75 valve was measured at 132 cc/min with the flow beginning at approximately 4 inches of solvent. The flow rate for the non-approved valve was measured at 36 cc/min with the flow eventually beginning at 5 inches of solvent, after waiting a few seconds.

The only two anomalies found in the fuel delivery system that could account for the loss of engine power was a restriction in the inline fuel check valve at the wobble pump location and a kink in the main engine fuel feed line. A restriction in the check valve at the wobble pump location would probably not result in an engine power loss, as fuel can still be drawn through the internal check valves in the wobble pump, providing an additional path of fuel to the engine. However, the path would have resulted in additional line losses due to the additional routing and check valves. The prior problem with the wobble handle moving up and down indicates that the inline fuel check valve was restricted to the extent that fuel was being drawn through the wobble pump to compensate for the restriction. The subsequent lowering of the fuel pump pressure likely lowered the flow of fuel through the check valve to a point where the fuel did not have to be bypassed through the wobble pump.

4. The aircraft was equipped with a non-approved fuel check valve that did not meet the manufacturer’s flow specifications. The fuel check valve not only presented a restriction in the fuel delivery to the engine, but was equipped with a stiffer valve plate return spring, which could delay the restarting of the engine if a fuel tank were to be run dry.

The examination and testing of the inline fuel check valves indicated that one valve did not meet the original component manufacturer's flow specifications, and as such was unapproved. Transport Canada has sent a letter to the airframe manufacturer requesting their position on this potential safety issue and what corrective action will be taken. The aircraft manufacturer's airworthiness department has taken the issue of the unapproved inline fuel check valve under advisement.

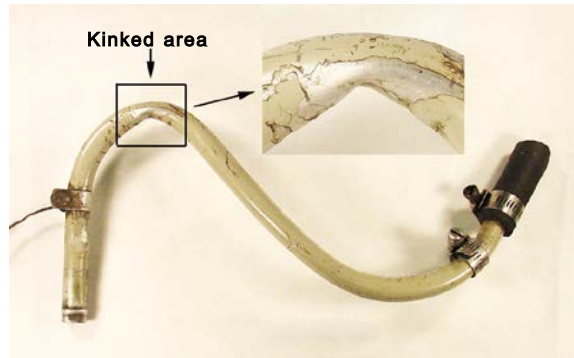
The second anomaly was a significant kink in a section of the aluminum main engine fuel feed line (P/N C2P1017), mounted directly behind the engine oil cooler temperature regulating valve. The valve controls the flow of oil through the cooler. The kink was located on a bend in the line and had reduced the size of the line to

approximately 1/2 of its original diameter. The fuel line was located in a protected area of the fuselage and would not have been damaged from impact forces. As a result, the kink was believed to be damage caused during an unspecified maintenance action at some unknown time prior to the occurrence (see Figure 2).

The main fuel line was in an airframe compartment just aft of the engine firewall and behind the oil cooler temperature regulating valve. This area of the compartment was subjected to high temperatures during this flight, as the oil cooler would have been flowing at high capacity to dissipate heat from the hot engine oil. The result would have been heating of the fuel line and the fuel flowing through it. The kink in the fuel would have restricted the flow of fuel through the line causing a localised drop in fuel pressure at the narrowest point (venturi effect).

Because of the location of the fuel tanks, there is very little head pressure in the tank to force the fuel forward. As well, suction in the fuel line was lower than normal because of the adjustment to the engine-driven fuel pump. As the tank level decreased and the fuel line temperature rose, it is likely a fuel vapour lock occurred. The boiling point of the fuel at the location of the kink would have been lowered because of the drop in pressure caused by the venturi effect. The kink, located at a bend in the line, would also have induced a turbulence in the fuel where the fuel flow over the bend would have separated from the internal wall of the line, downstream of the kink. As the fuel passing over this low pressure area was heated by the hot air being dissipated from the oil cooler, the fuel likely reached a temperature at which it vaporized.

1. The main engine fuel feed line had been damaged and kinked at some unknown time prior to the occurrence, which restricted the flow of fuel through the line.

3. The area of the kink in the fuel line was in a hot area behind the engine oil cooler, which likely led to a fuel vapour lock situation resulting in a loss of engine power.
