AVIATION INVESTIGATION REPORT

A02P0126

MAIN ROTOR BLADE FAILURE

MD HELICOPTERS INC. 369D (HELICOPTER) C-GHFA

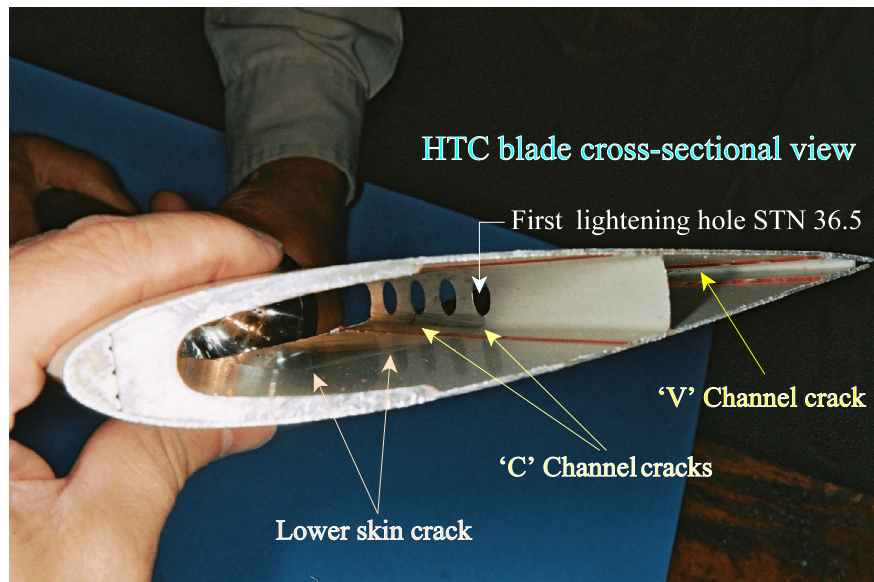
Figure 1. Main rotor blade cracking

The visible crack on the exterior surface of the blade measured 4.5 inches long and ran in a chord-wise direction from the approximate aft edge of the spar to the trailing edge of the lower skin at STN 36.5. Once the blade was sectioned it was found that, in addition to the lower skin crack, the "V" channel at the trailing edge of the blade had a longitudinal crack that

measured 2.7 inches long. This crack was roughly centred about the lower skin crack and the "C" channel crack, below the first lightning hole. No cracking of the spar or upper skin were detected in the area of the lower skin crack. (Figure 1)

The "C" channel crack fracture faces were found to exhibit beach markings and patches of deteriorated striations that are indicative of a fatigue mode of progressive cracking. The fatigue cracking was found to initiate from the inside diameter of the first lightning hole in the "C" channel of the blade. It progressed downward through the lower section of the channel and into the channel to skin adhesive.

A line type fatigue initiation was observed on the inside surface of the lower skin below the "C" channel. The fatigue then progressed through the lower skin to its outside surface and spread both forward and rearward in a chord-wise direction from that point.

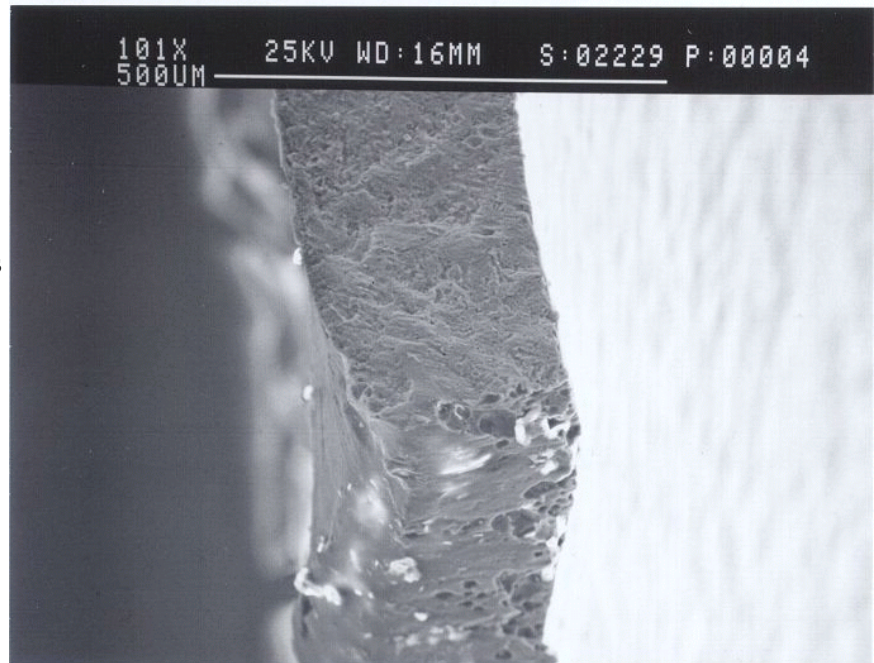
Figure 2. SEM image revealing pitting (101 X magnification)

The fatigue initiation was found to be associated with relatively large pits on the "C" channel (Figure 2) lightning hole surface. The pitting on the "C" channel was present when primer was applied to the part. Rods of strontium that are incorporated into the primer were found adhered to the surfaces of the pits. A secondary crack extended out of the lower side of the third "C" channel lightning hole. The cracking at the third "C" channel lightning hole appeared to be

associated with pitting on the inside diameter surface of the hole. The blade skin and "C" channel were both found by material analysis to be typical of Alclad aluminum alloy AA 2024. No significant contaminants were detected on the crack fracture surfaces.

The pitting on the "C" channel was present when primer was applied to the part. These imperfections or pits caused a stress riser and were the origin of a crack in the "C" channel lightening hole that propagated to the blade's lower skin. The structural integrity of the main rotor blade was compromised.
