AVIATION INVESTIGATION REPORT

A02Q0021

IN-FLIGHT ENGAGEMENT OF COLLECTIVE LEVER LOCK

EUROCOPTER AS 350 BA C-FPOO

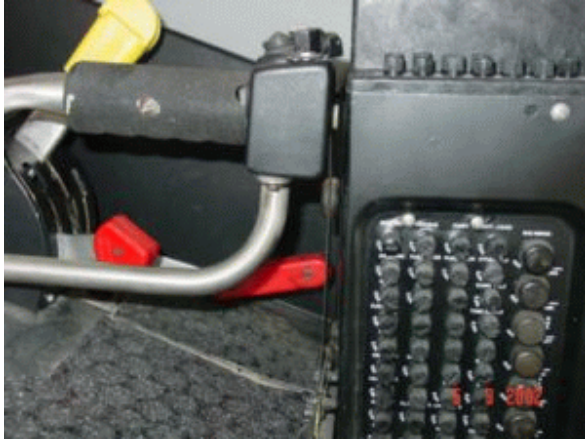
When examining the occurrence helicopter before it was moved, an AME noted and reported that the collective lever locking plate was not engaged and, after engagement, it disengaged normally with light pressure on the collective lever; these observations were corroborated by the TSB investigator. But the space between the end of the collective lever and the electrical console was about 5 mm (see Figure 1), which is 11 mm less than the Eurocopter specification (16 mm \pm 0.5 mm) (see Figure 2).

Examination of the occurrence helicopter also revealed that some work had not been completed by the AMO. The stop screw was in an inverted position, and the connecting rods were shorter than those prescribed by the manufacturer, which allowed the collective control to overtravel down. This condition, combined with the down setting of the collective lever and the collective locking plate setting, contributed to the locking of the collective control by reducing the space between the electrical console and the collective lever.
