AVIATION INVESTIGATION REPORT

A03A0012

LOSS OF DIRECTIONAL CONTROL

BOEING 737-200 C-FGCJ

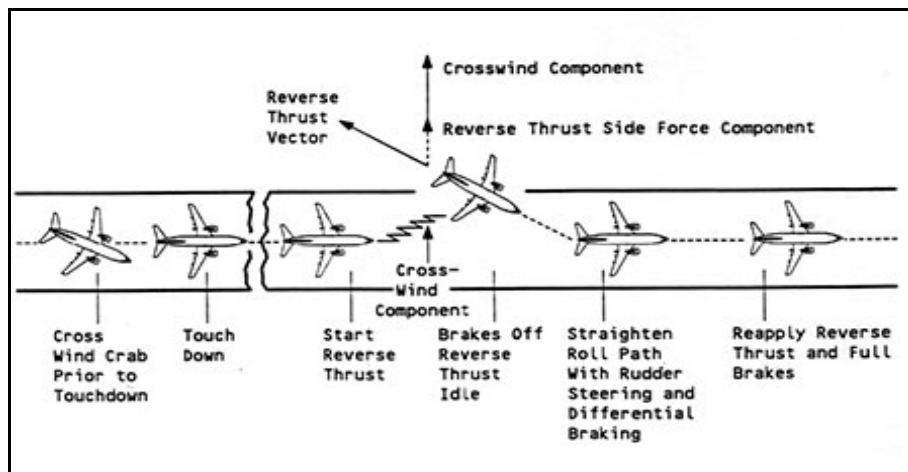
Figure 1. Reverse Thrust on Slippery Runways With Crosswind

The reverse thrust side force and a crosswind can cause the airplane to drift to the downwind side of the runway if the airplane is allowed to weathervane into the wind. As the airplane starts to weathervane into the wind, the reverse thrust side force component adds to the crosswind component and drifts the airplane to the downwind side of the runway. Main gear tire cornering forces available to counteract this drift will be reduced when the antiskid system is operating at maximum braking effectiveness for existing conditions. To correct back to the centreline, reduce reverse thrust to reverse idle and release the brakes. This will minimize the reverse thrust side force component without the requirement to go through a full reverser actuating cycle, and provide the total tire cornering forces for realignment with the runway centreline. Use rudder, steering, and differential braking, as required to prevent overcorrecting past the runway centreline. When re-established on the runway centreline, reapply steady brakes and reverse thrust as required to stop the airplane."

The absence of hydroplaning-related damage to the tires and the lack of standing water on the runway suggests that hydroplaning did not occur and was not the reason for the loss of directional control. Immediately after touchdown the aircraft weather vaned. It is likely that the combination of drift, reverse thrust, crosswind, and the wet runway resulted in the aircraft drifting to the downwind side of the runway, as stated in the Boeing operating manual.
