AVIATION INVESTIGATION REPORT

A03C0068

FLIGHT CONTROL MALFUNCTION

GOVERNMENT OF CANADA  
DEPARTMENT OF TRANSPORT  
BEECH KING AIR C90A C-FGXU  
DAUPHIN, MANITOBA 25 NM SW  
13 MARCH 2003

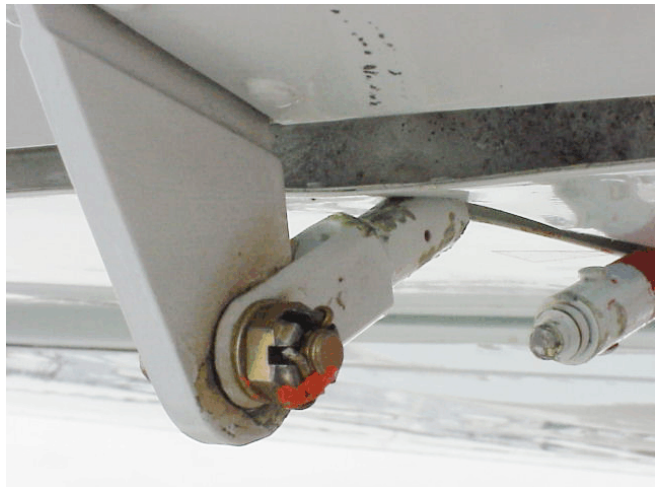
The occurrence happened approximately 150 flight hours after the inspection, at an airframe time of 8050 hours. An examination of the aircraft after the occurrence revealed that the left elevator trim-tab pushrod had failed at the threaded rod, flush with the surface of the jam nut, adjacent to the adjustable fork-end (see Photo 1). The fork-end was seized at a right angle to the trim-tab horn. The pushrod cutout in the elevator lower surface showed rub marks from the jamming of the fork-end in several locations in the cutout after the failure occurred. The torque on the attachment hardware was checked and found to be 90 inch-pounds. The manufacturer's recommended torque is 25 to 30 inch-pounds, with a provision to go as high as 50 inch-pounds to aid in aligning the slot in the castellated nut. It was reported that a torque wrench had been used during the installation of the castellated nut.

The trim tab and attachment hardware was forwarded to the Transportation Safety Board of Canada (TSB) Engineering Branch for examination. Scanning electron microscope examination of the fracture face on the threaded rod showed fatigue originating in a thread root. The fatigue

cracking had progressed to overstress rupture with no noticeable final overstress region, suggesting that the failure occurred under normal service loads when the crack reached critical size. Metallurgical testing of the pushrod showed that it met material specifications.

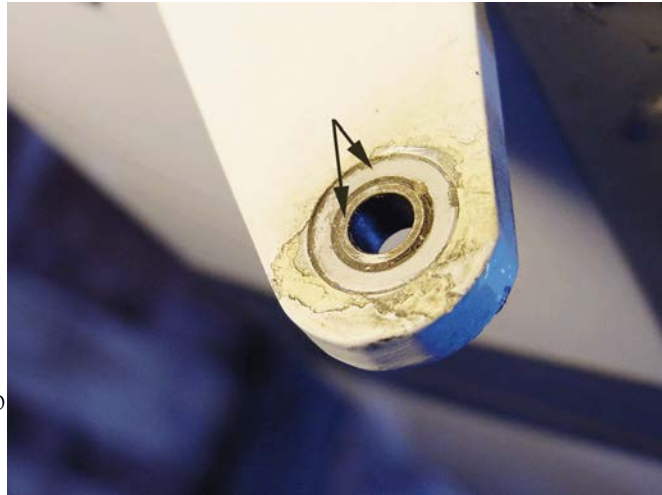
used to measure the force required to rotate the clevis; the results averaged 52.7 pounds of force. It was noted during the tests that the inner bushing remained fixed in the outer bushing and the clevis rotated about the inner bushing (see Photo 2). The clevis is designed to remain fixed to and rotate with the inner bushing.

The inner bushing was removed and a significant amount of non-uniform, circumferential galling<sup>2</sup> was observed extending around the entire circumference of the outer surface of the inner bushing. A dimensional check against the manufacturer's specifications showed that the inner bore of the outer bushing was undersized and non-cylindrical, while the diameter of the inner bushing was oversized, resulting in an interference-fit<sup>3</sup> between the two bushings and the non-uniform galling. The manufacturer's designed clearance range is between 0.0001 and 0.0016 inches; the measured clearance was between 0.0000 and -0.0013 inches.
