AVIATION INVESTIGATION REPORT

A03C0118

ENGINE FAILURE – FORCED LANDING

de HAVILLAND DHC-3 OTTER C-GGON

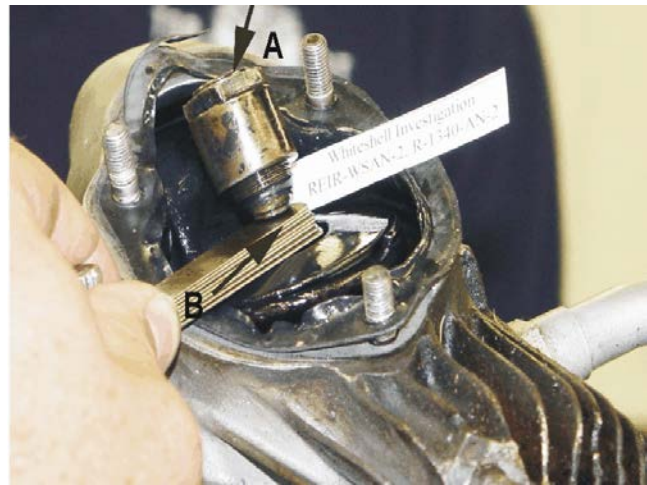
An examination of the airframe did not reveal any pre-impact anomalies. The engine, a Pratt & Whitney Wasp R-1340-S3H1-G, was removed from the accident site and taken to a local overhaul facility for tear-down analysis. During the rotation of the crankshaft, it was noted that the No. 3 cylinder exhaust valve did not open. The valve adjustment screw assembly was observed to protrude above the lock nut by 1/16 of an inch and the valve clearance was measured at 0.233 of an inch. The engine's maintenance manual specifies a minimum protrusion of the valve adjustment screw of 1/8 of an inch and a valve clearance of 0.035 of an inch (Figure 1).

During assembly of the No. 3 cylinder exhaust push rod, a spacer was incorrectly installed end-wise under the ball end. When the ball end was pressed into place, the spacer was likely set and partially bent within the tube, bringing the overall length of the push rod into a range that was considered satisfactory during installation. The investigation was unable to determine when the spacer was incorrectly installed.

During normal engine operation, the repetitive lifting action of the valve would have further bent the spacer, effectively shortening the overall length of the push rod and increasing the clearance between the valve and the valve rocker. This increased clearance would have resulted in a pounding action of the cam roller against the cam ring lobes. An adjustment of the valve clearance during the inspection conducted at 100 hours time in service would likely have brought the clearances back into tolerance; however, the cam roller and cam ring had already been damaged. Small fragments of cam roller material would have begun to break off, creating a flat spot on the roller. As the roller stopped turning and began to slide over the cam lobes, an increased wear pattern developed. At some point, the valve was again adjusted, accounting for the valve screw protrusion being out of limits. The adjustment was likely made in an attempt to bring the ever-diminishing valve clearance back into tolerance. The wear eventually progressed to the point where the exhaust valve was not opening. The failure of the exhaust valve to open would have resulted in the exhaust gases accumulating in the combustion chamber and migrating back through the opening of the intake valve into the induction system. The hot exhaust gases would have ignited the fuel/air mixture in the induction, resulting in a backfire and the loss of engine power.

It could not be determined when the No.3 exhaust valve was last adjusted or when the valve adjustment screw protrusion was set beyond limits. The company did not check the valve clearances on a progressive 400-hour schedule, as required by the maintenance manual and could not account for the valve adjustment screw protrusion being set beyond limits. Had the out-of-limits screw protrusion been noted during the adjustment of the valve or during a regularly scheduled inspection, an examination might have revealed the excessive wear in the valve train and prevented the engine power loss.

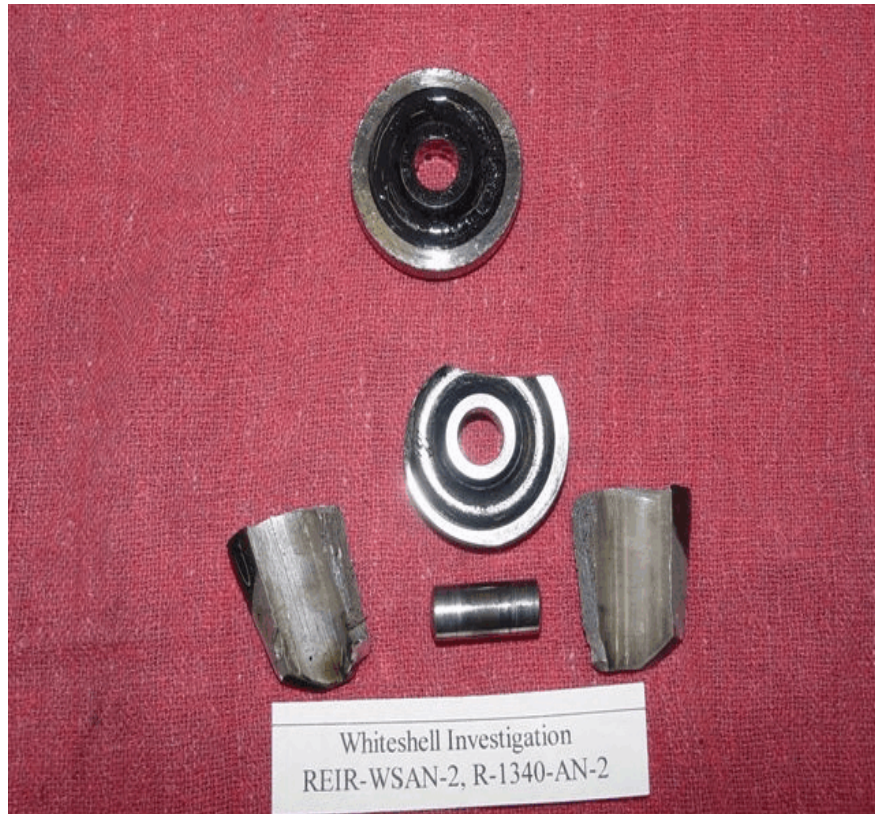
Appendix A - Worn Cam Roller

The front engine case was removed and the No. 3 cylinder exhaust roller was found to be excessively worn. The top portion of the cam roller slot tappet guide had split off and broken. The cam roller was measured and found to be worn 0.249 of an inch with a flat spot on one side (Appendix A). The cam ring was inspected and all four exhaust lobes were found to be excessively worn and out of limits. The No. 3 cylinder exhaust valve push rod was inspected and the ball ends were removed to check for the number of adjustment spacers under the ends. Push rods can be lengthened or shortened by adding spacers underneath the ball ends to accommodate valve adjustments during overhaul or cylinder replacement. Two spacers were noted under one end with one spacer found on the opposite end. The single spacer, however, had been installed standing on end and had been forcibly folded over at a right angle.

The breakage or failure of the top portion of the cam roller slot tappet guide likely occurred because the combination of wear on the No. 3 exhaust cam roller and cam lobes resulted in a longer stroke of the tappet assembly and the eventual protrusion of the cam roller pin beyond the tappet guide. This protrusion of the cam roller pin would have resulted in the cam roller pin drifting outward and splitting the top portion of the tappet guide roller slot. It is likely that the failure of the top portion of the tappet guide roller slot was the result of the engine backfire and did not contribute to the loss of engine power.
