AVIATION INVESTIGATION REPORT
A03O0302

ELEVATOR CONTROL RESTRICTION AT TAKE-OFF

AIR CANADA JAZZ
de HAVILLAND DHC-8-102 C-GONJ
OTTAWA/MACDONALD-CARTIER INTERNATIONAL AIRPORT
OTTAWA, ONTARIO
04 NOVEMBER 2003

Report Number A03O0302

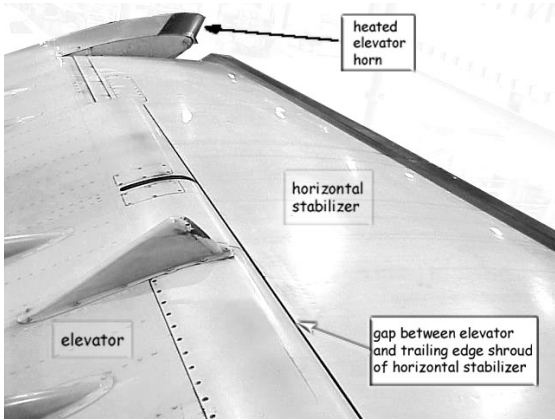
Photo 1. Left horizontal stabilizer with elevator trailing edge down

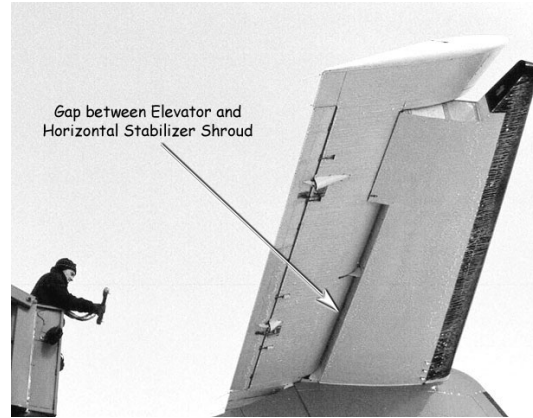
- Ice may have been present in the gap between the elevator and the shroud at the trailing edge of the horizontal stabilizer. Previous occurrences have shown that contamination in this location can interfere with elevator movement by jamming between the elevator and the shroud. This was considered the most likely method of interference in this occurrence.

Photo 2. Underside of stabilizer showing gap, controls in locked position

1. A remnant of clear ice most likely migrated into the gap between the nose of the left-hand elevator and the shroud at the rear of the stabilizer when the elevator was moved trailing edge up during control checks and interfered with movement of the elevator when the pilot attempted to rotate for take-off.

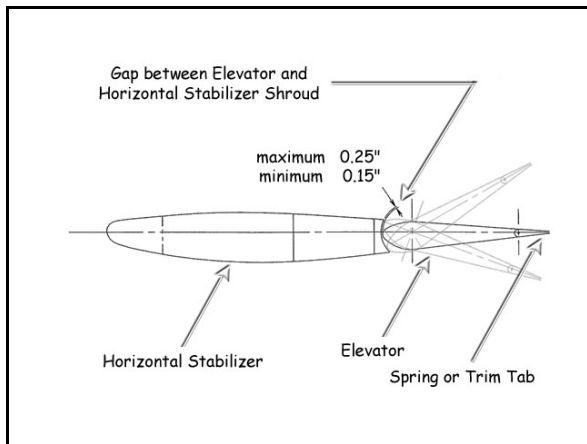
Figure 1. Horizontal stabilizer and elevator cross section

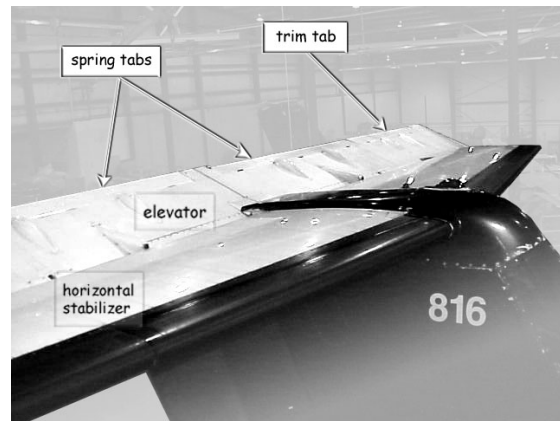
Photo 3. Horizontal stabilizer with elevator in trailing edge up position

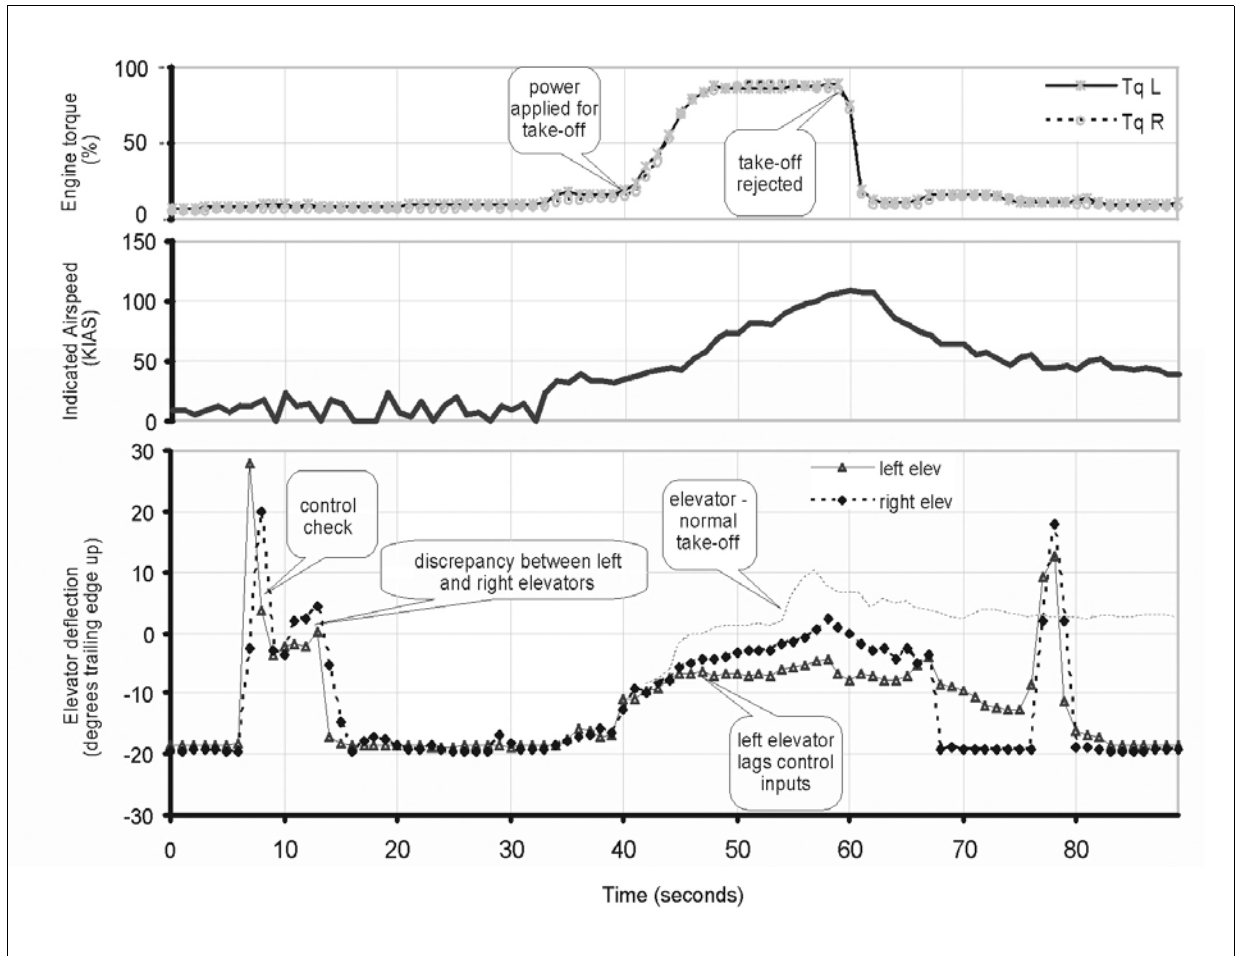
Appendix A – Flight Data Recorder Information

2. At the beginning of the take-off run, both elevators moved in unison to approximately 7.5° trailing edge down at 45 knots indicated airspeed (KIAS). As the aircraft accelerated, a split developed, the left elevator essentially not moving while the right elevator continued to move trailing edge up to a maximum of 2.2° up. The maximum split was 8° at 107 KIAS.

3. After the take-off was rejected, as the aircraft decelerated through 65 KIAS (the speed at which the PF normally releases the control yoke to use the tiller), the right elevator went full trailing edge down while the left elevator hung at about 10° trailing edge down for 10 seconds. At 50 KIAS, the elevators both moved abruptly to about 15° trailing edge up and back to full trailing edge down, consistent with the PNF locking the controls in accordance with normal rejected take-off procedures.
