**AVIATION INVESTIGATION REPORT
A03P0194**

COLLISION WITH TERRAIN

**AIR SPRAY (1967) LTD.
LOCKHEED L-188 ELECTRA C-GFQA
CRANBROOK, BRITISH COLUMBIA 2.5 nm SOUTH
16 JULY 2003**

Report Number A03P0194

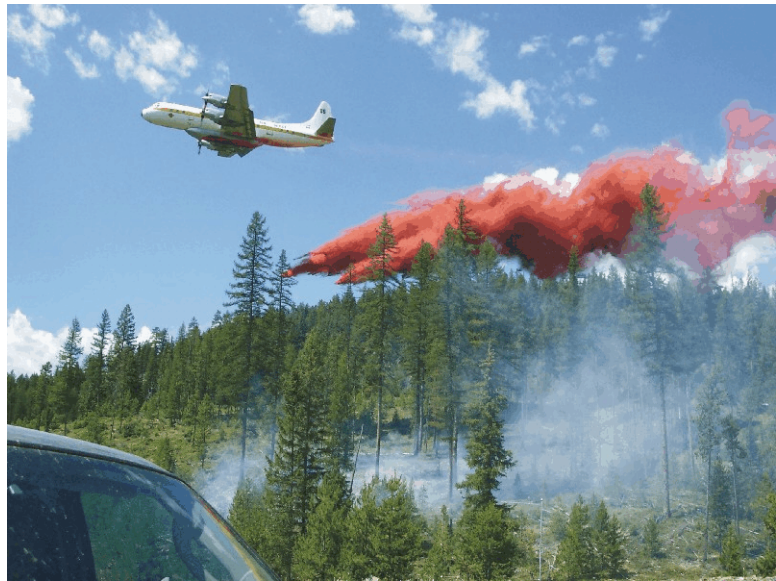
Photo 1. Tanker 86 delivers retardant to target fire at 1220 mountain standard time

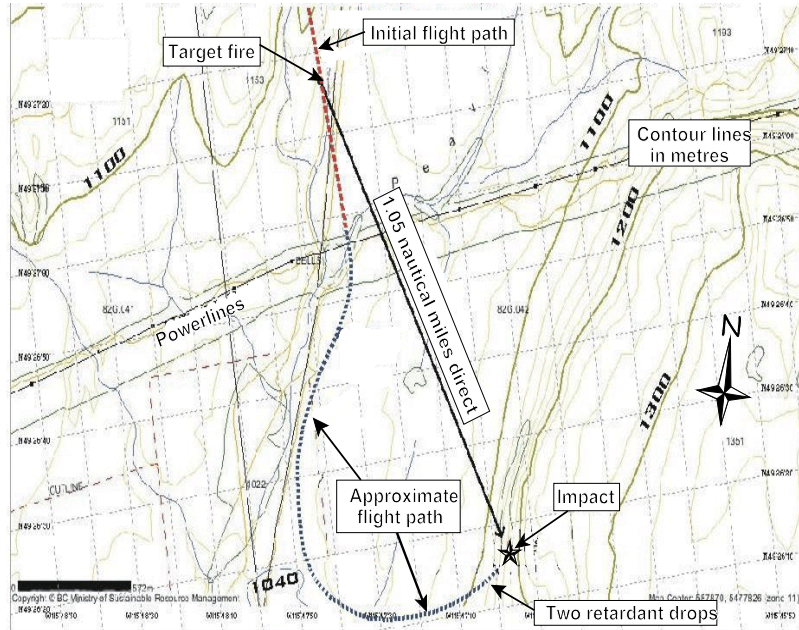
The bird dog joined up with Tanker 86 and followed on the left, rear quarter as it flew over the drop site. After the Electra released the specified retardant load, at 1220 mountain standard time (MST),² the bird dog entered a right-hand turn to circle the fire zone to allow the AAOs on the right side of the aircraft to assess the drop. At the same time, and as the Electra passed over the power lines, its flying pilot transmitted that they were in the right turn. The tanker was seen to turn right initially, then turn left. About 50 seconds later, Tanker 86 was seen in an extreme, left-bank angle immediately before it struck the ridge and exploded (see Figure 1).

Figure 1. Final flight path of Lockheed L-188 Electra C-GFQA

The distance from the power lines to the accident site is about 0.75 nm (4550 feet), and after the right-hand exit turn, the lateral span available across the valley to the ridgeline is about 0.65 nm (4000 feet). (See approximate flight path in Figure 1.)

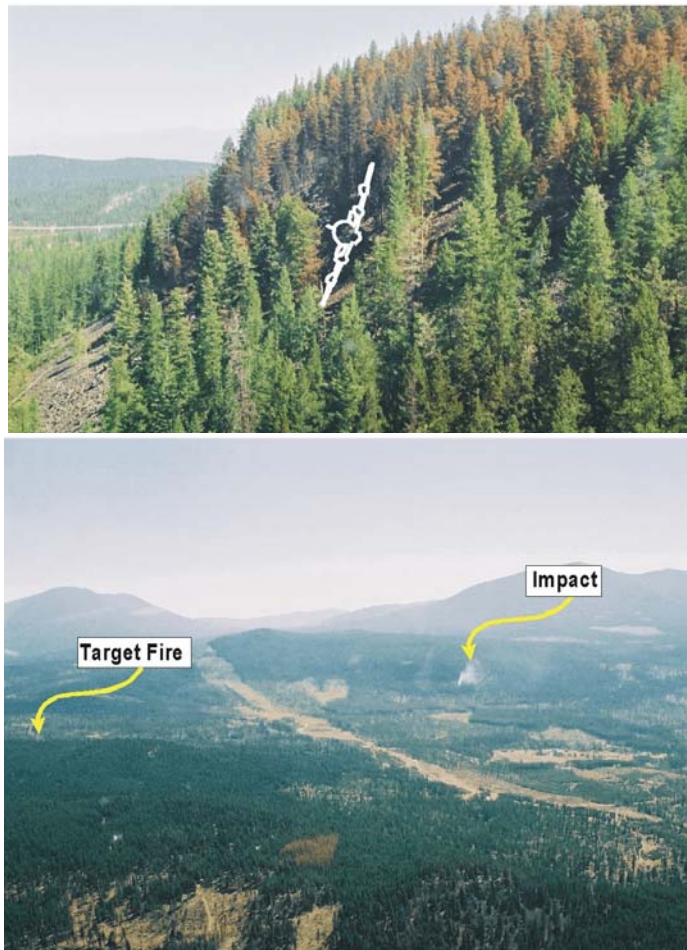
The surrounding area is more densely tree-covered and tends to conceal the bulge and rock outcrop that the aircraft struck. The terrain adjacent to the initial flight path slowly rises to the east and includes the accident site ridge, with the exit route down the valley toward the south and Moyie Lake (see Photo 3). This area provided ample manoeuvring room over relatively flat terrain. The ridge that the aircraft struck blended into the rising terrain and was not obviously separate from its surroundings.

Photo 3. View of valley to the southeast

Flight path recreation performed by both fixed- and rotary-wing aircraft at the same time of day and lighting conditions as the accident revealed that the ridgeline and the land mass that jutted out from it were particularly difficult to discern until about 0.5 nm away, even with prior knowledge. As well, the sun was overhead at the time of the accident and there was a lack of shadow relief, compounding the visual acuity problem.
