AVIATION INVESTIGATION REPORT

A03P0332

MAINTENANCE ERROR – IN-FLIGHT FUEL LEAK

AIRBUS A330-300 C-GHKX

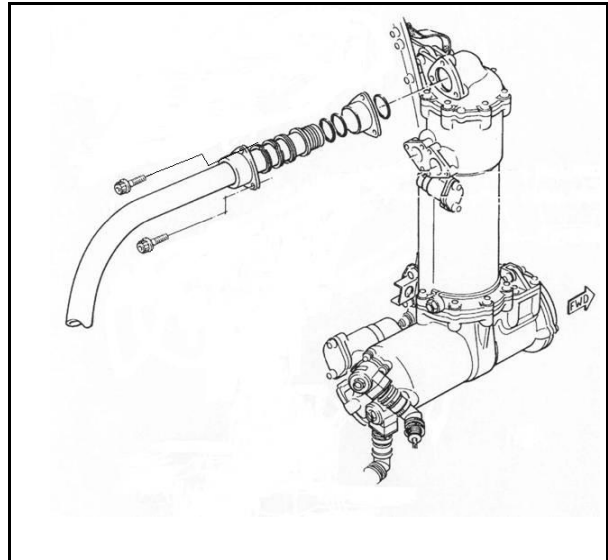
The technicians reviewed the air/oil heat exchanger defect in the logbook, noted the discrepancy with the duty board, and decided to check the fuel/oil heat exchanger first. It was decided that two of the technicians, one of whom was authorized by Air Canada with maintenance release authority for the Airbus A330 and the TRENT 700 engine, would troubleshoot the suspected leak. They disconnected a low-pressure (LP) inlet coupling to the fuel/oil heat exchanger (see Figure 1), and fuel sprayed from the disconnected line. Confirming that the fuel/oil heat exchanger was not the source of the leak, the technicians prepared to reconnect the LP fuel line and ordered replacement seal rings. Some time later, the inlet coupling was reattached to the fuel/oil heat exchanger and the three bolts were tightened to the

correct torque. However, a retainer, a crucial component to the security of the coupling, was omitted. The technicians who removed the LP fuel line on the fuel/oil heat exchanger were unfamiliar with the style of coupling used and did not refer to the Airbus A330 TSM, nor did they refer to all relevant sections and pages of the aircraft maintenance manual (AMM) when removing or reinstalling the LP fuel line. In addition, the removal and reinstallation of the LP fuel line was not recorded on any maintenance documents,

Transportation Safety Board of Canada (TSB) investigators and Air Canada maintenance personnel examined the engine and found that the LP inlet fuel line to the fuel/oil heat exchanger of the number 2 engine had detached. Although the fuel-line coupling appeared to be intact and the three bolts holding the coupling together were tight, the retainer was missing. The missing retainer was found further down the detached fuel line, obscured from view. The engine manufacturer, Rolls-Royce, indicated that it is possible, within the tolerance range of all the LP components, that the three bolts that hold the LP connection in place may not bottom out if the retainer is omitted. It is, therefore, possible to achieve torque of the proper value. In light of this scenario, the compression on the seal rings is possibly sufficient to prevent leakage at idle power. The flight data recorder (FDR) was removed from the aircraft and sent to Air Canada's maintenance facility in Dorval, Quebec, for downloading. The downloaded information was analysed by the TSB Engineering Laboratory.

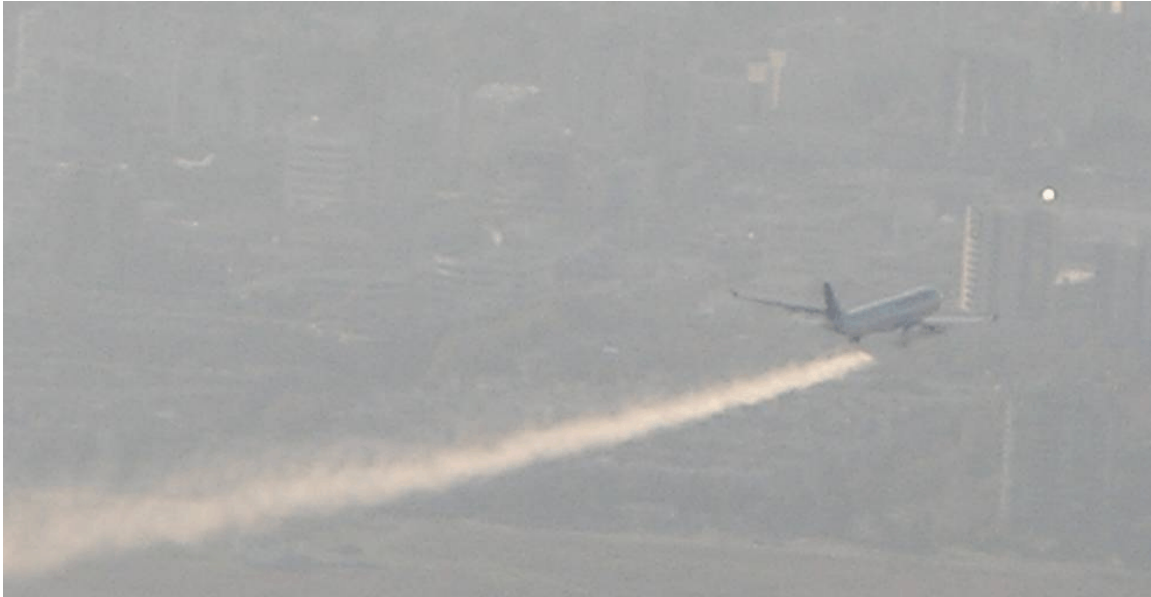
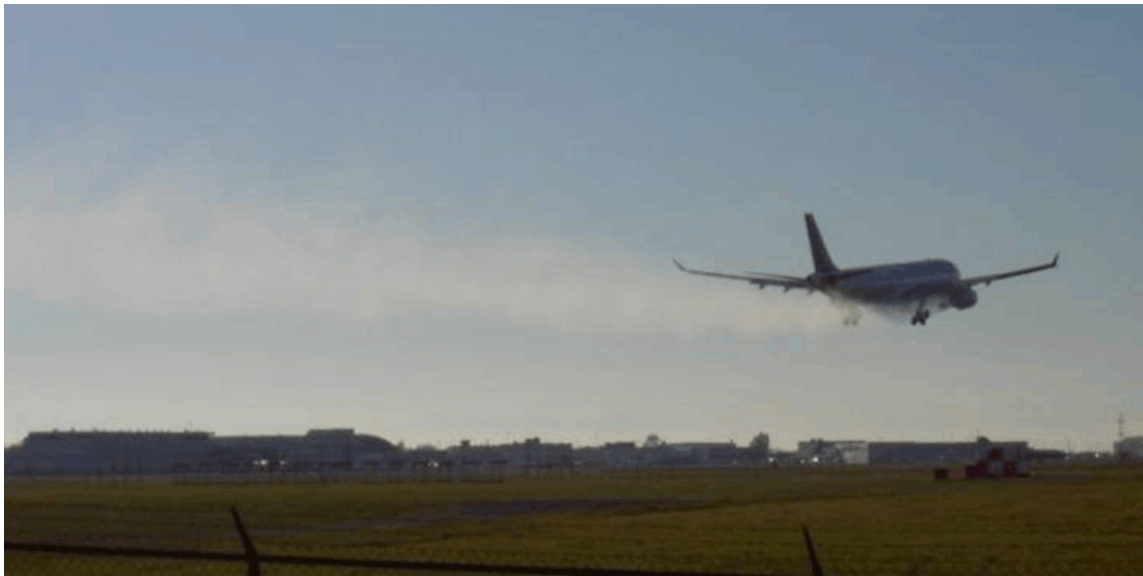
Appendix A – Visible Fuel Leak from Flight ACA216

The following day, the aircraft departed for Calgary, Alberta, as Flight ACA216. The taxi and the take-off roll were normal. The departure was during daylight hours and in clear weather conditions, and pilots of another aircraft waiting to depart observed a fuel leak from ACA216 as a significant vapour trail (see Appendix A). The pilots of that departing aircraft informed the Vancouver tower of the vapour trail coming from the number 2 engine of ACA216, and, in turn, the Vancouver tower relayed this information to ACA216.

As the engine power levers were advanced for take-off, an increase in fuel pressure, flow rate, and, perhaps, engine vibration caused the LP fuel line to detach from the fuel/oil heat exchanger because the retainer was missing. The fuel leak resulted in a large vapour trail, noticeable to other aircraft crew and observers on the ground (see Appendix A). A high-power ground run performed after the maintenance work had been completed would have greatly increased the probability of detecting the incorrect installation.
