AVIATION INVESTIGATION REPORT
A04H0001

LOSS OF CONTROL

GEORGIAN EXPRESS LTD.
CESSNA 208B CARAVAN C-FAGA
PELEE ISLAND, ONTARIO
17 JANUARY 2004

Report Number A04H0001

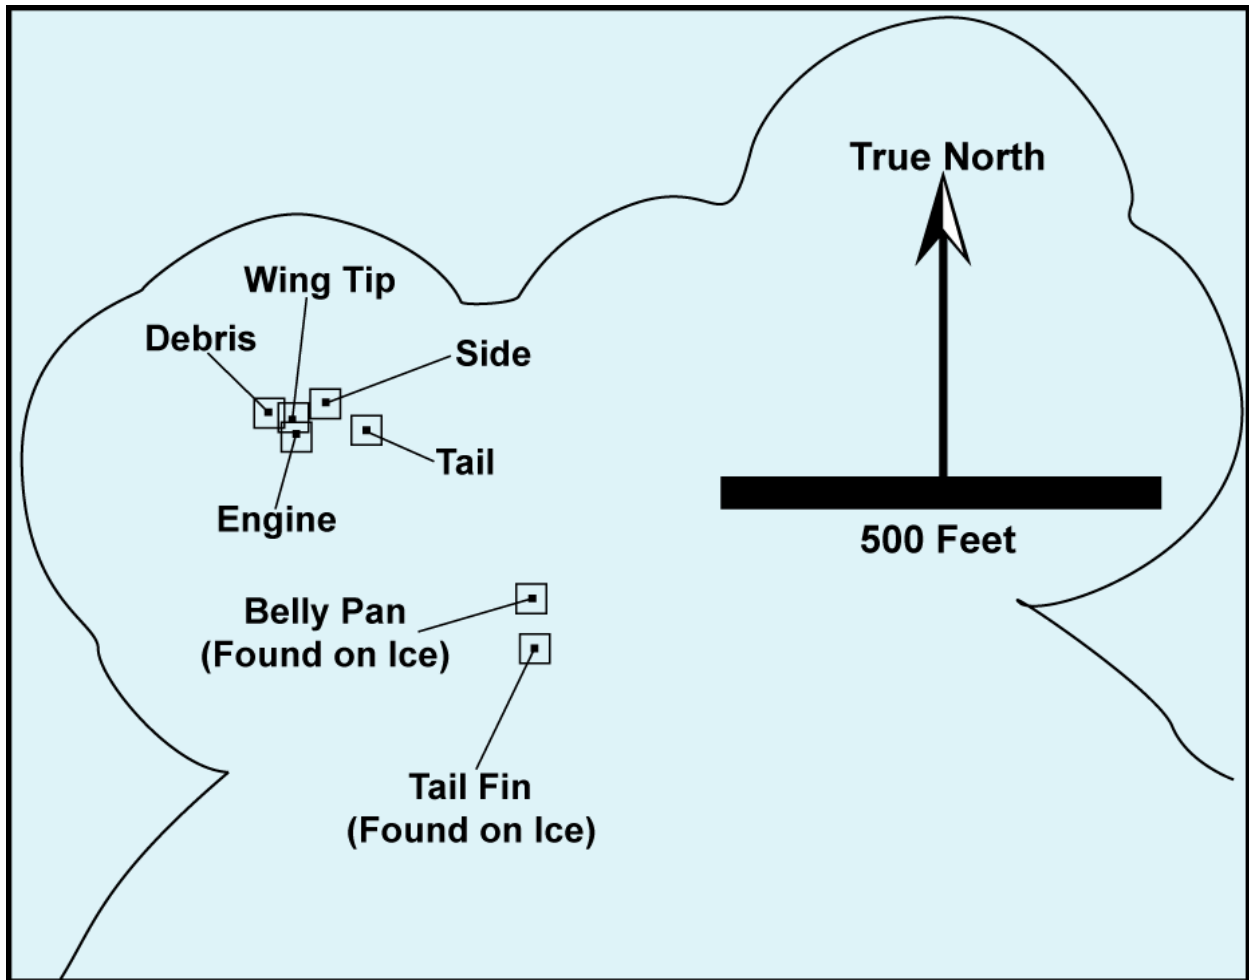
Appendix E – Crash Site Debris Field

The aircraft was destroyed on impact with the ice (see Appendix E). The aircraft was found on the bottom of the lake, in approximately 27 feet of water, in an upright position, listing to the left and pointing westerly. Much of the aircraft was only loosely held together. The engine appeared to be attached by only cables and wires. There was severe damage to the front of the fuselage, extending back to the trailing edge of the wings. The forward part of the fuselage was fully open at the front end and split open along the sides in several places. The wing carry-through area was torn out of the top of the fuselage and only partially attached at the side. Both wings were partially detached, with extensive compression damage along their leading edges. The left wing was bent aft. The tail section was relatively undamaged. All the observed fractures throughout the aircraft structure were considered to have been the result of either impact damage or cuts made during salvage. There was no indication of structural failure before impact.

The structural damage indicates that the aircraft struck the ice in a steep, nose-down attitude with the left wing down. Examination of the aircraft instruments indicated that, at the time of impact, the aircraft was banked approximately 80° left wing down and pitched approximately 35° nose down. The airspeed was approximately 128 knots and the vertical speed was approximately 2250 feet per minute.

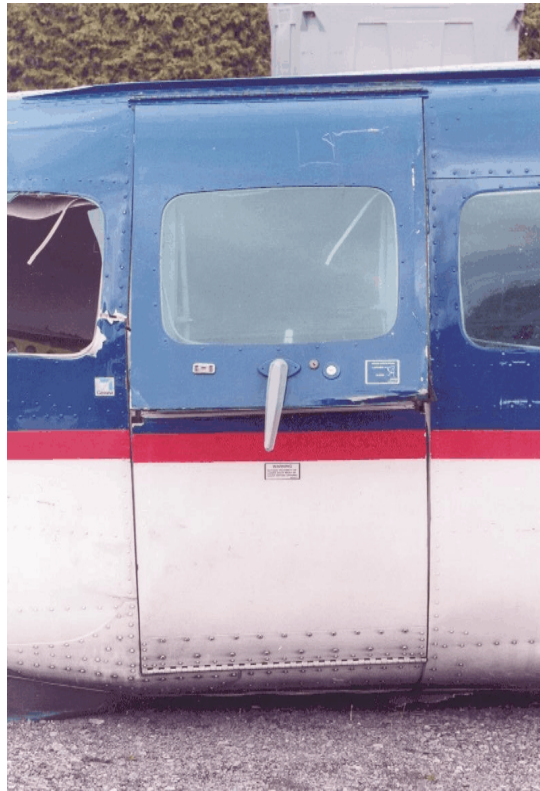
Photo 3. Exterior view of cabin passenger door

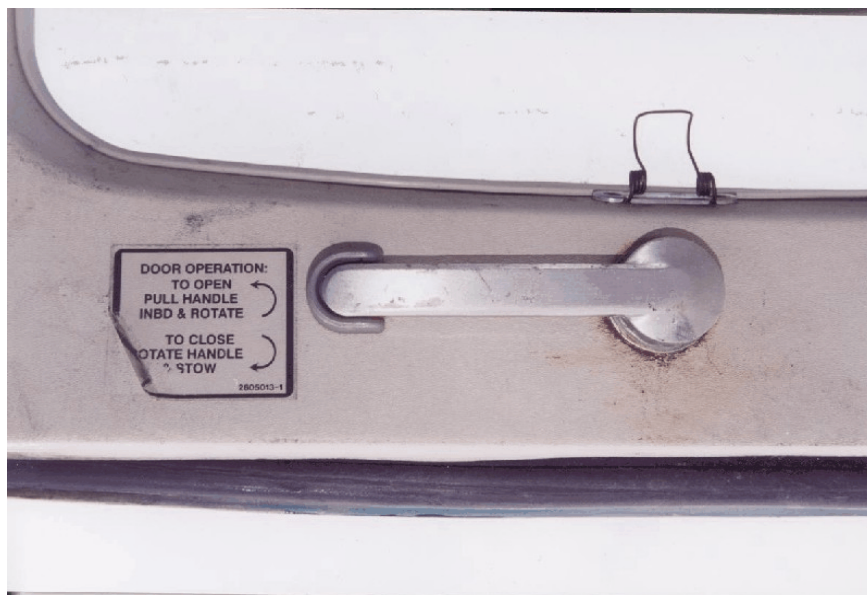
Photo 4. Interior view of upper hatch in the closed position

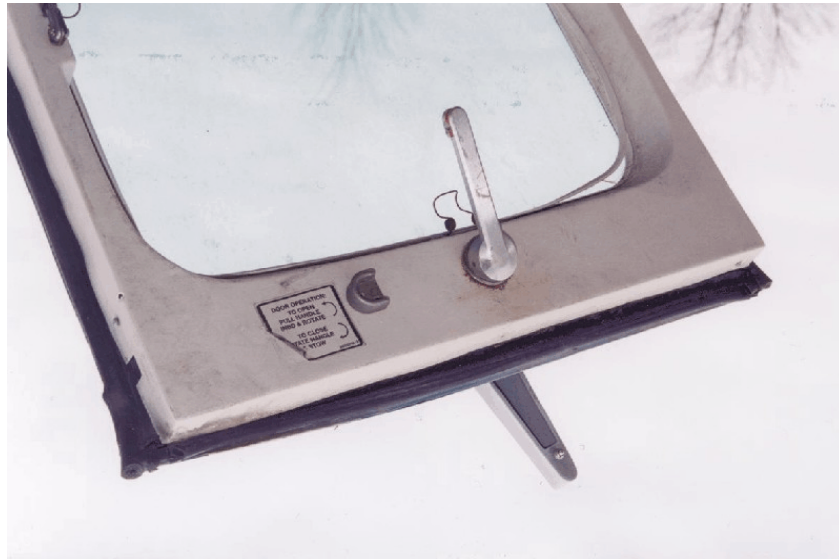
Photo 5. Interior view of the upper hatch in the open position

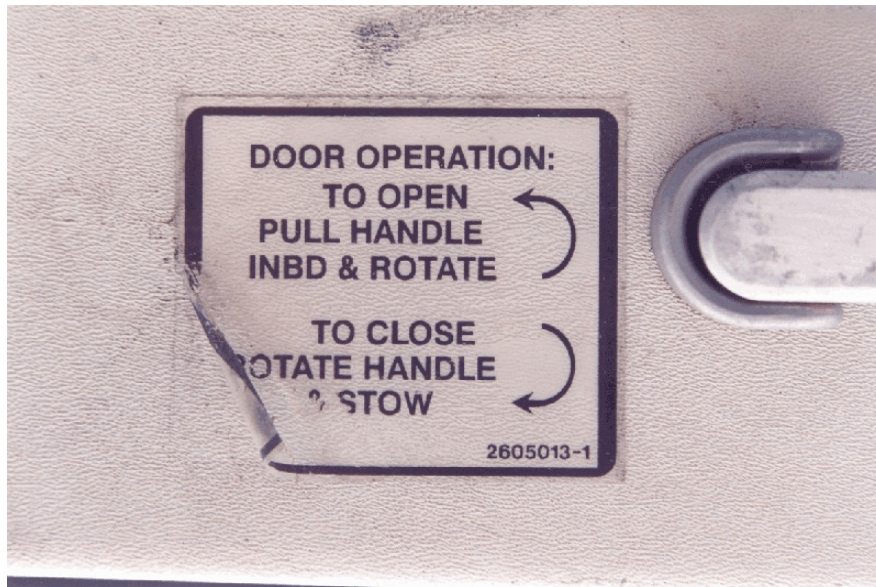
TC reviewed a Georgian Express Ltd. safety features card in June 2000 and issued a “meets standards” letter to Georgian Express Ltd. However, the safety features card retrieved from the occurrence aircraft was an Air Georgian safety features card. This card was reviewed by TSB investigators against TC’s Commercial Air Service Standard 723.39(4) for content, accuracy, and clarity. Some required safety information was missing, specifically information about stowing carry-on baggage and about brace positions for adults holding infants. In addition, pictorial instructions regarding the passenger restraint systems and the operation of the emergency exits were unclear and difficult to understand.

Photo 6. Close-up of placard showing direction of rotation opposite to actual handle movement
