AVIATION INVESTIGATION REPORT
A04P0142

IN-FLIGHT POWER LOSS

VANCOUVER ISLAND HELICOPTERS LTD.
BELL 206L C-FVIX (HELICOPTER)
TASU CREEK, BRITISH COLUMBIA
28 APRIL 2004

Report Number A04P0142

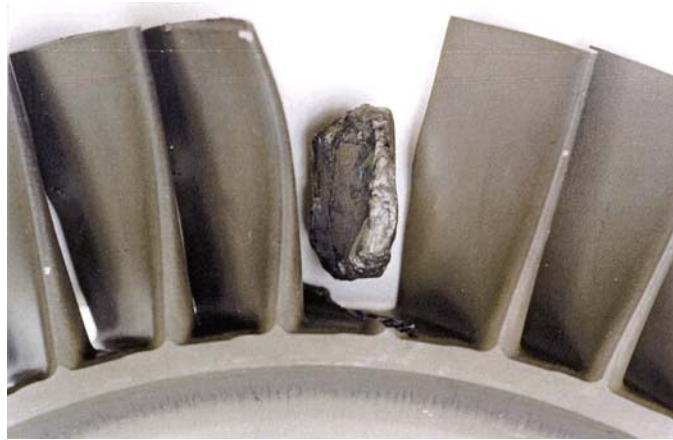
Examination of the second-stage turbine wheel revealed one failed blade (see Photo 1). Records indicate that the second-stage turbine wheel had accumulated 375.8 hours TTSN, out of an allowable service life of 1775 hours. An optical examination indicated blade failure as a result of fatigue cracking, with multiple initiation sites in the fillet area on the convex side of the blade. Fatigue cracking accounted for approximately 75 per cent of the fracture, with the remainder being an instantaneous overstress rupture. While the majority of the fracture face was normal to the blade axis, the origin area was almost parallel to the blade axis or radial to the turbine wheel. The blade following the failed blade had been bent opposite to the direction of rotation. Bending of this blade effectively reduced its overall length, preserving the pre-event tip condition. Further examination of the bent blade revealed minimal tip rub, and no blueing or mushrooming. Significant tip rub was observed on 75 per cent of the blades, from the failed blade over an arc of approximately 270° clockwise from a leading-edge view. Rubbing on these blades had produced smearing damage to the tips of the blades with blued and mushroomed material at the outer diameter on the cambered face. The balance piston seal (large labyrinth seal) also showed rub damage around approximately 270° of arc, consistent with the blade tip rub. Additionally, rub damage was noted on approximately 80 per cent, or 300° of arc, of the inner stage seal, again consistent with the blade tip rub.

Photo 1. Remains of the failed blade

Secondary smearing damage was observed on the trailing edge of several blades, consistent with interaction with the liberated piece of failed blade. The first- and second-stage wheels were mated at the curvic coupling, according to the reference marks vibro-etched on the hubs. Comparison of the blade tip rub showed both wheels were affected in the same general area, with the worst rub damage approximately 90° ahead of the failed blade location.

A scanning electron microscope examination of the second-stage turbine wheel blade fracture revealed multiple adjacent origin areas. Examination of the surface of the crack showed an oxidation layer that served to delineate a clear underlying pattern of fatigue striations. The fracture topography at the initiation site was consistent with low-cycle fatigue cracking as the initial mode of failure, with the observation of beach marks and widely spaced striations. The low-cycle fatigue cracking progressed radially inward toward the hub and then turned normal to the blade axis, progressing in a high-cycle mode. The blade eventually failed in the overstress extension of the high-cycle fatigue cracking. Secondary cracking was also observed in the fillet area, below the fracture plane. Energy dispersive x-ray analysis indicated the blade material was consistent semi-quantitatively with IN 713C, the specified material.

1. Thermally induced fatigue cracking initiated radially inward in a low-cycle mode in the blade platform fillet area, then progressed normal to the blade axis in a high-cycle mode, eventually resulting in a blade failure due to overstress rupture when the remaining area could no longer support the applied loads.
