## **AVIATION INVESTIGATION REPORT**

**A04P0206**

### **ENGINE POWER LOSS**

**MD HELICOPTER (HUGHES) 369D C-GWPQ  
BOB QUINN AIRSTRIP, BRITISH COLUMBIA**

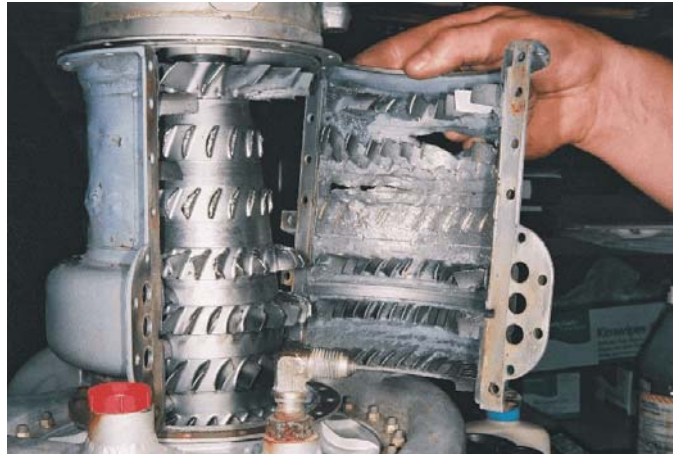
Examination of the compressor case halves showed burst-type tear damage in the skins of both halves, adjacent to the 2<sup>nd</sup> stage and 3<sup>rd</sup> stage rotor paths. Penetration through the skin was from the inside in all instances. The most significant tear was a large hole through the skin of one of the

**Photo 1.** Compressor case half removed exposing damage to blades and vanes leading and trailing edges

case halves in the 2<sup>nd</sup> stage rotor path, approximately 70 mm long by 13 mm at its widest opening. It was concluded that most or all of the 2<sup>nd</sup> stage rotor blades exited the compressor at this location.

The 1<sup>st</sup>, 4<sup>th</sup>, 5<sup>th</sup>, and 6<sup>th</sup> stage compressor vanes were intact, but showed impact damage on both the leading and trailing edges of the vanes. The damage observed was consistent with the failure debris passing through the compressor while it continued running for a short period following the failure. Five of the 2<sup>nd</sup> stage stator vanes had fractured at or near the root. The vane stubs were bent over in the direction of rotation, and a sixth vane had completely pulled out of its slot in the vane band. All of the vanes from the 3<sup>rd</sup> stage stator had also fractured at or near the root with the vane stubs bent over in the direction of rotation. Optical microscopic examination of the vane fractures revealed predominantly impact and rub damage in the direction of compressor rotation, which had obliterated most of the original fracture surface details. However, the vane fracture profiles and damage patterns were consistent with overload failures and secondary damage. The leading and trailing edges of the vanes in all stages were also examined for erosion; no measurable erosion was observed.

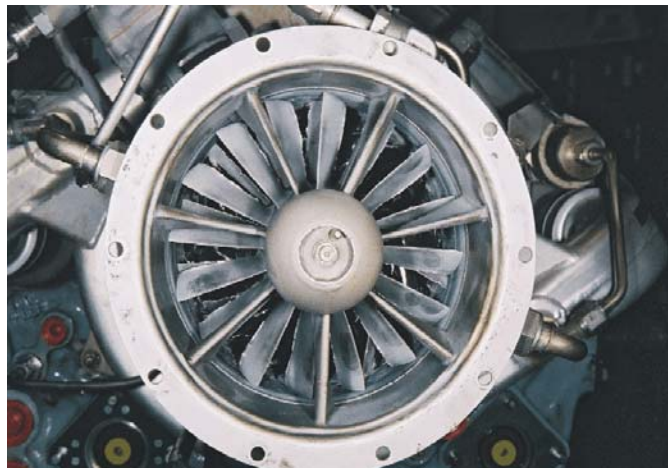
**Photo 2.** Inlet front support guide vanes and first-stage rotor blades leading edges showing minimal foreign object damage

The leading edges of the compressor front support vanes and 1<sup>st</sup> stage rotor blades were examined in detail for any indication of foreign object damage (FOD). On the leading edge of the front support vane, located at about the one o'clock position, there were two small indentations (Photo 2). The original surface of the vane at each mark was still visible with some oxidation and was not disturbed by any material smearing, indicating that the marks had been present for quite some time. The leading edges of the 1<sup>st</sup> stage rotor blades showed some tip damage on a few blades, and a relatively minor impact mark near the root of one blade that warranted a more detailed examination.

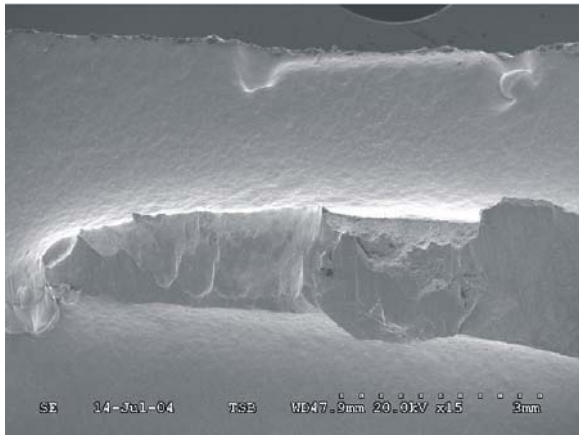
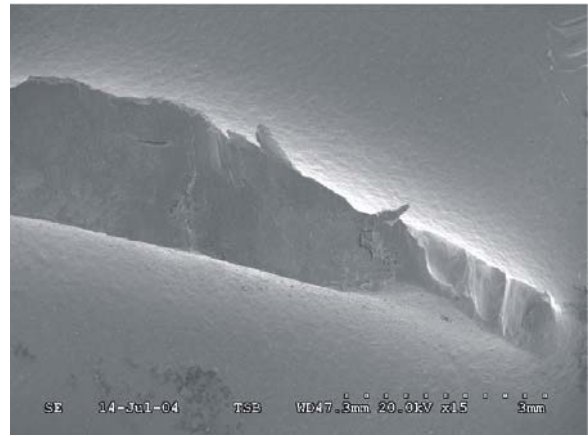
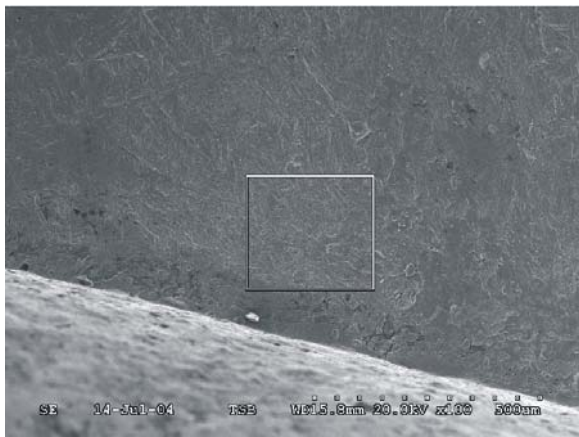
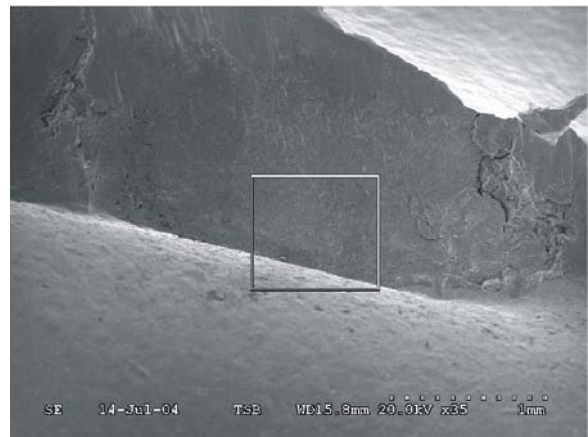
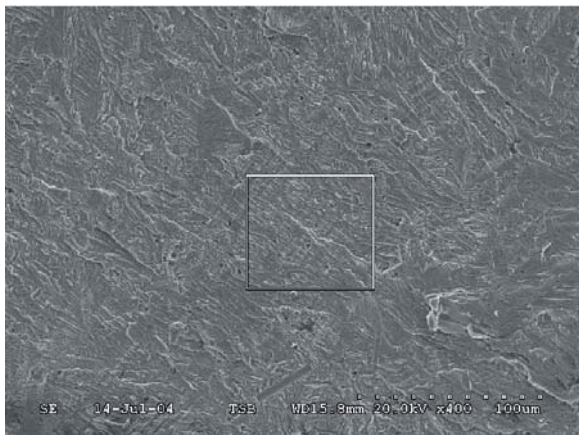
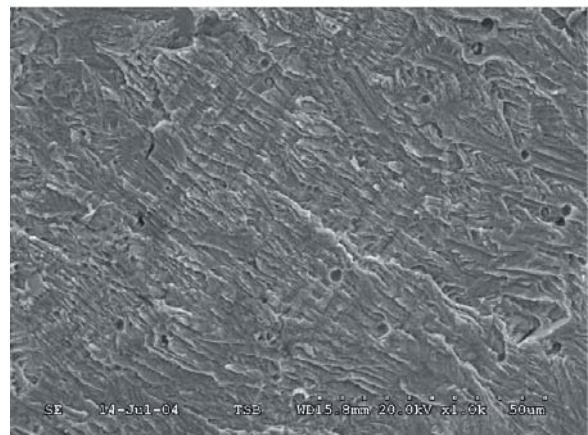
*Appendix B – Photos 3 to 8 Showing 2<sup>nd</sup> Stage Compressor Rotor Blade Fatigue Failure*

A SEM examination of the 2<sup>nd</sup> stage rotor blade, showing faint striations, confirmed the presence of distinctive fatigue striations beginning near the leading edge of the blade and progressing aft towards approximately mid-span (see Appendix B, photos 3 through 8). The aft section of the blade fracture towards the trailing edge was characteristic of the final overload failure of the blade. All fracture detail in the leading edge region where fatigue initiated seemed completely obliterated by post-fracture rub damage, and only small pockets of resolved fatigue striations remained.

High cycle fatigue fracture was confirmed for one of the 2<sup>nd</sup> stage rotor blades, and separation of this blade is considered to be the lead event in the compressor failure. This is consistent with the damage pattern observed in the compressor, including the shedding of all of the 2<sup>nd</sup> and 3<sup>rd</sup> stage rotor blades, and the major penetration observed in the case halves in the 2<sup>nd</sup> stage rotor path. Failure analysis of the stator vanes did not reveal any indications of premature failure, and the vane failures were all considered to be secondary in nature, resulting from the initial 2<sup>nd</sup> stage rotor blade failure. This was supported by a review of several other compressor failures for this engine type, which showed that, in all cases where a compressor stator vane failure was identified as an initial cause of failure, there was no associated shedding of the compressor rotor blades such as occurred in this incident.

1. The compressor failure resulted from the separation of a 2<sup>nd</sup> stage rotor blade due to a high cycle fatigue fracture, which had initiated near the leading edge of the blade.
2. The material of the blade met the desired hardness; however, the damaged area of the blade near the leading edge contained a porosity pocket.
3. While post-fracture mechanical damage in the leading edge area prevented determination of the fatigue crack propagation direction forward of the detected porosity, it is possible that the fatigue crack initiated at the porosity pocket.

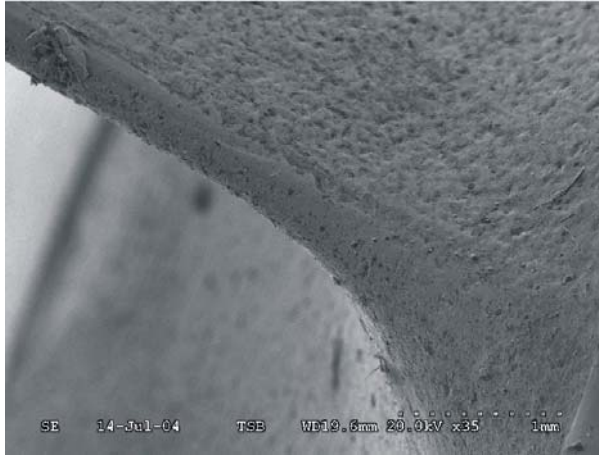
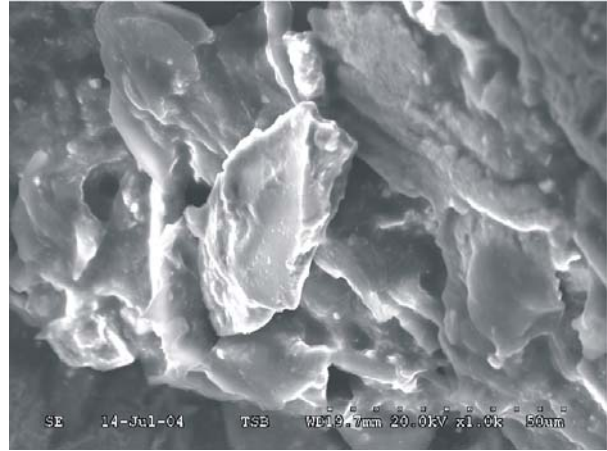
Optical examination of the impact mark showed that the leading edge material of the blade had been disturbed by contact with a small piece of foreign material or debris, and there appeared to be a small particle of material trapped within the indentation. The indentation was examined at higher magnifications in the scanning electron microscope (SEM). Elemental analysis confirmed the presence of a small aluminum-rich particle that was foreign to the surrounding material of the blade (Appendix C, photos 9 and 10). The material debris that had been collected from the engine cowl area during recovery and the compressor rotor blade pieces were examined, and four pieces of what appeared to be broken rivets were identified. An analysis for material composition showed material spectra containing a predominant nickel peak for sample number 1, predominant titanium and cadmium peaks for sample number 2, and predominant

iron and chromium peaks for sample number 3. Sample number 4 was almost wholly aluminum with small amounts of magnesium, which is consistent with a standard aluminum rivet material.

The possibility of FOD as a precursor to the compressor rotor blade failure was considered. However, for a number of reasons, it could not be concluded positively that FOD was a precursor. On this installation, an inlet barrier filtration system was installed; however, there appears to have been impingement by a small foreign particle on one of the 1<sup>st</sup> stage rotor blades, as evidenced by what appeared to be a recent impact mark and a particle of aluminum metal transfer. The engine had continued to run for a short time after ground impact, and it is possible that something was ingested into the compressor at that time, leaving the mark observed on the 1<sup>st</sup> stage blade. On the other hand, the mark on the leading edge of the front support vane was oxidized, indicating that it had been present for some time. Since the debris in which the piece of aluminum rivet was found was collected among general debris found in the engine cowl area after the accident, it cannot be positively linked to the presence of the small particle of aluminum in the impact mark. Given these observations, FOD cannot be ruled out. However, the presence of a porosity pocket near the fatigue-initiation zone makes FOD a lesser candidate as a probable fatigue crack initiator.

Photos 9 and 10 are scanning electron microscope images of impact mark at 1<sup>st</sup> stage rotor blade leading edge showing the presence of a small imbedded particle.

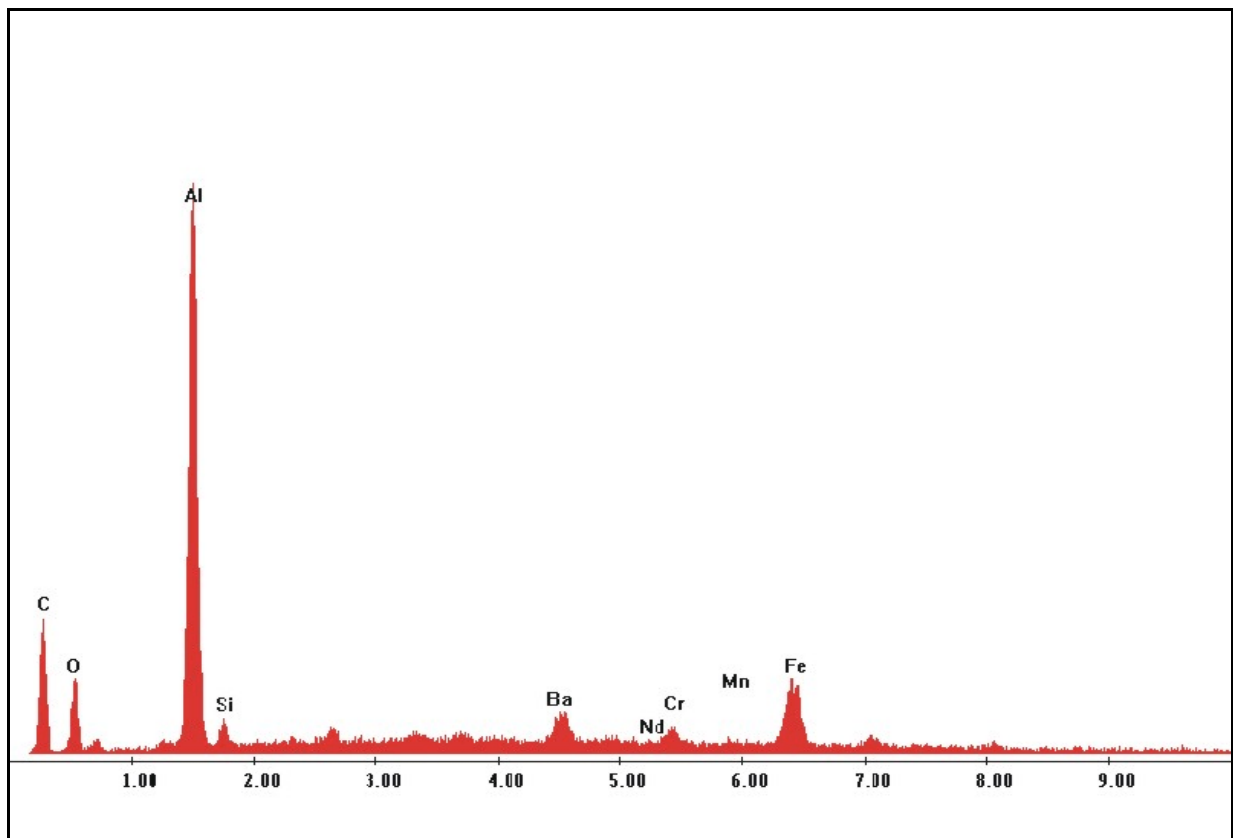
Figure 1. Material analysis spectra of particle revealed a predominantly aluminum composition

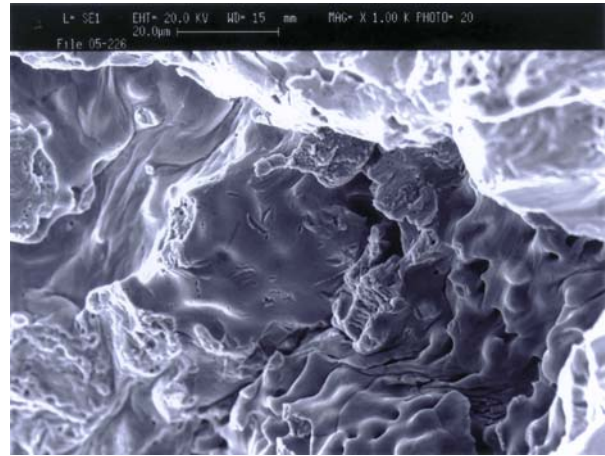
**Photo 12.** Evidence of porosity in the damaged area near the leading edge

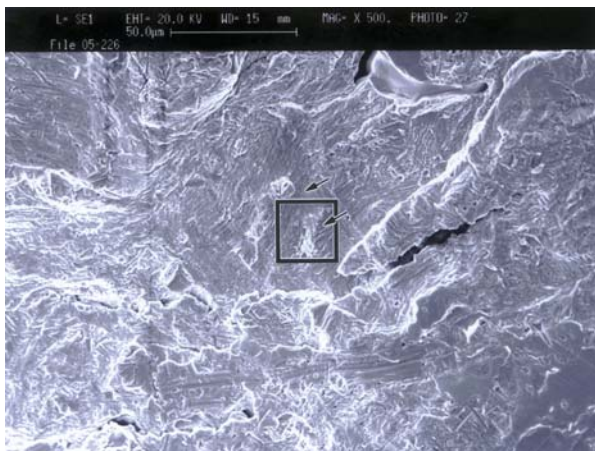
**Photo 13.** Area outlined by box in Photo 11. Direction of fatigue crack propagation identified by arrows.

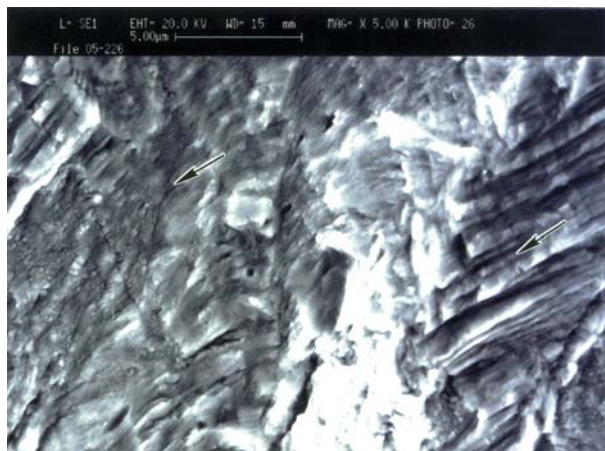
**Photo 14.** Area outlined by box in Photo 13. Fatigue striations indicating the direction of crack propagation from the region with porosity.

Photos 11 through 14 are scanning electron microscope images of the damaged area near the leading edge of the 2<sup>nd</sup> stage rotor blade showing evidence of porosity and direction of fatigue crack propagation.
