**AVIATION INVESTIGATION REPORT
A04Q0089 (AMENDED)**

RISK OF COLLISION

AIR CANADA AIRBUS A320 C-FDRP

PRO AVIATION CESSNA 172 C-FGIM

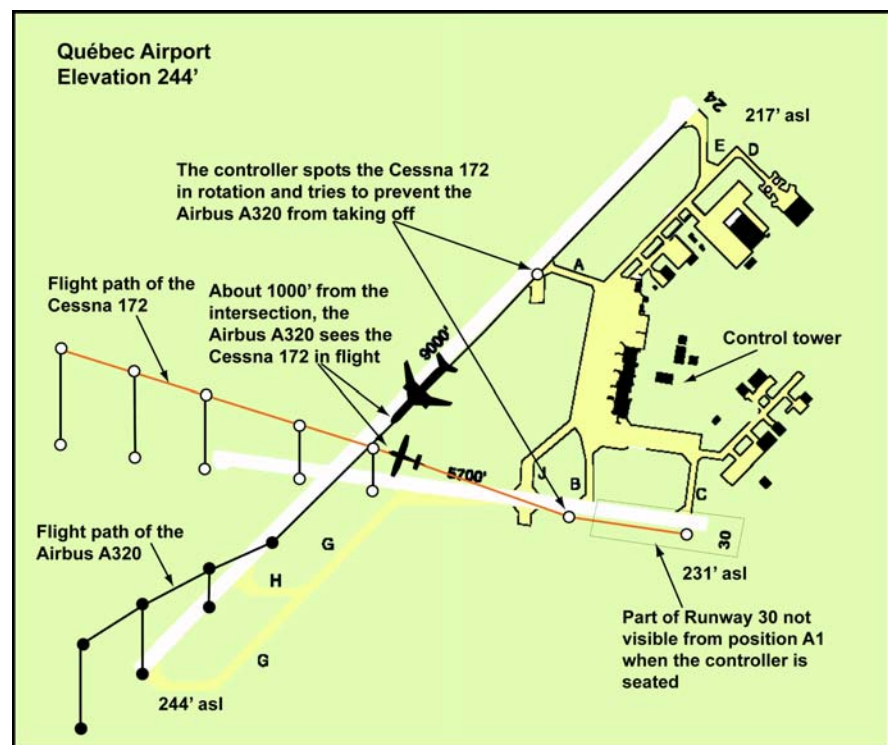
Figure 1. Flight path of the aircraft

taxiway Alpha, to abort take-off. After realizing that the Airbus A320 was not slowing down, the controller then attempted to instruct the pilot of the Cessna 172 three times to initiate an immediate left turn. Neither the instruction to ACA513 nor to the Cessna 172 could be heard on the air frequency, because the air frequency transmit button had been deactivated.

At 0935:20, about 1000 feet from the intersection of runways 24 and 30, when the Airbus A320 had reached its rotation speed (146 knots), the captain saw the Cessna 172 in flight on a converging track. He immediately ordered the co-pilot, who was at the controls, to delay the rotation and to not take off until they had crossed Runway 30. Radar data show that the Cessna 172 flew over the Airbus A320 with 200 feet of clearance above the intersection of the two runways.
