AVIATION INVESTIGATION REPORT

A04Q0188

RUNWAY EXCURSION ON LANDING

AVIATION CMP INC.
BEECH B300 (SUPER KING AIR) C-FMHD
SAINT-GEORGES, QUEBEC
01 DECEMBER 2004

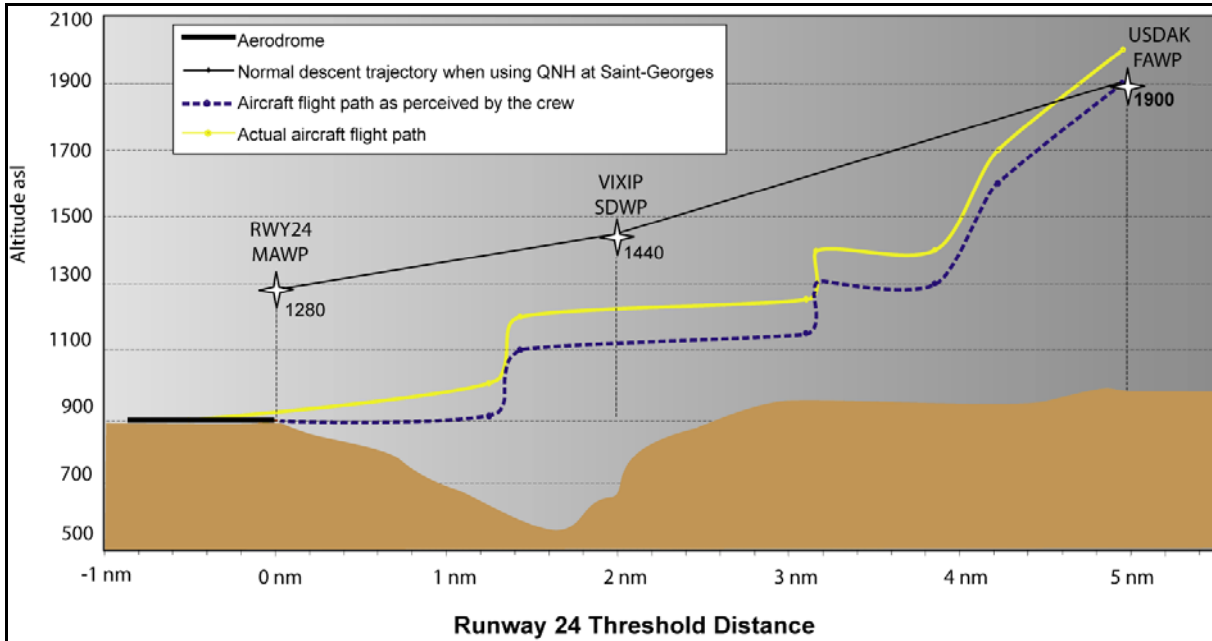
Figure 1. Estimated flight profile of Runway 24 approach

The approach profile⁶ includes three levels: over ITRAL, the aircraft can descend to 1900 feet; at 5 nm from the runway threshold, over USDAK, the final approach waypoint (FAWP), the aircraft can continue descent to 1440 feet; and, at 2 nm from the threshold, at the descent waypoint (SDWP) VIXIP, it can descend to the minimum descent altitude (MDA) of 1280 feet (see Appendix B). The missed approach waypoint (MAWP) is over the runway threshold (see Figure 1).

When planning the approach, the briefings were not completed in accordance with company standard operating procedures (SOPs). The crew did not discuss approach procedures or a missed approach procedure. About 3 nm from USDAK and 1900 feet asl (about 1000 feet above ground), the co-pilot saw the ground. He immediately reported the position of the aircraft in reference to the ground and reported the weather conditions. A few seconds later, the pilot-in-command set the altitude selector to 1100 feet, 200 feet below the MDA, and set the radio altimeter to 380 feet, the height above aerodrome (HAA) at the MDA. At a little over 3 nm from the threshold, the aircraft was 200 feet above the ground.

Both the pilot-in-command's and the co-pilot's altimeters were set to 29.55, whereas the barometric pressure at Saint-Georges was 29.65. Therefore, the altitude displayed by the aircraft's altimeters would have been 100 feet lower than the actual altitude of the aircraft. For that reason, when the aircraft was at the MAWP for the Runway 06 approach, it was 80 feet above the MDA and 100 feet higher than the crew thought. The aircraft was higher than the normal approach and could not descend fast enough to land safely.
