AVIATION INVESTIGATION REPORT

A05A0059

STALL AND LOSS OF CONTROL DURING CLIMB

DE HAVILLAND DHC-8-100 C-GZKH

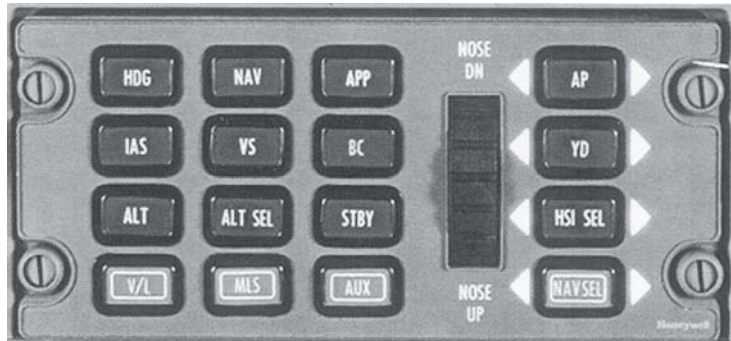
Figure 1. Flight guidance controller

guidance controller toward nose down (see Figure 1) to increase the airspeed. While attempting the adjustment, the captain saw the aircraft's stick shaker activate, causing the autopilot to disengage. This occurred at 14 800 feet above sea level, at 104 KIAS. The captain then began to manually fly the aircraft.

The aircraft is configured with a Sperry SPZ-8000 digital automatic flight control system (AFCS). A single flight guidance controller (see Figure 1) is used to select modes of operation and engage/disengage the autopilot. Most of the controls on the AFCS controller are alternate-action push-button (push ON, push OFF). There are two vertical modes available. The IAS button captures and holds the aircraft's indicated airspeed at the time of selection. The vertical speed (VS) button captures and holds the aircraft's VS at the time of selection. When VS mode is engaged, the airspeed is not controlled by the AFCS.

The steady rate of climb after autopilot engagement indicates that the crew had inadvertently selected VS mode instead of IAS mode. This selection error was not detected, in part because there was no requirement in the SOPs for the crew to announce and confirm the IAS mode selection on the AFCS. The indicated airspeed then fluctuated near the value the crew intended, perhaps bolstering the crew's belief that the aircraft was operating in the intended IAS mode, and leading them to become complacent about monitoring the airspeed. Also contributing to the monitoring error was the co-pilot's preoccupation with paperwork during the climb. Because the crew had inadvertently selected an inappropriate AFCS mode and did not detect this error or adequately monitor the airspeed, the airspeed eventually decreased during the climb to the point of stall.

The Transportation Safety Board of Canada (TSB) issued Safety Advisory A050019-1 on 22 July 2005 on the subject of inadvertent selection of inappropriate automatic flight control system (AFCS) modes of operation. The letter suggested that Transport Canada (TC) ensure that operators have incorporated measures into their procedures to ensure the correct selection and monitoring of AFCS climb modes. On 04 October 2005, TC responded, advising that a copy of the advisory had been passed on to all TC regions, and that the Department would take the necessary action, as required. Since the occurrence, the operator has revised its standard operating procedures (SOPs) to contain a challenge and response action whenever AFCS modes are engaged in the climb.

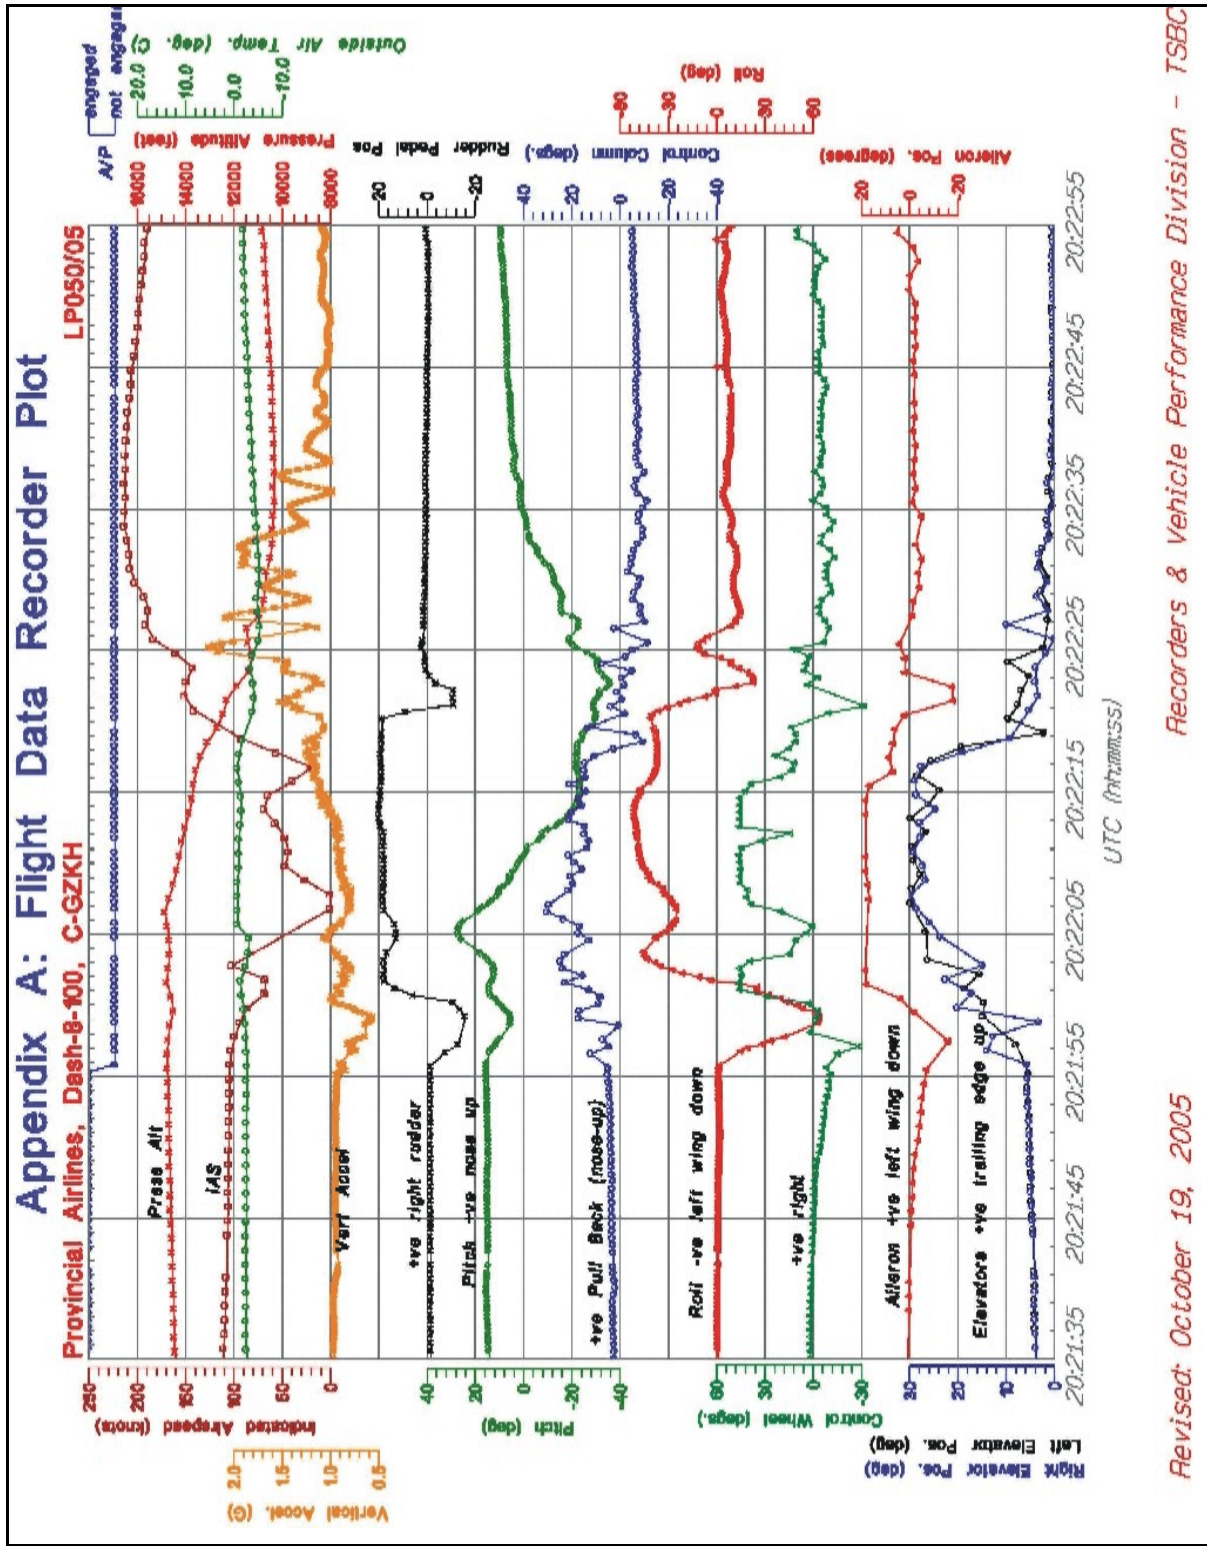
Within a second of autopilot disengagement, the aircraft began to roll right and pitch down (see Appendix A – Flight Data Recorder Plot and Appendix B – Flight Data Recorder Plot – Engines). Immediately after the aircraft began to roll, it was noticed that there was ice on the left engine inlet. The roll angle increased to 64°, the pitch angle went from 15° nose up to 5° nose up, and the aircraft vertical acceleration dropped to approximately 0.5 g. The aircraft pitch then increased to 30° nose up briefly before decreasing to 40° nose down. These conditions are indications that the aircraft wing had fully stalled. However, the captain interpreted the indications as severe turbulence.

The FDR data show that the aircraft underwent three distinct stalls during the loss-of-control event, with the third stall being the most severe. The data show that the control column position cycled rapidly back and forth as the stall developed, but was moved generally aft, remaining aft during all three stalls. There was significant aileron and rudder pedal movement during the event, but these controls were ineffective in regaining control and were in response to the aircraft's movement, rather than the cause of it. The data indicated that aircraft control was regained when the control column was moved forward.
