AVIATION INVESTIGATION REPORT

A05O0115

MAIN ROTOR BLADE FAILURE

**TASMAN HELICOPTERS LTD.
BELL 212 (HELICOPTER) C-GNHX
RICHARDS LANDING, ONTARIO
10 JUNE 2005**

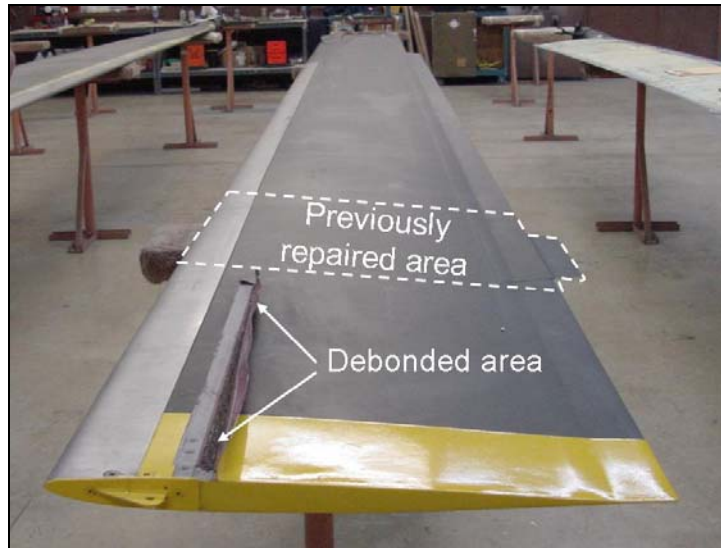
After landing, a post-flight inspection revealed that one of the main rotor blades had sustained damage. A small section of skin near the blade tip, aft of the spar doubler, on the lower surface of the rotor blade had debonded. The skin was raised and curled, but had not separated from the blade (see Photo 1). The debonded skin measured 25 inches by 2 inches between stations 263 and 288. It was later discovered that several of the main rotor head components and transmission had been damaged by the severe vibrations encountered during the flight.

Photo 1. Debonded lower surface of rotor blade and repair area (blade resting upside down)

While paint was being stripped from the rotor blade in preparation for repair, deep corrosion pitting was discovered on the lower skin surface between stations 243 and 262, just inboard of where the debonding later occurred on the 10 June 2005 flight (see Photo 1). Because the pitting pattern exceeded the allowable limits, the repair shop proposed a repair procedure to Bell Helicopter and received approval. The repair procedure included removing the damaged skin and replacing it with a bonded external doubler. The trailing edge trim tab was also replaced.

Following the repair using the bladder and heater blanket tool, the blade was in service for approximately four flight hours before the lower skin debonded on the occurrence flight at the spar doubler between stations 263 and 288.

1. A section of the main rotor lower blade skin debonded during flight, causing the helicopter to develop severe vibrations resulting in an emergency landing.

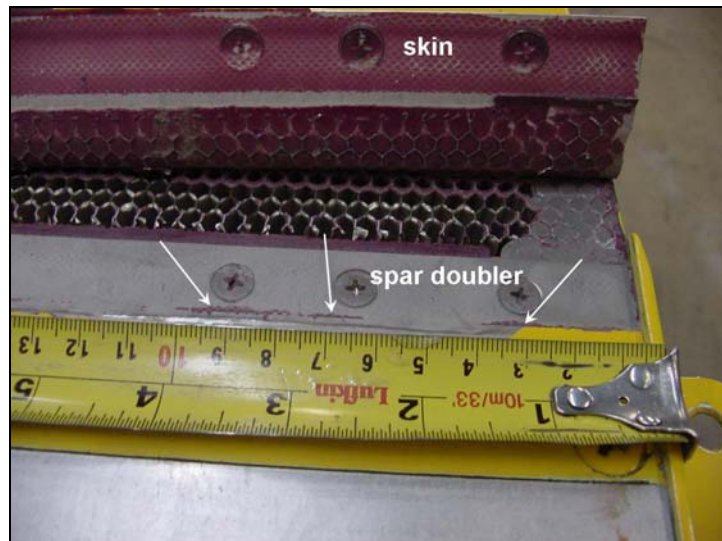
The debonded section between stations 263 and 288 was examined. There was a cohesive bond of the adhesive to the skin substrate. However, the original bonding adhesive used during the manufacturing process was not uniformly adhered to the spar doubler; only small remnants of the adhesive remained (see Photo 2). The total amount of adhesion could not be accurately quantified because the adhesive on the skin and on the spar doubler had eroded. This erosion of the adhesive was caused by the airflow and environmental elements entering the debond area in the time frame between the skin debonding and the completion of the emergency landing.

Photo 2. Close-up of blade tip with arrows showing adhesive residue on the spar doubler

A scanning electron microscope examination of the debonded skin sample indicated that the adhesive, while remaining firmly attached to the skin, had replicated sanding marks from the spar along the adhesive to spar interface, clearly showing that most of the adhesive had bonded well to the skin, but not to the spar. There was little indication of any adhesive remaining attached to the spar surface. The sanding marks on the spar surface are indicative of the standard procedure used for surface preparation before applying the adhesive. Following this initial examination, preparation for repairing the blade was begun by cleaning the spar surface. However, during this process, the surface was altered, and bonding evidence was removed, preventing further analysis of the bond to the spar surface.

During the examination of the bond between the spar doubler and the skin, in different areas of the affected blade, it was determined that all areas inboard of the repaired section exhibited cohesive bonding. However, the previously repaired area showed sporadic cohesive separation on the skin side, and the debonded area showed that the bond between the spar doubler and the skin was not cohesive.

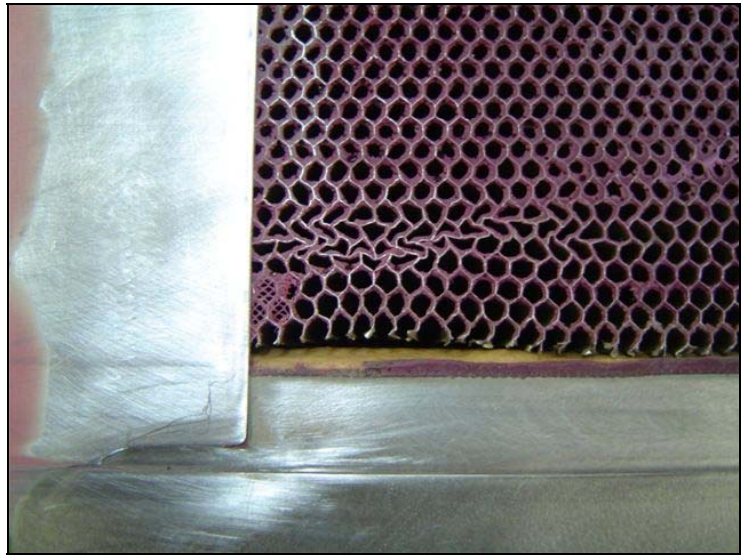
During the examination of other sections of the blade along the spar doubler, two areas were discovered where the honeycomb inner core was crushed and had separated from the rear of the spar. The two areas were located between station 211 and station 224 and between station 263 and station 287. A layer of foam adhesive rests between the core and the spar (see Photo 3). In the two damaged areas, the adhesive foam was present at the spar, but there was no contact between the adhesive foam and the core. Bell Helicopter's Engineering Department determined that, even though there was a non-effective bond between sections of the honeycomb core and the spar, the skin-to-spar bondline would not have experienced static or fatigue failure during the service life of the rotor blade.

Photo 3. Honeycomb core crush and separation for spar

Bell Helicopter's Engineering Department determined that the debonding between the honeycomb core and spar would not have resulted in the skin separation. There were two areas on the blade observed to have core/spar separation. The first was located between station 263 and station 287, in the area where the lower skin debonded. The second area was located between station 211 and 224. This second area of damage was located away from the repaired area and the debonded area, indicating that this type of damage most probably occurred during the original manufacturing process.

1. The second area of blade damage likely occurred during the manufacturing process, but was not detected at that time. No information is available to assess how this type of damage affects blade integrity and the associated consequences during operations.
