**AVIATION INVESTIGATION REPORT  
A05O0125**

**POWER LOSS AND COLLISION WITH TERRAIN**

**PROGRESSIVE AERODYNE SEAREY C-GCWR  
OSHAWA AIRPORT, ONTARIO**

**25 JUNE 2005**

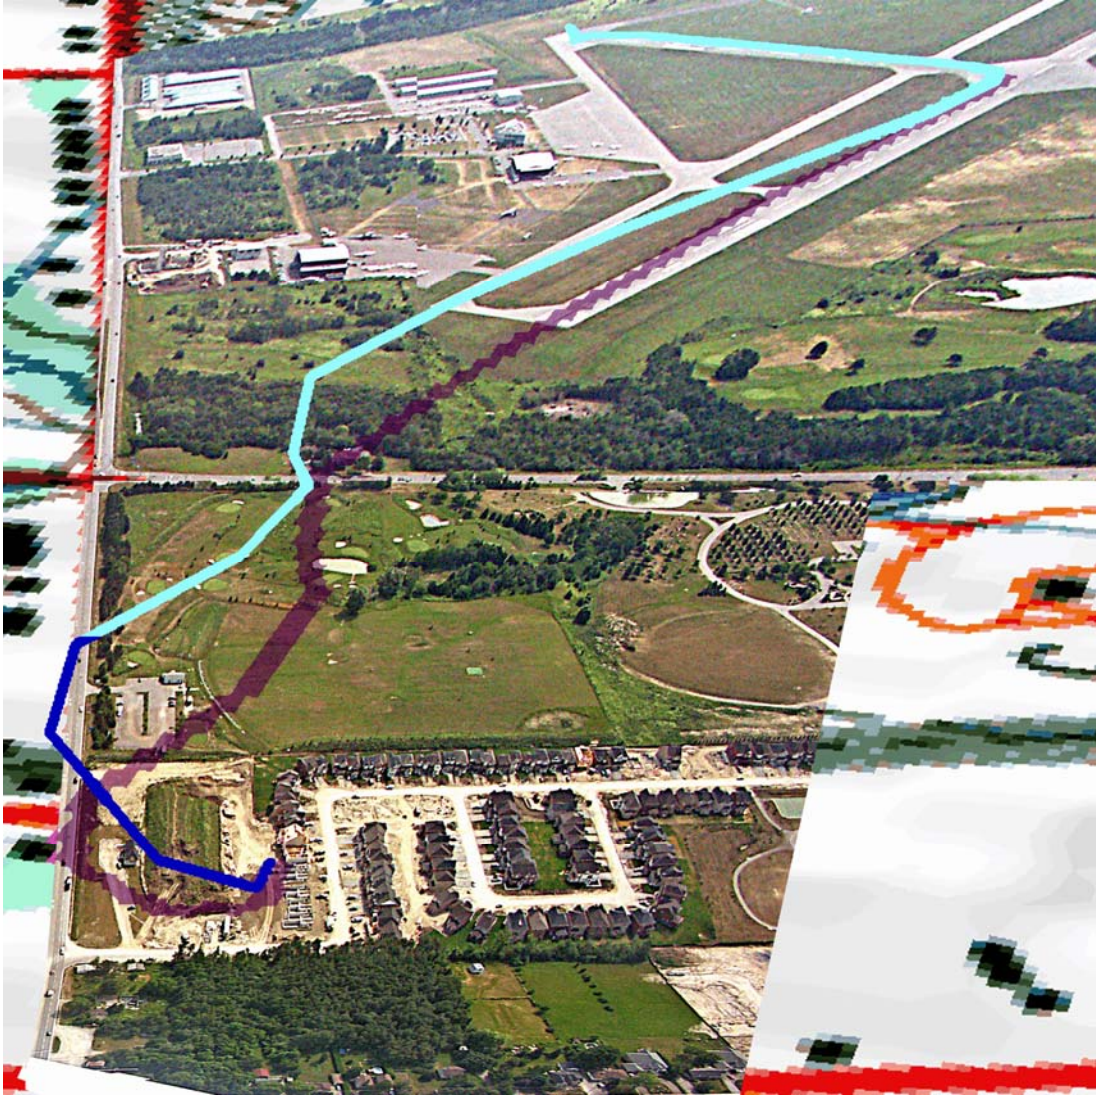
*Appendix A – C-GCWR Ground and Flight Path*

range of 20 to 40 mph. The GPS yielded time, position, and altitude information indicating that the aircraft climbed at 60 to 65 mph indicated airspeed and reached a maximum height of 322 feet agl before beginning the final dive. The flight path is shown in Appendix A and the flight data derived from the GPS and other known data are presented at Appendix B.

Also, shortly after take-off, the aircraft made a turn, inconsistent with normal formation procedures or with the planned routine. Before the turn, the climb rate was more than 400 fpm, consistent with the climb rate contained in the climb report. During the turn, the rate of climb dropped to 150 fpm, indicating a partial loss of engine power. The left turn is consistent with the pilot recognizing a problem and initiating return to the airport.

The climb rate began to increase, returning to over 400 fpm, indicating a recovery of engine power. C-GCWR then turned back to the right toward the lead aircraft, which would be consistent with the pilot returning to the air show plan, indicating that he believed the problem to be transitory and now resolved. Taking into account the discrepancies in the fuel system, this sequence is consistent with air being introduced into the fuel system causing a transitory degradation of engine performance.

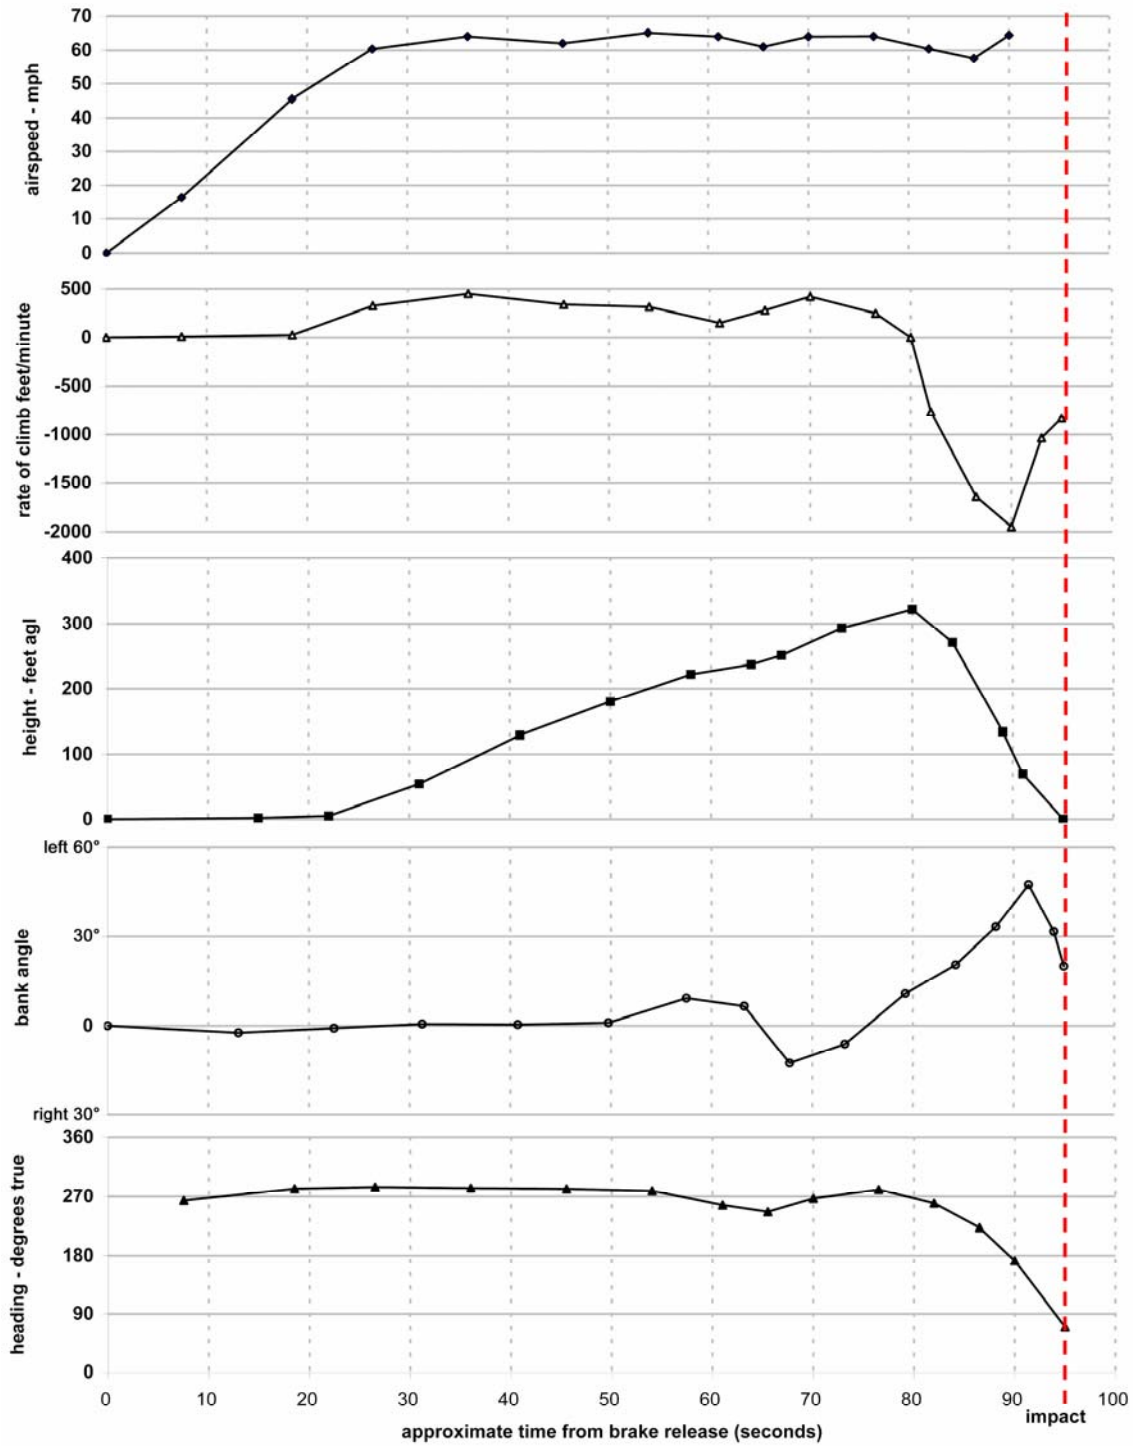
# Appendix B – Flight Data Derived from the Global Positioning System

The investigation focused on the beginning of the turning descent that culminated in the collision with terrain. Although some reports suggested that the aircraft stalled and spun, airspeeds derived from the GPS data indicate an 18 mph margin over flaps 20° stall speed or 10 mph margin over flaps-up stall speed. Airspeed remained above the estimated stall speed, adjusted for the calculated bank angle, throughout the descending left turn. In view of the predictable stall characteristics of this aircraft type and its lack of propensity to spin, it was concluded that the aircraft did not stall or spin before entering the descent.

**C-GCWR - GPS-derived flight data**
