**AVIATION INVESTIGATION REPORT
A05O0225**

CONTROLLED FLIGHT INTO TERRAIN

**WABUSK AIR
PIPER PA-31 NAVAJO C-GKMW
KASHECHEWAN, ONTARIO
30 SEPTEMBER 2005**

Report Number A05O0225

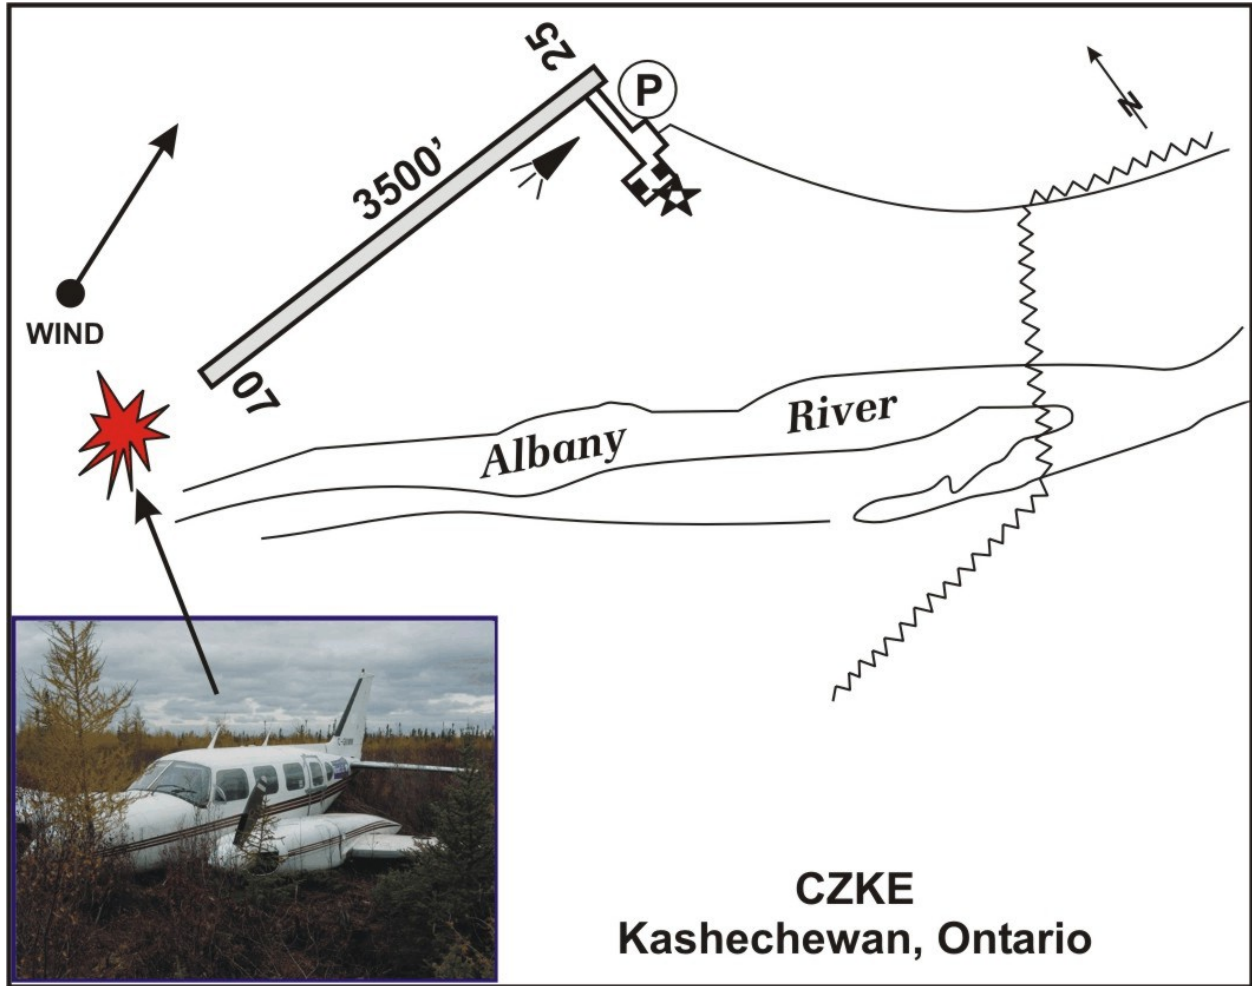
Appendix A – Accident Site

After the aircraft came to rest (see Appendix A), a passenger seated ahead of the exit kicked the door until it opened, after which the passengers evacuated the aircraft. The flight crew exited last. The bags that were not tied down were strewn about the rear of the cabin, but did not delay the evacuation.
