**AVIATION INVESTIGATION REPORT**  
**A05P0103**

**TAIL-ROTOR STRIKE (EXTERNAL LOAD) – LOSS OF CONTROL**

**TRANSPORT CANADA**  
**MBB BO 105 HELICOPTER C-GCHX**  
**BELLA BELLA, BRITISH COLUMBIA**  
**07 MAY 2005**

Report Number A05P0103

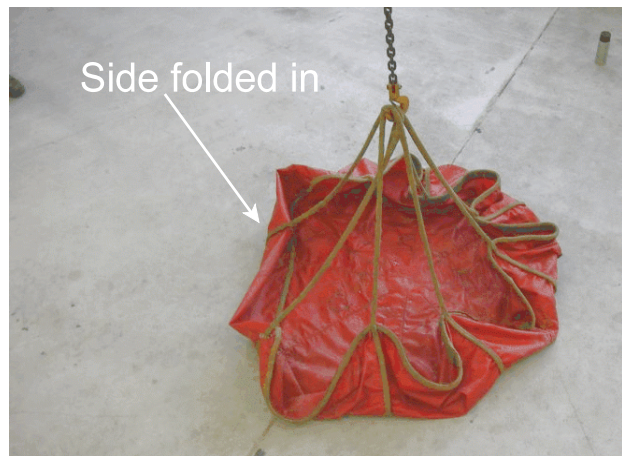
**Figure 1.** Bonnet

The helicopter was moving at about 60 knots when the pilot felt and noticed the bonnet open. The sling gear was still in it, but the bonnet was folded in (see Figure 1) between the one o'clock and the two o'clock position. About two seconds later, the bonnet and longline travelled to the port side of the helicopter, appearing at the pilot's ten o'clock position, slightly above eye level. It moved backwards and out of sight, then there was a bang followed by some thrashing noises, and the helicopter began to turn right. The pilot could see the line hanging from high on the tail, trailing down, back and out at about the four o'clock position. The bonnet was not evident on the line. As this was happening, the pilot slowed the helicopter and reduced power by lowering the collective and bringing the throttles to the engine idle position. Just before impact, the pilot increased the throttles to full and raised the collective a small amount. The helicopter hit the water sooner than expected, and the pilot had not activated the emergency floatation system.

It is most likely that the polypropylene rope, used to snug the top of the bonnet, slid up the beackets and the bonnet opened in flight. The pilot described seeing the starboard front area of the bonnet folded in, likely because the separated beacket allowed the formation of an asymmetric shape. The resulting shape and the bonnet's light weight and high drag allowed the bonnet to fly up and into the flight path of the helicopter, carrying the longline with it. The longline subsequently came into contact with the tail rotor and disabled it, rendering the helicopter uncontrollable.

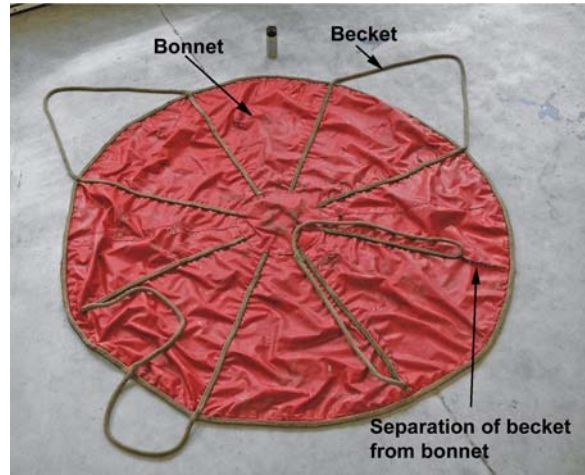
Figure 2. Bonnet showing beacket and separation

The helicopter wreckage was photographed and the sling gear was recovered. The longline was wrapped around the tail-rotor driveshaft, between the tail rotor and the 90° gearbox. The line had released from the helicopter's belly hook and lay about 2 metres away from the helicopter hook. The line was broken about 8 metres from its lower hook. All the beackets of the bonnet (see Figure 2) were secured in a short sling, which was secured in the lower hook. The polypropylene rope was still wrapped around the beackets, but it was loose (see Figure 3). Two of the beackets were partly separated, one about 23 cm from the lip of the bonnet (see Figure 2). Further examination of the helicopter wreckage on land revealed that the longline was released before the helicopter struck the water.

1. The rope used to snug the top of the bonnet most likely slid up the beackets, allowing the bonnet to open and fly into the flight path of the helicopter carrying the longline with it. The longline came into contact with the tail rotor and disabled it, rendering the helicopter uncontrollable.

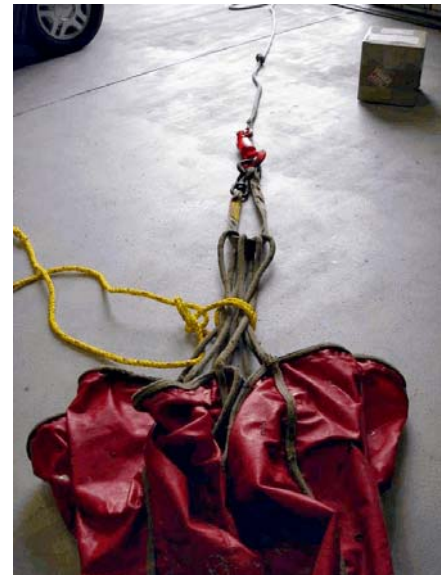
Figure 3. Bonnet with sling

The sling equipment being used was a 33-metre synthetic rope line (longline) attached to the helicopter's belly hook, with a swivel hook at its end. Attached to that extended hook was a bonnet (see Figure 1) with some rope gear and slings inside. It was lashed closed with a polypropylene rope. The bonnet weighed less than 10 kg, and the total external load weight was less than 40 kg. The surface area of the external load was about 2.6 square metres. Figure 3 shows the actual gear and its configuration.
