**AVIATION INVESTIGATION REPORT
A05Q0157**

**FLIGHT INTO ADVERSE WEATHER -
COLLISION WITH TERRAIN**

**NORDPLUS 1998 LTÉE
de HAVILLAND DHC-2 BEAVER C-FODG
SCHEFFERVILLE, QUEBEC 20 nm NW
01 SEPTEMBER 2005**

Report Number A05Q0157

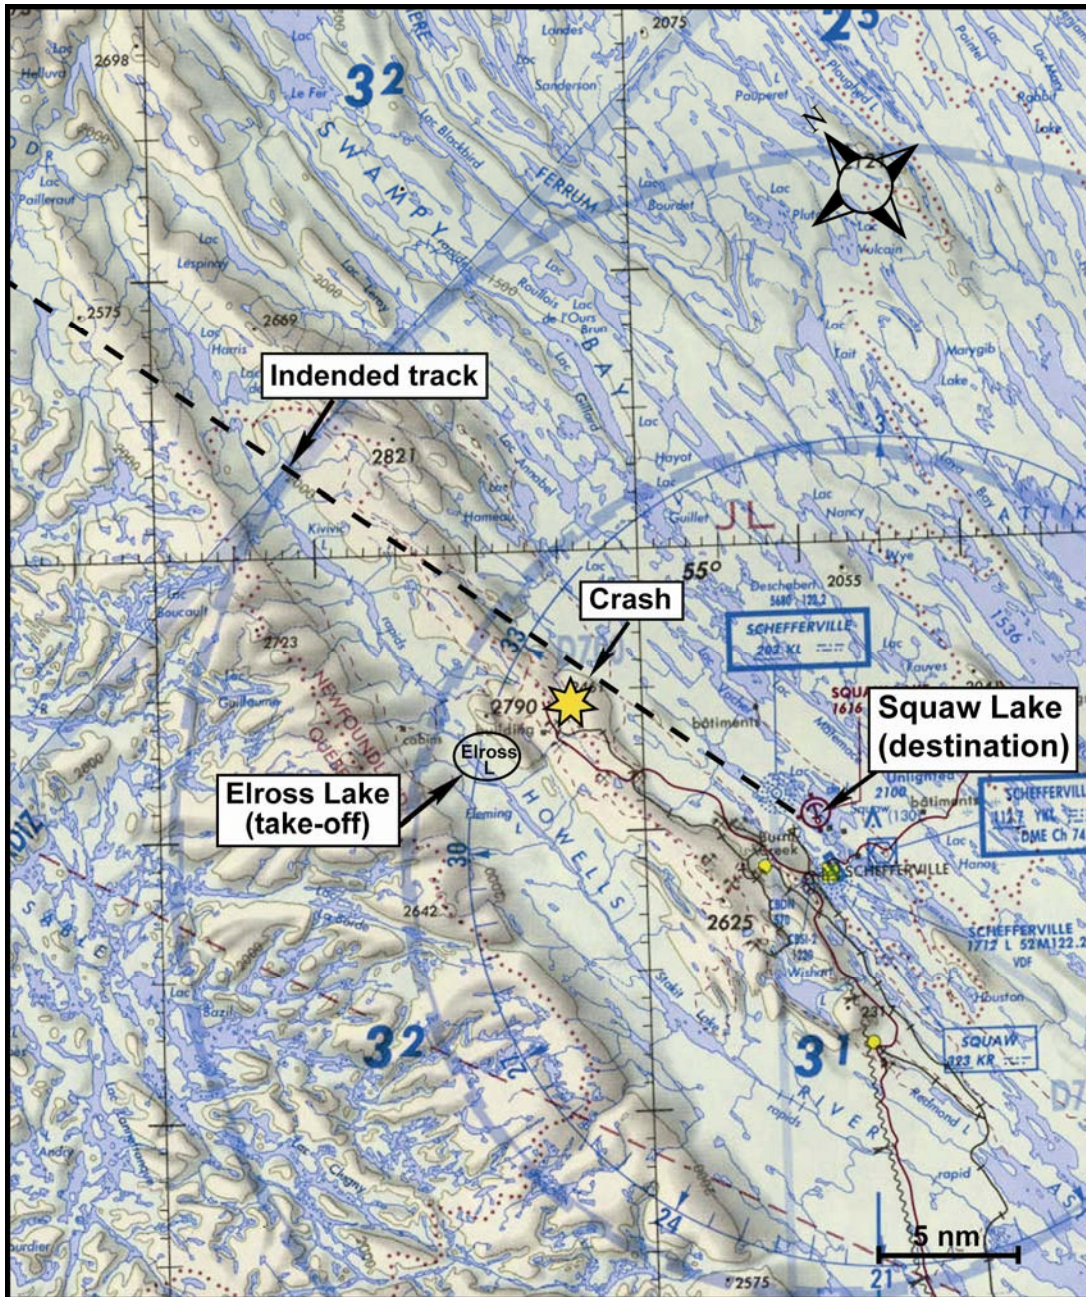
Appendix B – Howells River Valley

The accident site is located in a valley oriented north-south between two mountain ridges, which extend on either side of the Howells River. Elross Lake is situated within this valley (See Appendix B). When weather is marginal, local pilots normally will attempt to cross over the east side ridge further north where the elevation is lower. The river valley is not normally used as a poor weather route, because it is not very wide and does not provide a comfortable turn radius. Winds were strong from the east-south-east and would have caused updrafts in the valley on the lee side of the east ridge. Given the strong wind conditions, visibility and cloud level, the only reasonable way of exiting the valley would have been to fly south where the terrain flattens out before attempting to fly north-east towards Schefferville.
