AVIATION INVESTIGATION REPORT

A06C0204

CARGO DOOR OPENING ON TAKE-OFF

BOEING 727-227 C-GJKF

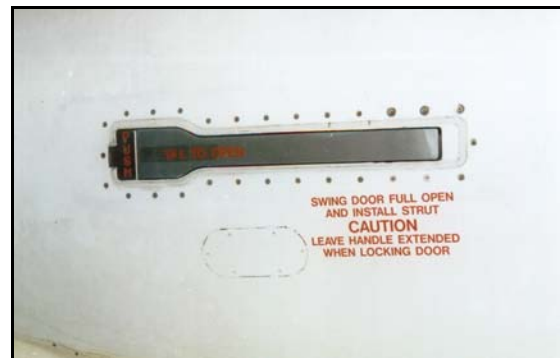
The cargo door, hinges, latch cams and microswitch were sent to the TSB Engineering Laboratory for further analysis. Inspection and bench testing of the door and microswitch revealed no anomalies. The aft cargo door is equipped with an instructional placard indicating how the door should be locked. The instruction reads as follows: "LEAVE HANDLE EXTENDED WHEN LOCKING DOOR" (see Photo 1). Discussions with the operator indicate that the placard was viewed by the operator as an instruction. The manufacturer viewed the placard as a caution only, to avoid damage to the door mechanism.

Photo 1. Placard instructions

The wording on the instructional placard of the aft cargo door can be misleading. Literal adherence to the instruction suggests that the door is locked when the handle is extended. It was determined that the wording on the instructional placard did not contribute to the occurrence.

On 27 February 2007, the TSB issued two occurrence bulletins concerning the instructions on the cargo door placard, and the cargo door closing procedures. The purpose of occurrence bulletins is to apprise Transport Canada and others in the aviation community in a timely manner of certain information that may raise potential operational or technical concerns.

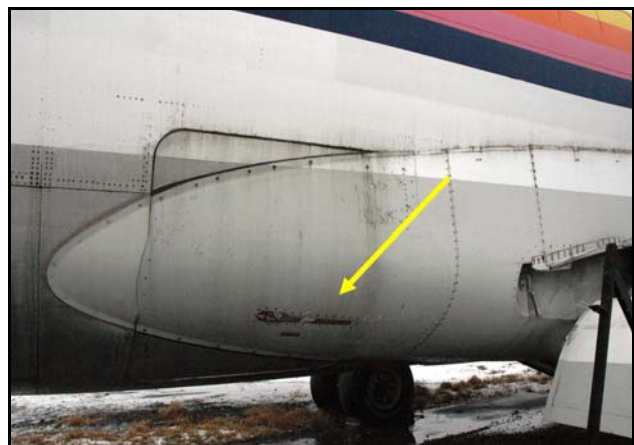
The first step in locking the cargo door is to close the door against the door frame while the external handle is fully extended. When the door is fully closed, the latch rollers are lined up with their respective cams. Movement/retraction of the handle inserts the overcentre latch rollers into their respective cams, resulting in the locking/inward and downward movement of the door. The door handle is then stowed into its recess (see Photo 2).

Photo 2. Aft cargo door handle stowed

The loading and unloading of KFA284 was carried out during the early hours of the morning, in the dark. It is likely that the cargo door was closed but not locked. Despite the position of the door handle, an unlocked aft cargo door in a closed position may appear to be locked, especially from a distance in the dark (see photos 2 and 3).

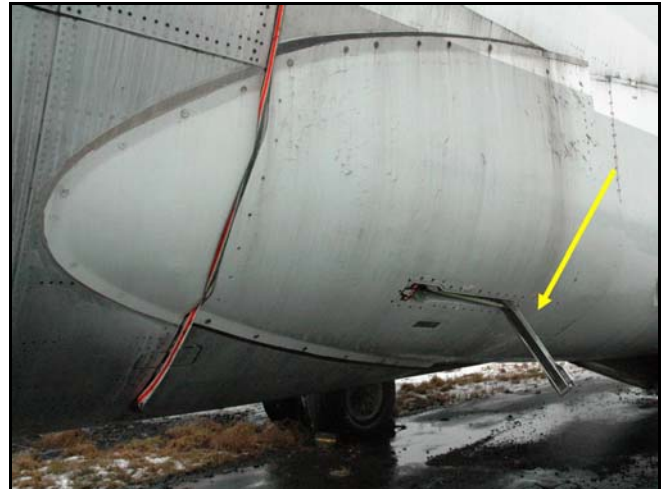
Further tests were carried out on an exemplary Boeing 727-227 aircraft. Numerous operational tests of the aft cargo door could not produce a condition that would extinguish the aft cargo door light on the second officer's annunciator panel and yet leave the door unlocked. Tests revealed that the door was able to close against the door frame and remain in position, with the handle fully extended (see Photo 3).

When the cargo door is open, the handle extends outward approximately 90° into the slip stream (see Photo 3). Previous analysis was conducted by Boeing and the United States National Transportation Safety Board on the external door handle of the cargo door, as a result of a similar occurrence. The analysis concluded that an airspeed of 190 knots produced a sufficient aerodynamic force to close the handle far enough to allow the spring forces inside the cargo door to pull the handle completely closed, even though the cargo door itself remained open. The maximum speed attained during the occurrence flight was in excess of 250 knots indicated airspeed.

Photo 3. Aft cargo door closed and unlocked
