**AVIATION INVESTIGATION REPORT**  
**A06O0150**

**ENGINE FAILURE - COLLISION WITH TERRAIN**

**EXPEDITION HELICOPTERS**  
**BELL B206L (HELICOPTER) C-GSMZ**  
**SMOOTH ROCK FALLS, ONTARIO**  
**21 JUNE 2006**

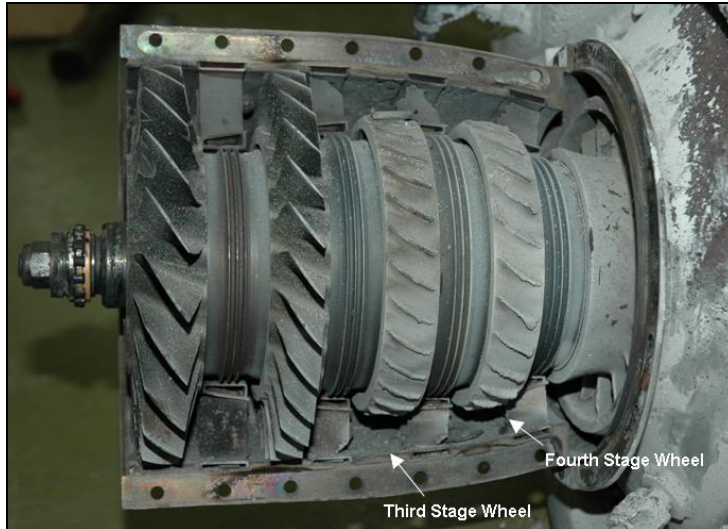
The engine was sent to the TSB Engineering Laboratory for teardown and examination. Visual inspection of the internal engine components revealed that all of the third- and fourth-stage compressor wheel blades had fractured at their roots. The outer portion of the blades of the first-stage turbine wheel had burnt off, and a crack, approximately  $\frac{1}{2}$  inch long, radiated inward from the outer edge of the wheel. Five blades of the second-stage turbine wheel had portions of their tips missing. A total of 28 of 54 compressor blade portions were recovered during the compressor disassembly.

**Photo 1.** Compressor section

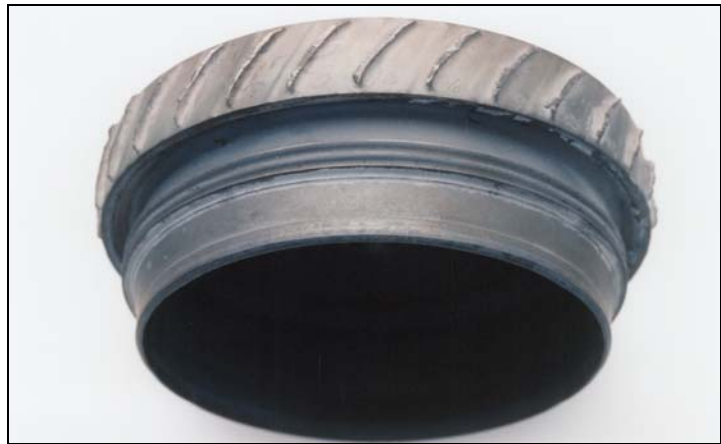
The examination of the third-stage compressor wheel revealed that 12 of the 29 blade roots were too damaged to determine the failure mode. The remaining 17 had cracks propagating across more than 50 per cent of the individual blade thickness. The progressive cracks were located mid-chord of each blade, and the blades were located uniformly around the circumference of the wheel.

**Photo 2.** Damaged third-stage compressor wheel

The cracks showed the clamshell shape of typical fatigue cracks. However, beach marks or striations were not observed due to the oxidation of the fracture surfaces caused by the post-impact fire. Consequently, it was not possible to estimate the propagation rate of the fatigue cracks. The fracture surfaces and cross-sections through the fatigue crack origins of selected blades did not reveal any specific cause for the initiation of the fatigue cracks. There was no evidence of foreign object impact damage on the blade surfaces that were available for examination.

1. The engine power loss event was a result of the failure of the third-stage compressor wheel.
2. Numerous blades on the third-stage compressor wheel had progressive cracks, which had propagated through approximately 50 per cent of the blade thickness. The liberated compressor blades caused severe internal damage to the third- and fourth-stage compressor wheels.
