**AVIATION INVESTIGATION REPORT
A06P0095**

LOSS OF CONTROL

**NORTHERN ROCKIES AIR CHARTER
CESSNA 185B C-FPKJ
PRINCE GEORGE AIRPORT, BRITISH COLUMBIA
31 MAY 2006**

Report Number A06P0095

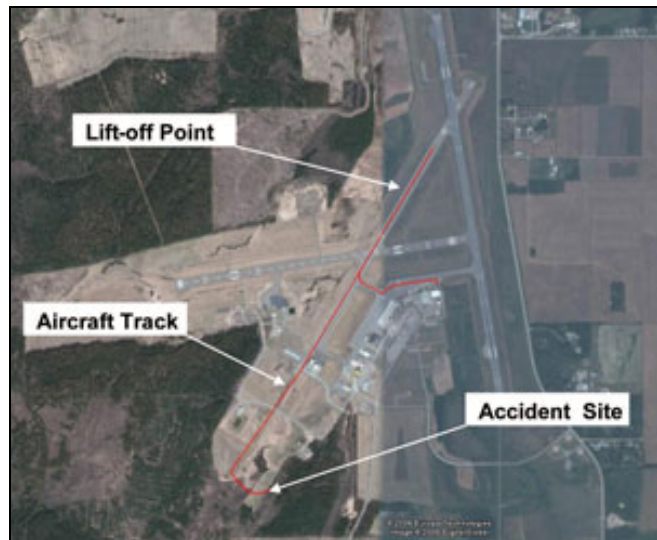
The pilot departed Prince George, British Columbia, from Runway 19 on a flight to Scoop Lake, British Columbia. The aircraft flew on the runway heading until it was about 2400 feet beyond the departure end of the runway, where it abruptly pitched up, climbed steeply, turned left, and rapidly descended into trees about 600 feet left of the runway's extended centreline. The aircraft was airborne for less than 47 seconds and reached a maximum height of about 270 feet above ground level. The aircraft was destroyed, and the pilot, who was the sole occupant, was seriously injured. There was no fire.

Photo 1. Departure path from Prince George Airport
