AVIATION INVESTIGATION REPORT

A06P0190

LOSS OF CONTROL - TRANSMISSION PYLON SUPPORT SPINDLE FRACTURE

**QUANTUM HELICOPTERS LTD.
BELL 206B (HELICOPTER) C-GSLV
ALICE ARM, BRITISH COLUMBIA
19 SEPTEMBER 2006**

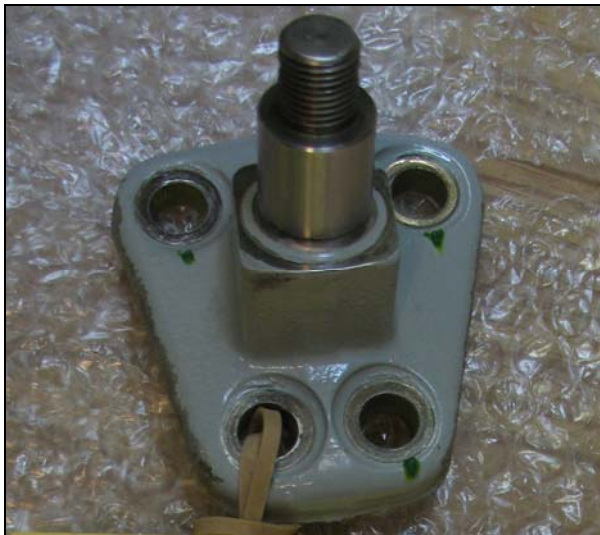
Photo 1. Exemplar pylon support spindle
