**AVIATION INVESTIGATION REPORT  
A06W0111**

**LOSS OF CONTROL - COLLISION WITH GROUND**

**PIPER PA-34-200T (SENECA II) C-GOLY  
EDSON, ALBERTA  
11 JULY 2006**

Report Number A06W0111

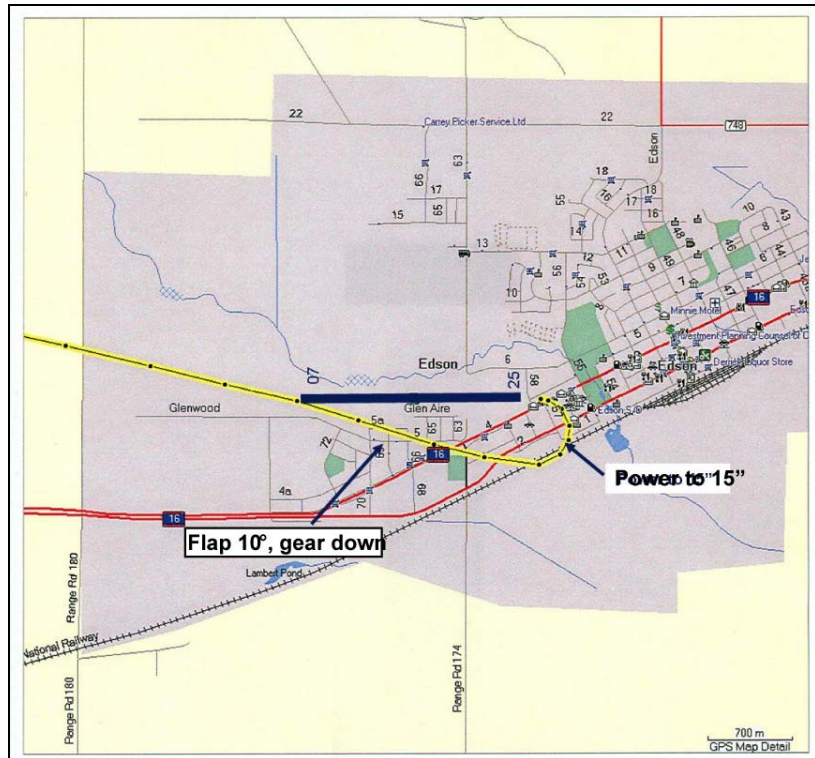
At 1309, the aircraft was abeam the displaced threshold of Runway 25, at approximately 750 feet agl and 104 knots groundspeed. To keep the aircraft from flying over the residential and commercial areas that were in close proximity to the approach end of Runway 25, the pilot made a turn toward the threshold, and reduced the power on the left engine to 15 inches of manifold pressure (see Figure 1). Shortly thereafter, roll and pitch control of the aircraft became difficult, and a high rate of descent developed. The aircraft's flight path was somewhat erratic, and the aircraft was banking side-to-side, while in a steep descending turn. The pilot leveled the wings and increased power on the left engine to approximately 40 inches of manifold pressure; this was near the maximum manifold pressure (power) available. The aircraft flight manual specifies a single-engine, go-around power setting of 40 inches of manifold pressure to prevent overstressing the operating engine.

Figure 1. Aircraft flight path

levelled the wings and increased power on the left engine to approximately 40 inches of manifold pressure; this was near the maximum manifold pressure (power) available. The aircraft flight manual specifies a single-engine, go-around power setting of 40 inches of manifold pressure to prevent overstressing the operating engine.

GPS track log data reflected an average rate of descent of 1330 fpm and an average rate of heading change of 6° per second while the aircraft was in the turn. The last complete recorded track log data point, at 1309:37, showed the aircraft at 80 feet above ground, at a ground speed of 63 knots, and on a track of 261°M.

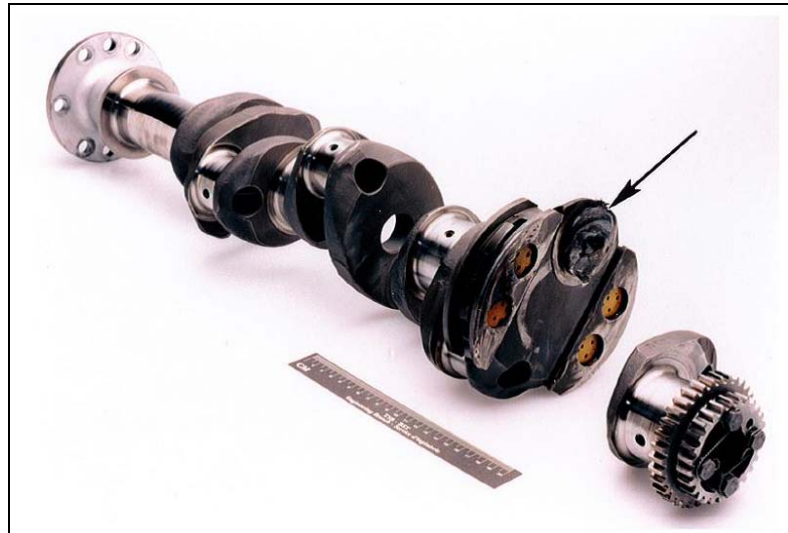
An examination by the TSB Engineering Laboratory revealed that the crankshaft failed from the extension in overload of a fatigue crack initiating from an origin subsurface to the fillet radius between the No. 1 rod journal bearing and the No. 2 crankshaft cheek (see Photo 1). The fatigue cracking initiated and grew to critical dimensions under normal service loading.

Photo 1. LTSIO-360 crankshaft fracture

The aircraft was returned to service on 28 December 2005 and flew for approximately 26 hours before the engine failure on the accident flight. The TSB Engineering Laboratory report indicated that no evidence was found that either the crack initiation or final separation was influenced by the previous propeller strike. The report also concluded that the high-cycle nature of the fatigue cracking, coupled with the extent of cracking, indicated that the fatigue crack was most probably present at the time of the engine overhaul MPI and propeller strike MPI. Although the crack initiated subsurface, the crack would have penetrated through to the surface of the fillet radius early in the growth phase, and should have been detectable by any MPI procedure.

1. A surface crack on the crankshaft, which should have been detectable during the magnetic particle inspection (MPI) procedures, went undetected during two separate inspections.
2. The crankshaft failed from the extension, in overload, of a fatigue crack initiating from an origin subsurface to the fillet radius between the No. 1 rod journal bearing and the No. 2 crankshaft cheek, resulting in the total power loss on the right engine.
3. The pilot attempted to perform a single-engine approach in a manner similar to what he recently practiced while flying a high-performance, military style, single-engine jet trainer. This deviation from flight manual procedures and common single-engine approach practices for multi-engine aircraft resulted in the loss of control and impact with the ground.

The overhaul facility conducted an internal quality assurance review of its non-destructive testing (NDT) procedures, techniques, and equipment to ensure compliance with existing standards.
