AVIATION INVESTIGATION REPORT

A07F0101

**HYDRAULIC PUMP FAILURE
BOMBARDIER BD-100-1A10, C-GFHR
GENEVA, SWITZERLAND
25 JUNE 2007**

Report Number A07F0101

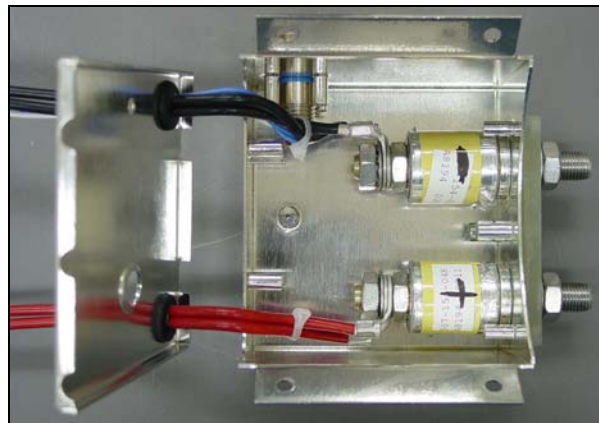
Photo 1. EMI filter assembly before final assembly

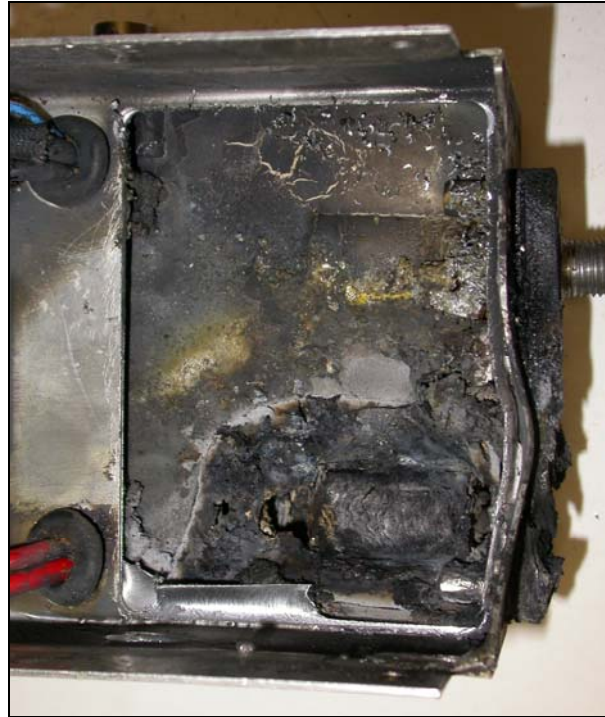
Photo 2. Filter assembly with bottom plate removed

The top and bottom of the filter assembly were machined off and the inside of the filter assembly was examined (see Photo 2). A portion of the negative terminal of the capacitor was above the potting material. The positive terminal of the capacitor was destroyed with very little remaining. The damage was consistent with an electrical short within the capacitor.

It could not be determined when the melting or burning started or stopped, and there was no identifiable discrepancy that would have caused the capacitor attached to the positive terminal of the EMI filter to overheat and fail.

1. The capacitor attached to the positive terminal of the electromagnetic interference (EMI) filter mounted to the left DC motor pump (DCMP) failed for unknown reasons, causing the positive terminal to melt and burn the associated wiring.

As a precaution, the following Bombardier advisory wire (AW), *Aircraft Flight Manual* (AFM) temporary revisions (TRs) and service bulletins (S/Bs) were issued by Bombardier and Parker Hannifin Corporation (Parker) to address the problem. The new DC motor pump (DCMP) configuration identified by the service bulletins and certified by Bombardier and Parker eliminates the capacitor from the electromagnetic interference filter assembly:

5. 21 September 2007 – Parker issued S/B 955805-5-29-380 to replace the DCMP filter and re-identify the DCMP as P/N 955805-7 (from a -5).
6. 11 October 2007 – Bombardier issued AFM TR-44-1 temporarily restricting the operations of the DCMP during flight.
