**AVIATION INVESTIGATION REPORT  
A07Q0085**

**IN-FLIGHT BREAK-UP**

**HELI-TRANSPORT SERVICES (CANADA) INC.  
EUROCOPTER AS350 B1 ASTAR (HELICOPTER) C-GZCN  
CHIBOUGAMAU, QUEBEC, 176 nm NE  
27 MAY 2007**

Report Number A07Q0085

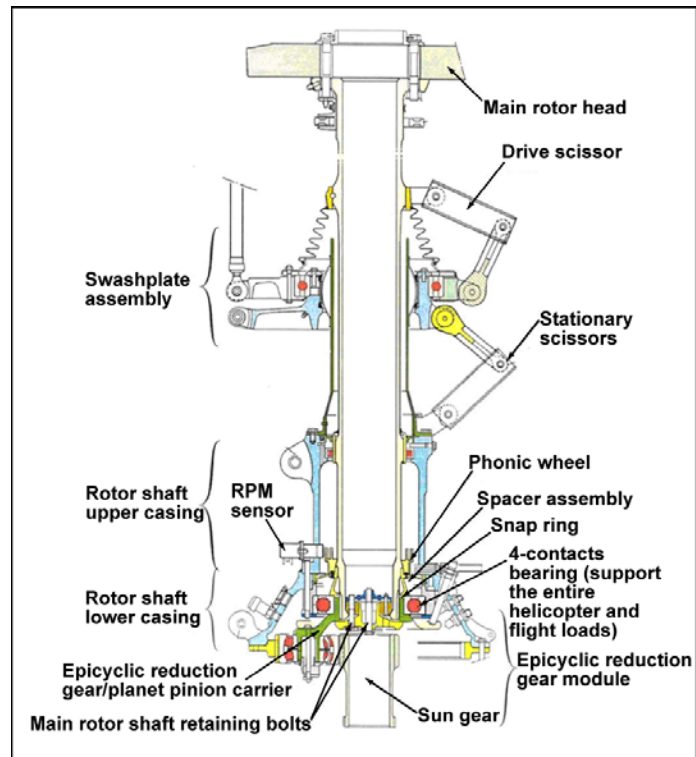
Figure 1. AS350 Main gearbox schematic

During the post-accident examination, the MGB was split at the main rotor shaft lower casing assembly line. The six main rotor shaft retaining bolts and the self-locking centre bolt attaching the epicyclic reduction gear to the mast were found unscrewed in the bottom of the sun gear. All of the associated locking tabs and bolts were accounted for. Additionally, snap ring segments were found above the phonic wheel (spacer assembly) in the rotor shaft upper casing (see Figure 1).

During the post-accident examination, the six mast retaining bolts and the self-locking centre bolt attaching the epicyclic reduction gear to the mast were found unscrewed in the bottom of the sun gear. In addition, segments of the snap ring were found above the spacer assembly as opposed to below the spacer assembly. The snap ring's sole function is to retain the spacer assembly, the casings and housings on the main rotor shaft while manipulating the MGB upper module before the epicyclic gear module is bolted on. It is not intended to take either the aircraft weight or dynamic loads experienced in flight.

If the snap ring is installed in the wrong sequence, which was the case in this occurrence, it will move out of its groove due to overload forces. This will release the tension on the mast retaining bolts and locking tabs. The tabs will no longer function as locking devices. The direction in which the sun gear turns and rubs the bolt heads allows for the progressive loosening of the mast retaining bolts. When the bolts no longer secure the mast, the main rotor shaft will move vertically and cause the main rotor blades to fly down into the forward fuselage.

The TSB post-accident examination revealed that the snap ring within the MGB epicyclic reduction gear module was installed before installing the spacer assembly. The wrong installation sequence of the snap ring, relative to the spacer assembly, allowed the snap ring to slip from its groove on the mast, which in turn prevented the locking tabs from holding the mast retaining bolts. The bolts loosened by rubbing inside the sun gear, and eventually fell out, allowing the main rotor shaft to move vertically. The vertical movement of the main rotor shaft caused the rotor blades to strike the forward fuselage.
