AVIATION INVESTIGATION REPORT A08C0108

ENGINE POWER LOSS

**CANADIAN NORTH INC.
BOEING 737-217, C-GKCP
SASKATOON, SASKATCHEWAN
22 MAY 2008**

Report Number A08C0108

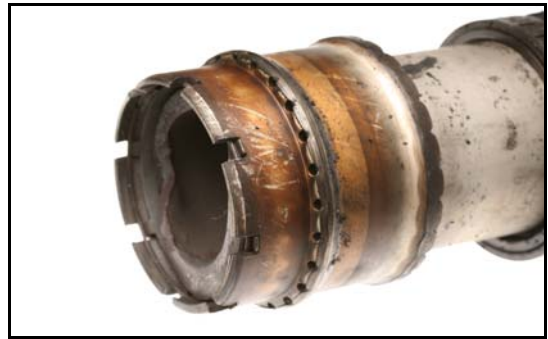
Photo 1. LPT Shaft & Retainer Nut

Tear-down of the right engine revealed a fractured LPT shaft in the area immediately surrounded by the high-pressure compressor (HPC) sealing tube aft fitting (See Appendix A - Pratt & Whitney JT8D). The number 4.5 bearing stack was found binding against the LPT shaft fracture (see Photo 1). The HPC sealing tube was also found fractured at three locations. These and other selected parts of the engine were sent the TSB Engineering Laboratory for further analysis.

The LPT shaft exhibited a twist and localized heat distress in the area of the fracture. The fracture surface was partially smeared. Analysis of the fractured surface that was left untouched revealed a ductile shear overload failure (see Photo 1).

The 4.5 bearing stack consists of the retainer nut, anti-rotation lock washer, snap ring, bearing spacer (squirrel cage), roller bearing, spacers, and seals. The anti-rotation lock washer and snap ring were found still in place on the retaining nut (see Photo 1). The retaining nut, anti-rotation lock washer and snap ring had unwound from the LPT shaft threads, leaving score marks on the inner surface of the anti-rotation lock washer tabs (see Photo 2). These score marks were consistent with the LPT shaft thread pitch (see Photo 3).

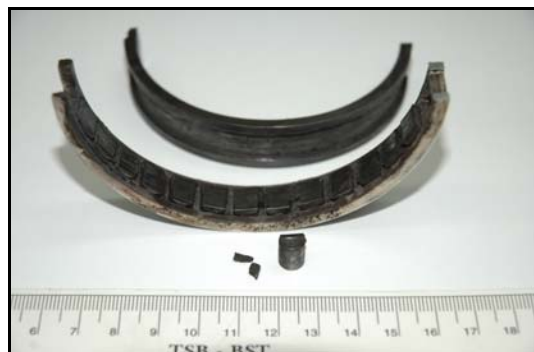
Photo 4. Worn 4.5 Roller Bearing

The retainer nut oil gallery ridges showed signs of heavy wear and the peaks of retainer nut threads were worn. The bearing spacer showed significant rub on the forward inner wall and on the aft inner wall. Although the spacer is considered part of the 4.5 bearing stack, it is incorporated into the high pressure turbine (HPT) shaft and rotates faster than the LPT shaft. A review of the records indicates that the 4.5 bearing had accumulated a total of 3668 hours and 2667 cycles since it was last overhauled. The rollers of the 4.5 roller bearing showed significant material loss with the flattened area facing the inner race (see Photo 4). Analysis of the 4.5 bearing components revealed that there were no pre-existing anomalies. The occurrence engine's 4.5 bearing stack,

The most likely scenario is that wear of the 4.5 roller bearing began within the previous two hours of engine operation. Wear of the 4.5 roller bearing reduced radial constraint of the LPT shaft, resulting in the LPT shaft beginning to flex. The root cause of the wear on the 4.5 roller bearing was not determined. Peak deflection of the LPT shaft occurred at approximately mid-span which is surrounded by the HPC seal aft fitting. The LPT shaft made contact with the HPC seal aft fitting and induced a very local, elevated heat-distressed area on the shaft. The elevated heat and wear compromised the physical properties of the LPT shaft and resulted in a ductile fracture from torsional shear overload. The LPT shaft began to rub the inside of the HPC seal tube, resulting in elevated temperatures and ductile fractures of the HPC seal tube. After the failure of the LPT shaft, reduced engine power at about ground idle level was sustained by the engine's high-pressure system.

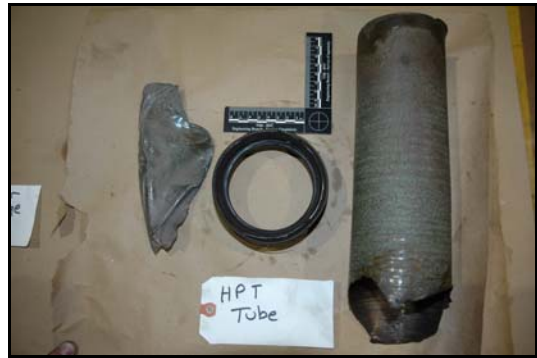
Photo 5. HPC sealing tube

A softened piece of the HPC sealing tube and the coating on the outside of the HPC sealing tube indicated elevated temperatures approaching 1000°F. The inside of the HPC sealing tube showed significant rub marks. Examination of forward HPC sealing tube fitting and the softened fragmented piece revealed ductile shear overload failures. The aft fitting revealed signs of excessive rub and an outward flanging ductile overload failure of the HPC sealing tube wall. There was no indication of coking or an oil fire in this area (see Photo 5).
