**AVIATION INVESTIGATION REPORT  
A08O0189**

**BOUNCED LANDING/GO-AROUND AFTER TOUCHDOWN**

**KELOWNA FLIGHTCRAFT AIR CHARTER LTD.**

**BOEING 727-227 C-GLKF**

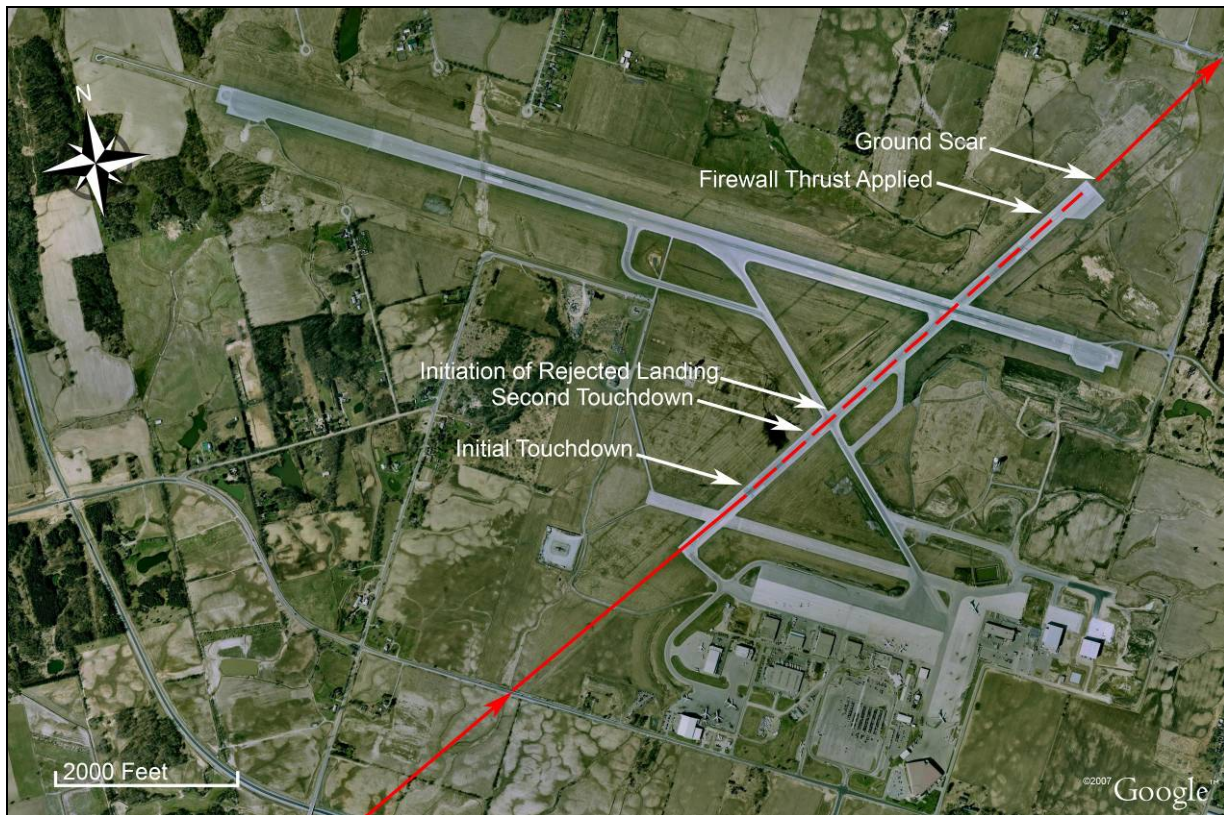
At 2216, the aircraft touched down hard, approximately 1200 feet past the threshold (see Photo 1), with a rate of descent of approximately 350 feet per minute. It then bounced approximately eight feet vertically, before landing firmly. The vertical acceleration for the first touchdown was recorded on the flight data recorder (FDR) at 1.9 g.<sup>3</sup> The maximum vertical acceleration was recorded on the second touchdown when it reached 2.3 g. Both these values indicate touchdown forces greater than normally experienced. Due to the limited FDR parameters, it could not be determined why, after a stabilized approach, the aircraft touched down at a high rate of descent.

**Photo 1.** Aircraft flight path
