AVIATION INVESTIGATION REPORT
A08P0353

CONTROLLED FLIGHT INTO TERRAIN (CFIT)

PACIFIC COASTAL AIRLINES
GRUMMAN G-21A C-FPCK
SOUTH THORMANBY ISLAND, BRITISH COLUMBIA
16 NOVEMBER 2008

Report Number A08P0353

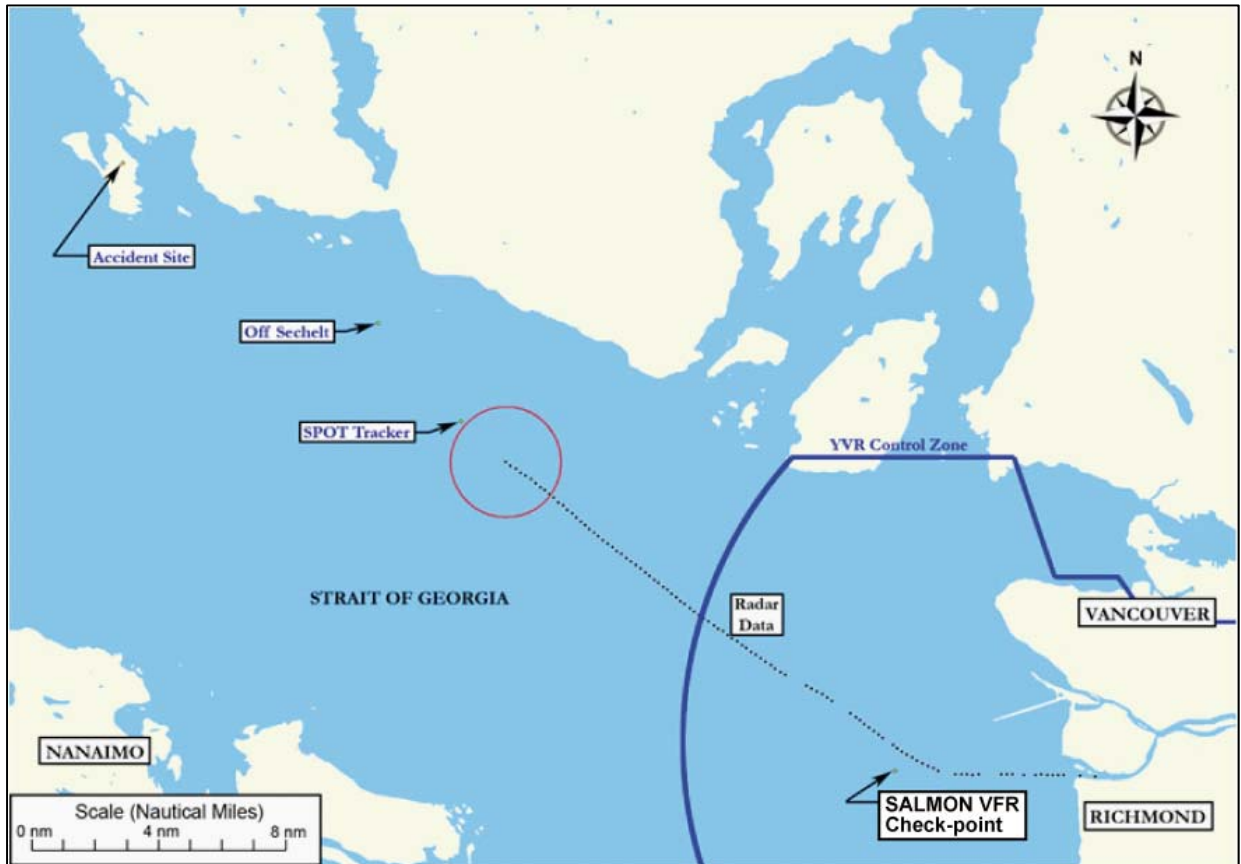
The first nine minutes of the flight appeared on CYVR radar, ending about 21 nm northwest of CYVR, about 15 miles southeast of the accident site. Radar returns show that the aircraft's ground speed remained steady around 140 knots, normal cruise speed for this aircraft, allowing for the 8-knot to 15-knot tailwind encountered between CYVR and South Thormanby Island. Although there was no intervening terrain between the radar source and the aircraft, the radar coverage was likely limited because of the low altitude at which the aircraft flew. Of 110 valid radar returns, 10 returns (9 per cent) showed the aircraft's altitude as 0 feet asl, 96 returns (87 per cent) showed the altitude as 100 feet asl, and 4 returns (4 per cent) showed the altitude as 200 feet asl. No radar returns showed the aircraft's altitude higher than 200 feet asl.

Figure 1. Accident flight data. Circle (2 sm radius) represents minimum required visibility.

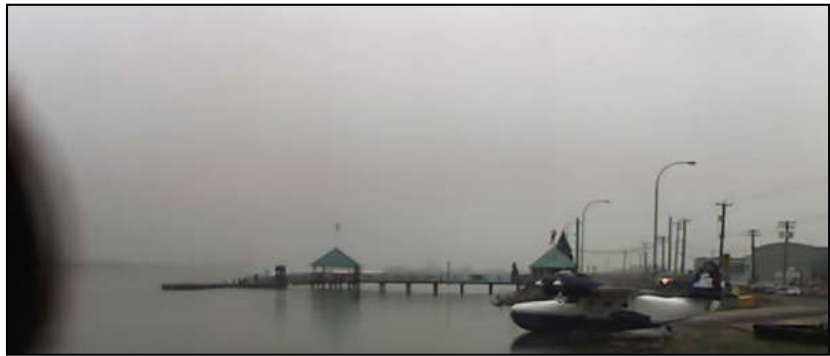
approved the pilot's request for SVFR to depart the control zone. Contrary to the most recent ATIS report, the actual conditions on the river at the time of take-off were below both VFR and SVFR criteria. A photograph (see Photo 1) was taken of the aircraft as it taxied down the ramp into the river just moments before take-off. The photo shows the weather conditions in the direction of take-off. An island (bottom middle of photo) approximately 0.6 sm away is barely visible, and this visibility persisted beyond the time of take-off. A similar photo was taken on a clear day for contrast (see Photo 2).

Photo 1. Accident aircraft entering river for take-off (accident flight)

Given the conditions at take-off and at the accident site, as well as the forecast and reported conditions for the en route section, it is likely that most of the flight was conducted below the required VFR minima. The conditions present on the day of the occurrence would have resulted in a high likelihood that IMC conditions would be encountered. The visibility portrayed in the photograph as the aircraft taxied into the river at Vancouver (see Photo 1) displays conditions below SVFR minima for fixed-wing aircraft.

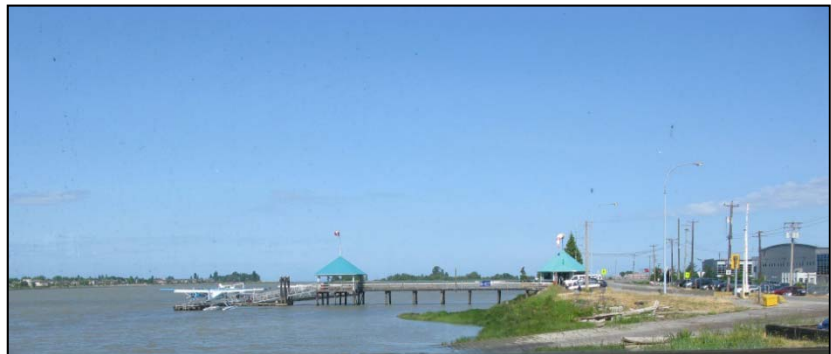
Photo 2. Same location as Photo 1 taken on clear day
