AVIATION INVESTIGATION REPORT

A08Q0051

OUT-OF-TRIM NOSE DOWN CONDITION LEADING TO AN AIRPLANE UPSET

AIRBUS A310-308 C-GPAT

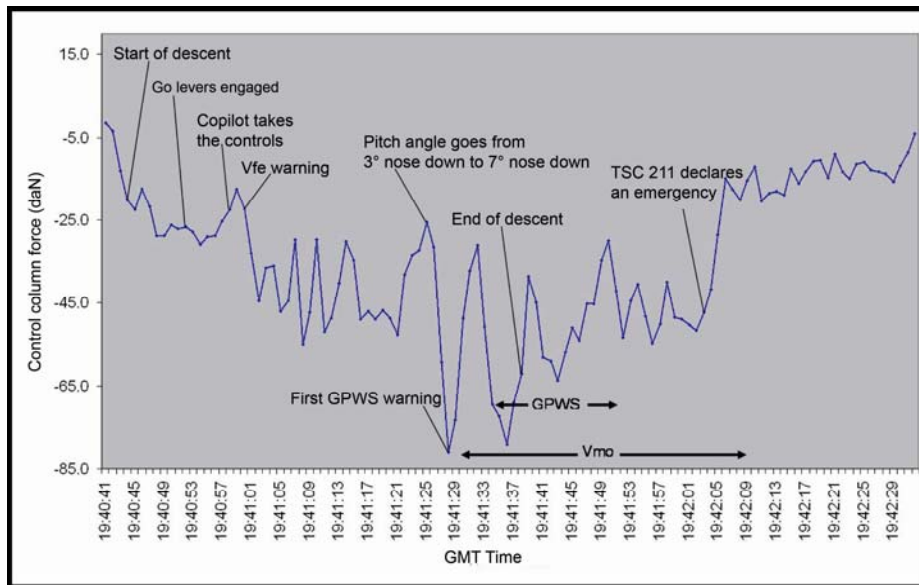
Figure 9. Control column force during descent and loss of control

During the critical phase of the flight, the control column force increased distinctly when the aircraft started its descent and the THS reached the ND stop of the electric trim. The control column force stayed at about -30 daN until the time the co-pilot took the controls. A momentary release of the control column can be observed at this time. Subsequently, the control column

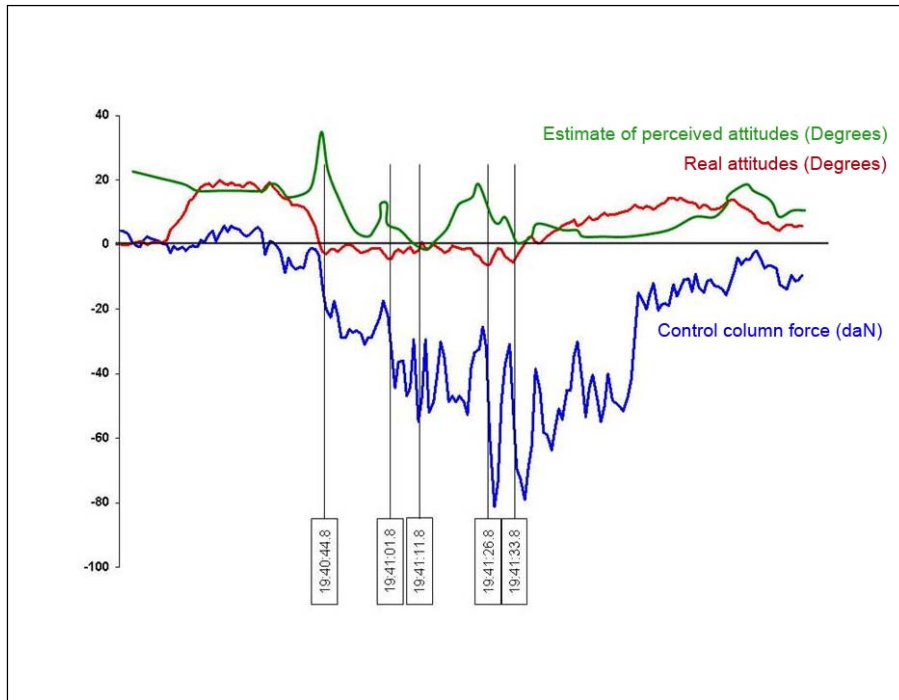
Figure 10. Somatogravic illusion during descent

The flight data were used to estimate ⁵² the aircraft's attitude perceived by the crew (see Figure 10). It was found that:

- At about 1440:44, at the end of the climb, the perceived attitude reached greater than 30° whereas the actual attitude was about -3°.
- Between 1440:44 and 1441:11, the perceived attitude was nose-up and greater than the actual attitude.
- Between 1441:11 and 1441:27, the perceived attitude rose again to +18°.
- A significant decrease in control column forces was noted at 1441:01, 1441:26 and 1441:33, when the pitch attitude was -4.2°, -6.3° and -5.6°, respectively.
