AVIATION INVESTIGATION REPORT

A08Q0055

LANDING WITH NOSE WHEEL RETRACTED

SERVICE AÉRIEN GOUVERNEMENTAL DU QUÉBEC
CHALLENGER CL-600-2A12 C-FURG
QUÉBEC/JEAN LESAGE INTERNATIONAL AIRPORT, QUÉBEC
20 MARCH 2008

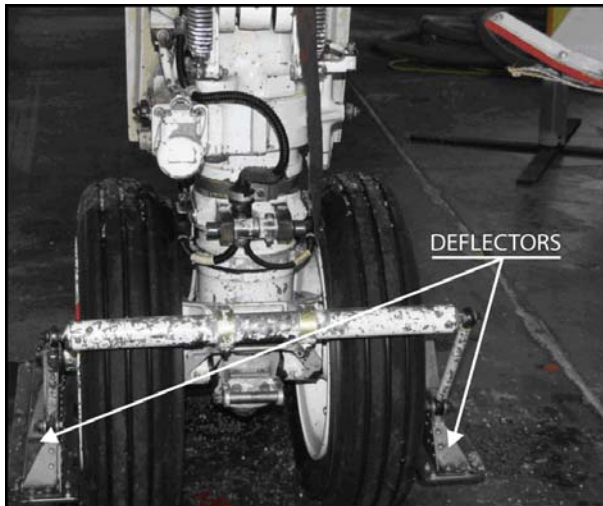
Photo 1. Nose gear deflectors

The nose gear consists of a set of dual wheels and two gravel deflectors installed on each side of the tires (see Photo 1). The total width of the landing gear set equipped with the two gravel deflectors is 23.125 inches. The opening of the nose landing gear well structure is 23.625 inches wide. To allow the gravel deflectors to move freely, a modification to the width of the well was done. A notch was made in each side of the well, making the total width 24.250 inches (see Photo 2).

The compression of the oleo strut allowed the landing gear to migrate out of the uplock latch and fall on to the nose landing gear doors. Some nose wheel rotation was also permitted in this unsecured position because the centring cam was no longer engaged in the compressed oleo strut, thereby resulting in the wheel/ deflector assembly not having sufficient clearance for the landing gear to extend normally. The rotation of the nose gear in the well resulted in the right-side gravel deflector becoming stuck, preventing extension of the nose landing gear.

1. The oleo pneumatic shock absorber (oleo strut) was found to be compressed due to a loss of nitrogen. As a result, the nose landing gear was released from the landing gear uplock latch, which allowed the wheel assembly to pivot and become jammed in the well.
2. The right deflector remained jammed in the nose landing gear well, preventing extension of the landing gear.

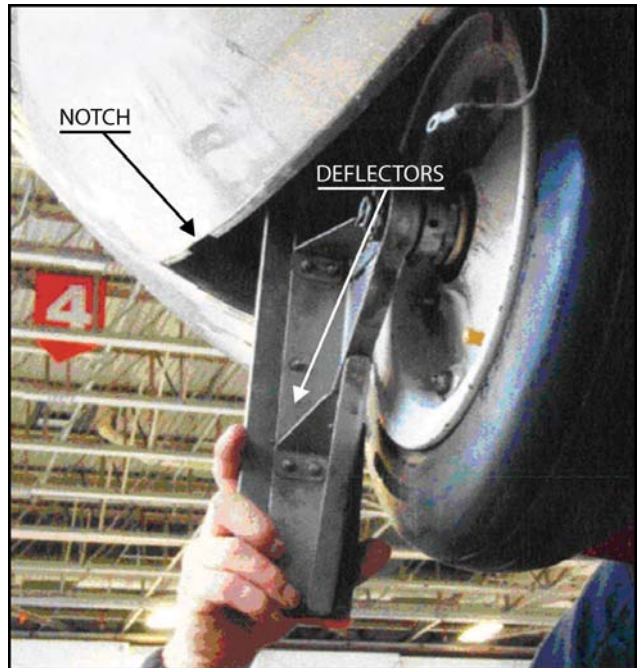
Photo 2. Notch for deflector

When retracting the landing gear, the fully extended oleo strut goes through the notches and the clearance between the deflectors and the nose landing gear well structure is 0.562 inches on each side. When the oleo strut does not extend and thus does not pass through the notches, the clearance is reduced by 0.250 inches on each side. For comparison purposes, the clearance between the tires and the structure is 3.562 inches on each side for aircraft not equipped with gravel deflectors. Service history on Challenger 601 aircraft indicates no record of oleo nitrogen depletion leading to the inability to extend nose landing gear for aircraft not equipped with a gravel runway kit.

C-FURG is equipped with a kit enabling it to operate on unpaved/gravel runways. When the oleo strut does not extend, the clearance between the gravel deflectors and the nose landing gear well is reduced to 0.250 inches on each side. Tests with the oleo strut compressed revealed that the gravel deflectors need only pivot a few inches to become jammed in the well. Nevertheless, when the oleo strut operates correctly, the clearance available is sufficient for the landing gear to deploy as designed.

1. The design of the landing gear latch and pin allows the landing gear to be released from the landing gear uplock latch and to drop into the well during flight, causing the right gravel deflectors to jam, preventing extension of the nose landing gear.
2. The clearance between the gravel deflectors and the nose landing gear well structure is very narrow when compared to similar aircraft that are not equipped with gravel deflectors. Another oleo pneumatic shock absorber (oleo strut) compression could result in the same situation occurring again.
