## AVIATION INVESTIGATION REPORT

A08Q0110

**LOSS OF VISUAL REFERENCES – COLLISION WITH WATER**

**EUROCOPTER EC 120B (HELICOPTER) C-GHNI**

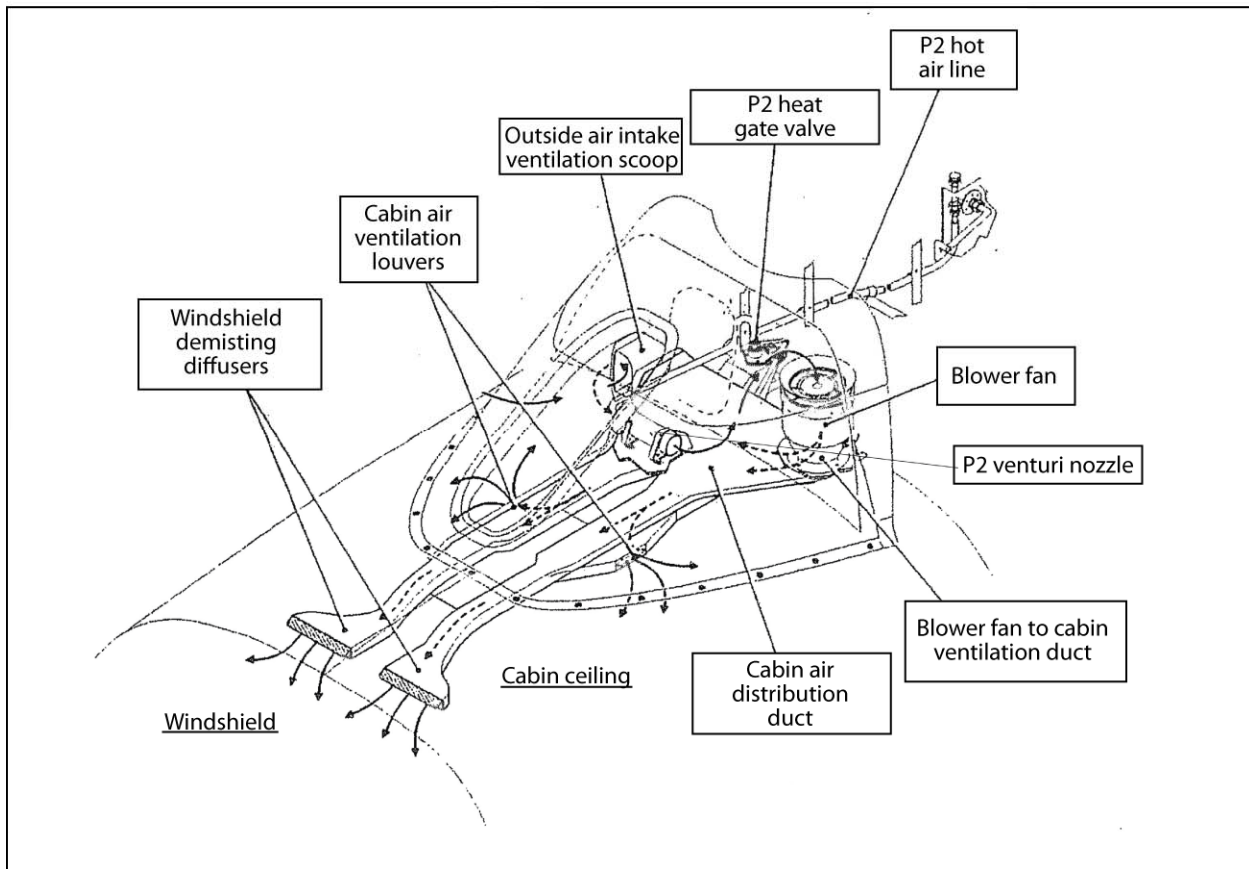
Figure 1. Cabin ventilation, heating, and demisting system.

Figure 1 shows the cabin ventilation, heating, and demisting system on the EC 120B. Outside air flows in through the front air intake and is diverted into the right-hand forward cowling compartment by the ventilation scoop. The air is then directed by a blower fan to the distribution system via a hole in the cabin ceiling. The cabin air distribution system comprises a duct fitted underneath the cabin ceiling and positioned on the aircraft centreline. This duct is divided into two arms. If the fan blower is selected to the open position (ON), only outside fresh air is drawn inside the cabin. If demisting is needed to clear the helicopter windshield and windows, the pilot adjusts the gate valve control knob, located on the cabin ceiling between the two front seats. The outside air crosses the hot air tapped from the engine centrifugal compressor outlet (P2) venturi nozzle where it is mixed with P2 air<sup>3</sup>. To obtain optimum air flow towards the front windshield, the pilot must close the louvers supplying air to the rear cabin. Examination of the helicopter after the occurrence showed that the P2 gate valve control knob and the louvers were in the appropriate positions for maximum airflow to the front as indicated in the EC 120B flight manual instructions. If the windshield becomes misted-up, the EC 120B is equipped with a bad weather window that can, if time permits, be opened by pilots in flight and used to see outside from the side of the aircraft.

When the pilot selected demist hot air to clear the windshield, the warm air from the ceiling ventilation ducting was instantly cooled when it hit the relatively cooler windshield. This rapid cooling caused the air to condense and fogged the windshield and front side windows. The immediate fogging of the windshield and front side windows, combined with the heavy precipitation, restricted the pilot's ability to maintain outside visual references. He did not have time to open the bad weather window, which could have given him some outside visibility. Without any outside visual cues, the pilot did not perceive that the helicopter was descending from 100 feet agl; it struck the surface of the water at low airspeed.

Eurocopter has developed an Information Notice on the use of the demist system that will be issued on 15 July 2009. This notice will alert all Eurocopter helicopter crews of windshield flash fogging that can occur in certain weather conditions when the demist system is activated, which could, subsequently, reduce visibility and temporarily create a loss of visual references. This notice will remind crews of the importance of using the bad weather window in such circumstances to ensure visual contact with outside references.

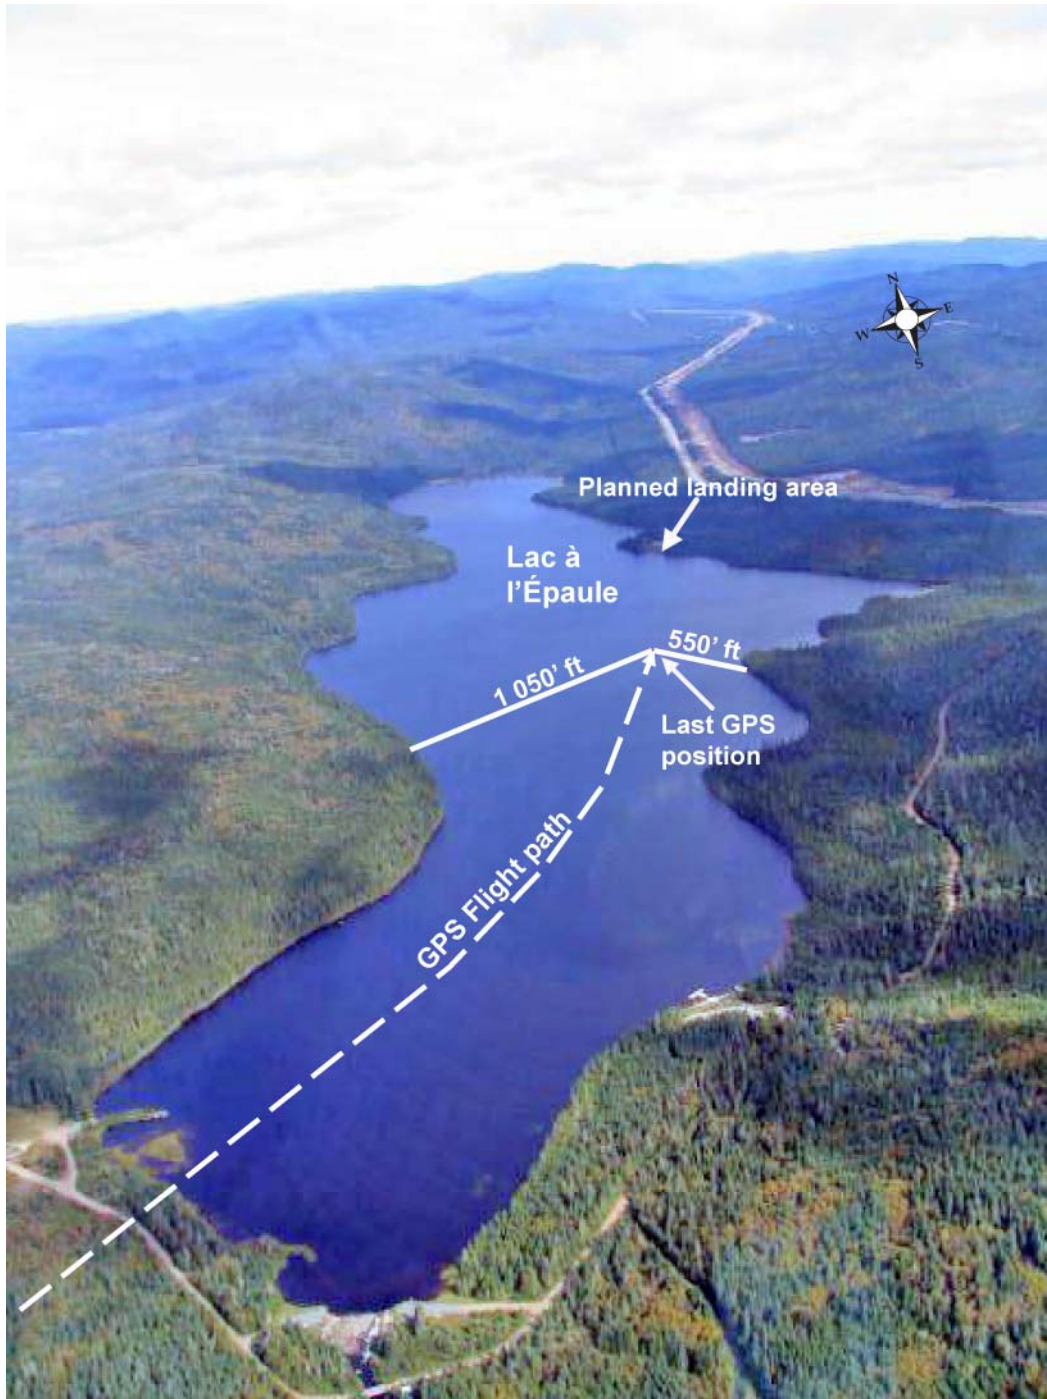
*Appendix A – Lac à l'Épaule*

The pilot did not find a safe landing area at the cottage located at the south end of the lake and proceeded towards the cottage at the north end of the lake (see Appendix A - Lac à l'Épaulé). While transiting northbound over the lake at approximately 100 feet agl, condensation started to accumulate on the front windshield as the pilot reduced speed. Visibility outside the aircraft was restricted by heavy rain showers. The pilot activated the demist hot air to clear the inside of the windshield, but instead the windshield and the front side windows immediately fogged up, completely restricting his outside visibility. The helicopter descended from approximately 100 feet agl and struck the water surface at an estimated speed of between 20 to 30 knots. Position information extracted from the global positioning system (GPS) appears in Appendix A.

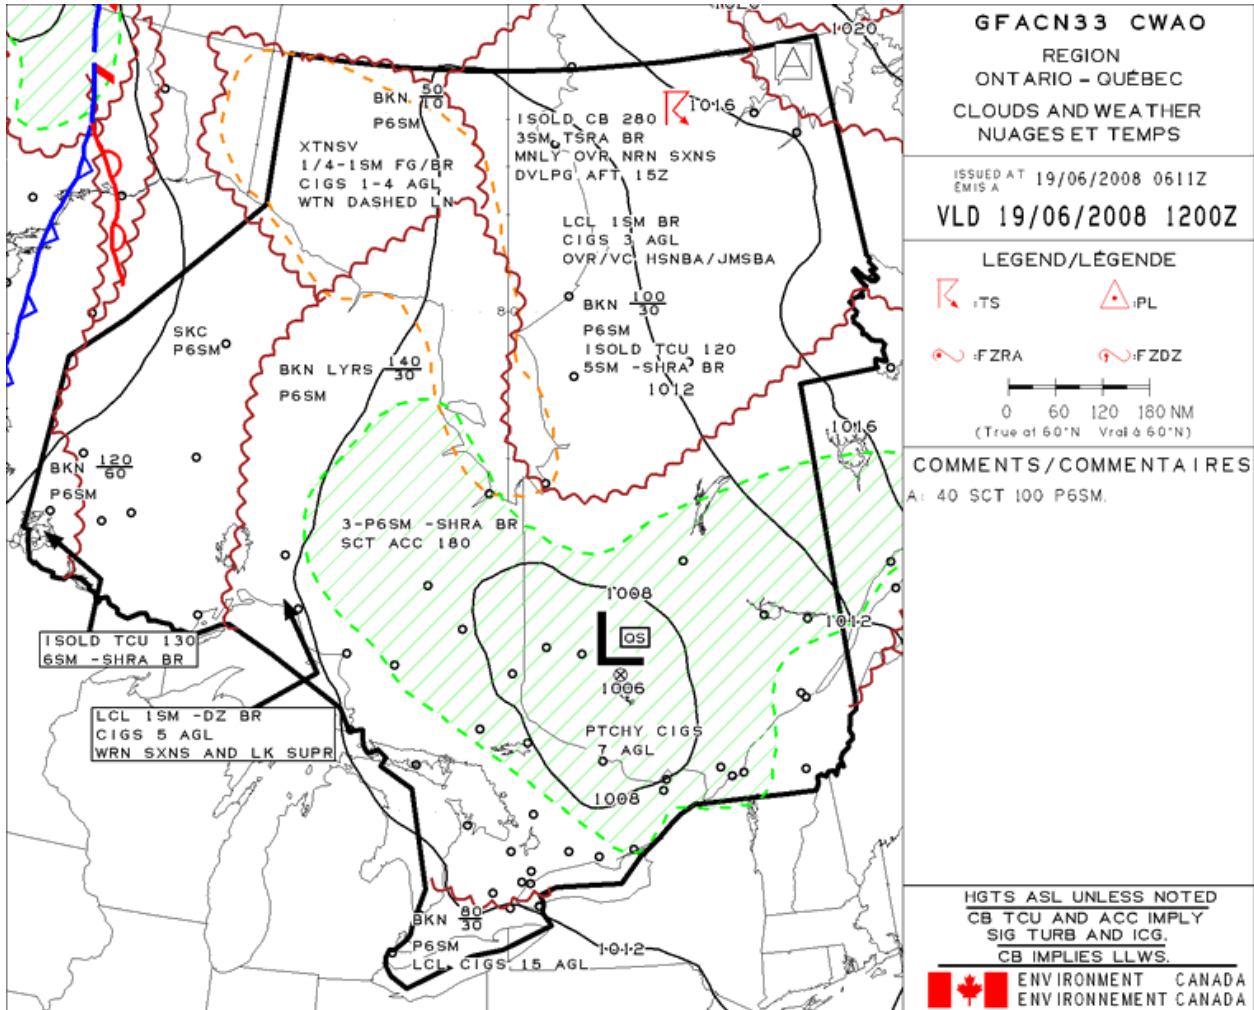
# Appendix B – Graphic Area Forecast

The graphic area forecast (GFA) weather charts showed a low pressure system moving eastwardly across Quebec and affecting the region in which the occurrence flight took place. The GFA predicted the following weather: visibility 3 sm to greater than 6 sm in light rain, showers, and fog, altocumulus castellanus clouds at 18 000 feet asl, and patchy ceilings at 700 feet agl (see Appendix B - Graphic Area Forecast).

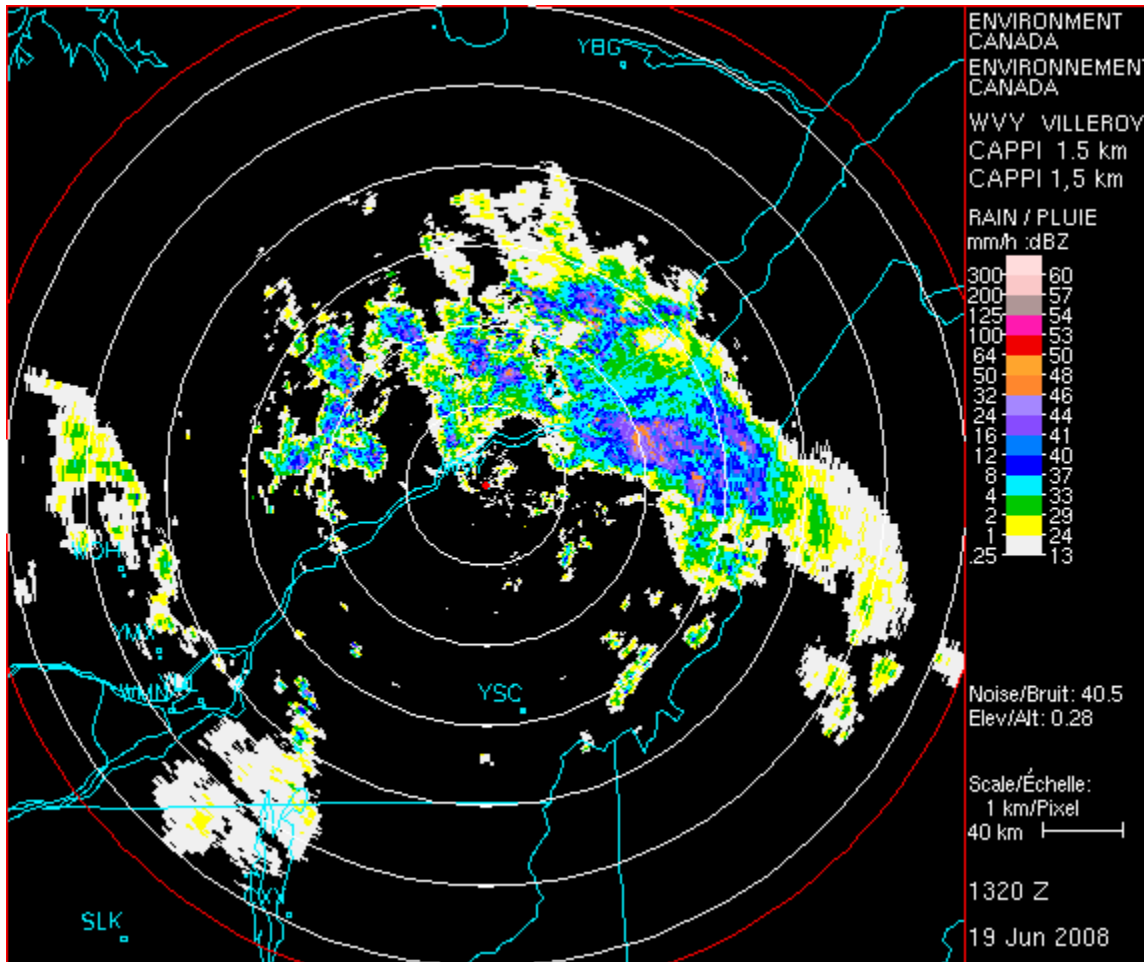
*Appendix C – Villeroy Radar Weather Station  
(southwest of Québec)*

The Villeroy radar weather station, located southwest of Québec, reported heavier rain showers in the mountainous area of the Jacques Cartier National Park and less precipitation south and north of the park during the period the flight took place (see Appendix C – Villeroy Radar Weather Station).
