**AVIATION INVESTIGATION REPORT
A10H0004**

RUNWAY OVERRUN

**TRANS STATES AIRLINES LLC
EMBRAER EMB-145LR N847HK
OTTAWA/MACDONALD-CARTIER
INTERNATIONAL AIRPORT, ONTARIO
16 JUNE 2010**

Report Number A10H0004

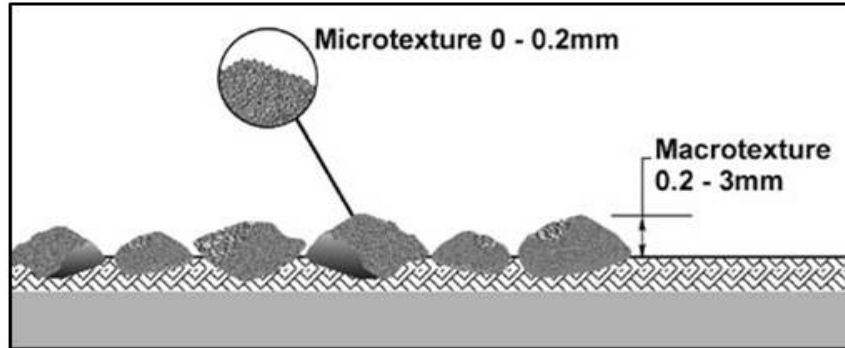
Runway surface texture is considered to be the main factor in the braking friction coefficient of a wet runway. Runway surfaces contain both macrotextures and microtextures (Figure 1²⁷).

Figure 1. Runway surface microtexture and macrotexture

Both ICAO Annex 14, Volume I, and Section 3.1.4.4 of TP312 recommend that the average macrotexture depth of a new surface be not less than 1 mm, to provide good friction characteristics when the runway is wet. Although a depth of less than 1 mm may still provide good drainage, a depth greater than the minimum value must be chosen when constructing a new surface, because normal wear will result in surface deterioration. The last reconstruction of Runway 07/25 before the occurrence was in 1994. Testing completed at CYOW after the accident indicated that macrotexture depth on Runway 07/25 varied from 0.418 mm to 1.262 mm, with an average depth of 0.928 mm.

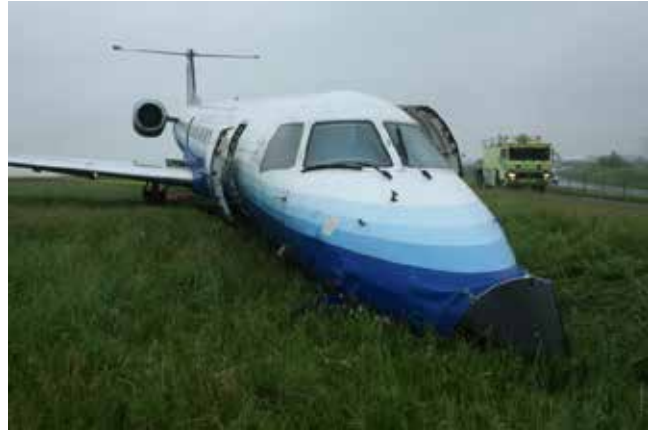
The aircraft's nose section was substantially damaged when the nose gear collapsed shortly after the aircraft exited the runway. The rearward collapse of the nose gear resulted in deformation of sections of the nose-cockpit area and structural damage to the nose area (Photo 1).

Photo 1. The EMB-145LR following the occurrence

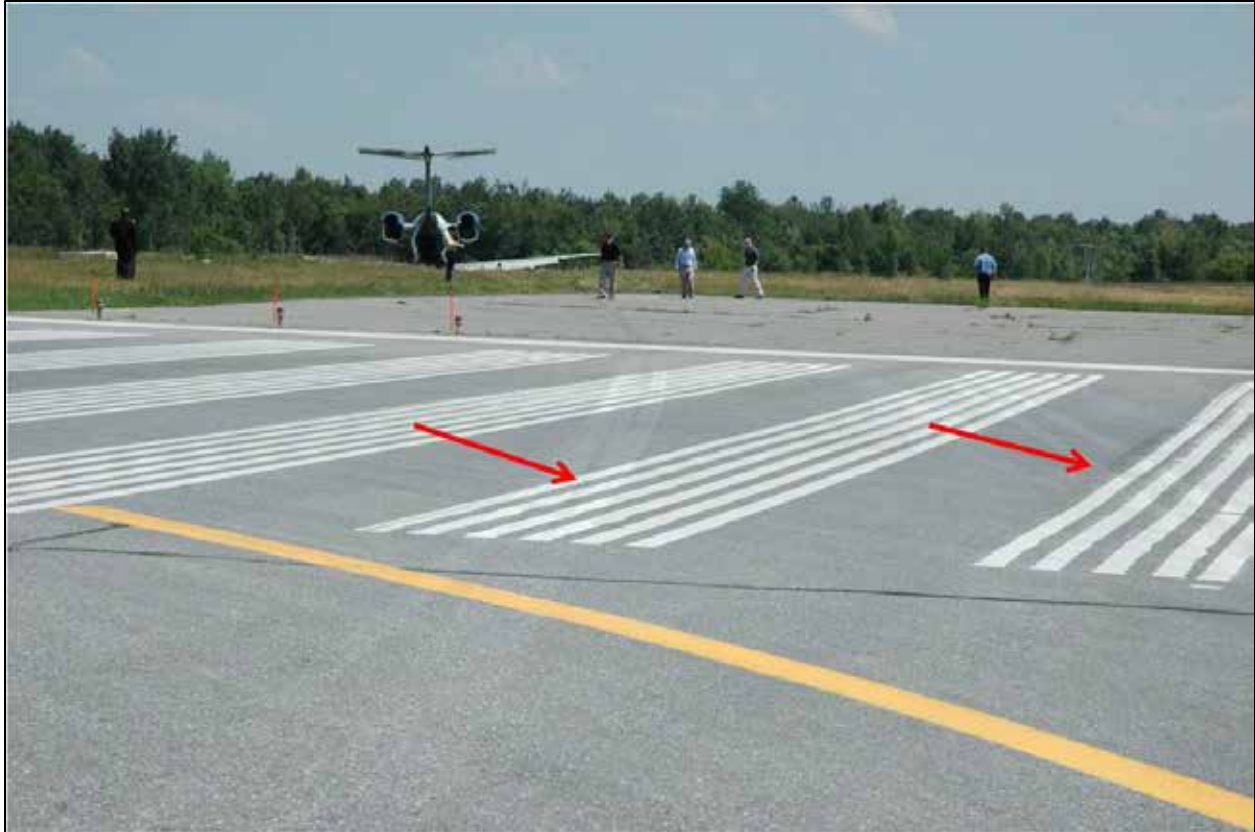
Photo 2. Steam-cleaned marks observed on the departure end of Runway 07

Embraer had a section in Embraer GP145/1650 that described these 3 types of hydroplaning. This document went on to describe the NASA critical speed, or hydroplaning speed, formula to calculate the hydroplaning speed of the tires. The NASA critical speed formula is equal to 9 times the square root of the tire pressure. The main tire pressure for the EMB-145LR is 160 psi, which equates to a hydroplaning speed of 114 knots. A second formula is used to calculate the hydroplaning speed if rain is encountered at the moment of touchdown, when the wheels are not yet turning. The formula changes to 7.7 times the square root of the tire pressure, which equates to 97 knots for the EMB-145LR. The occurrence aircraft touched down at 132 KIAS on a wet runway.

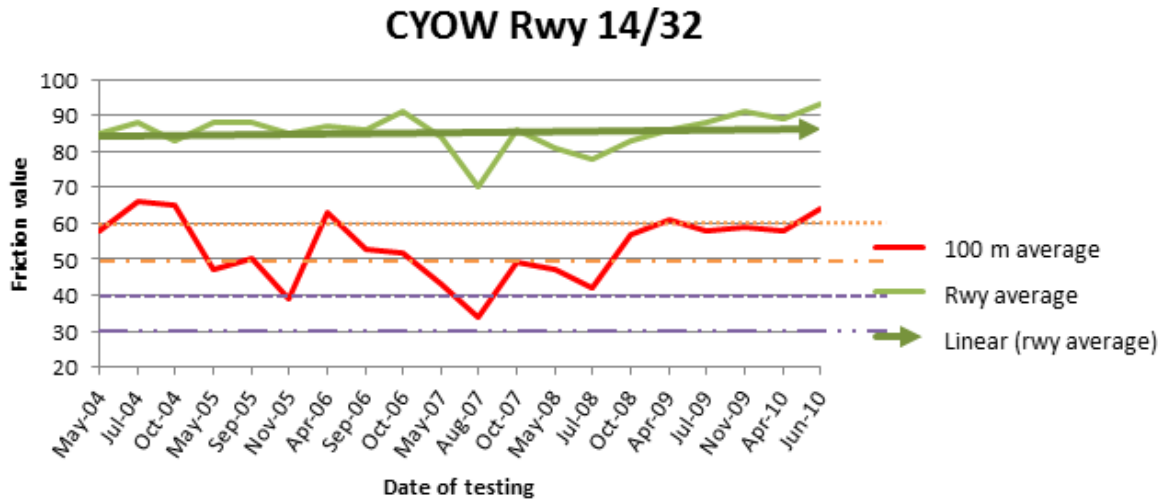
Runway 14/32 – Average friction reading = ~86
 – Average lowest 100 m sections = ~53

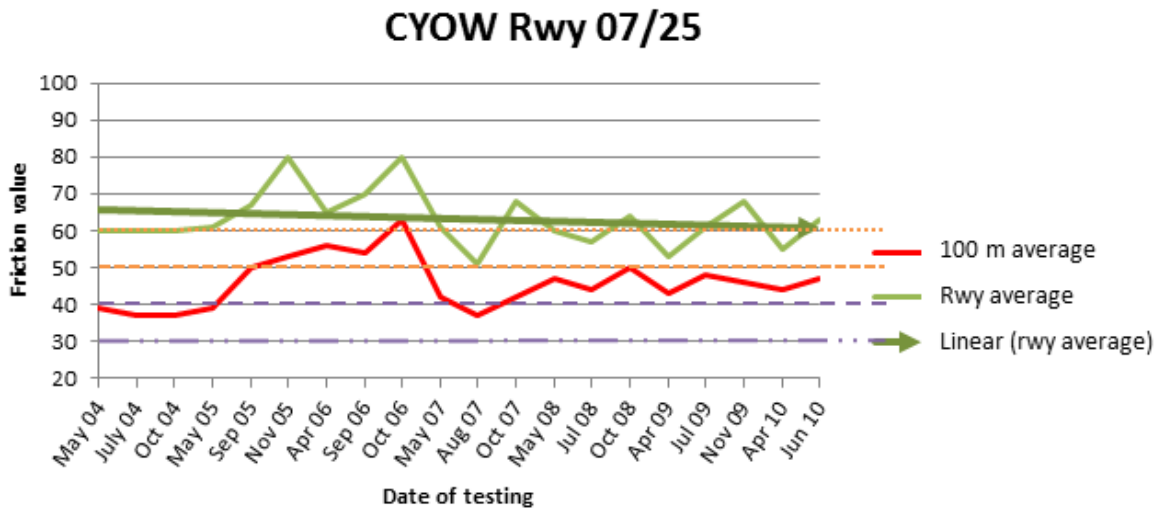
Runway 07/25 – Average friction reading = ~63
 – Average lowest 100 m sections = ~46

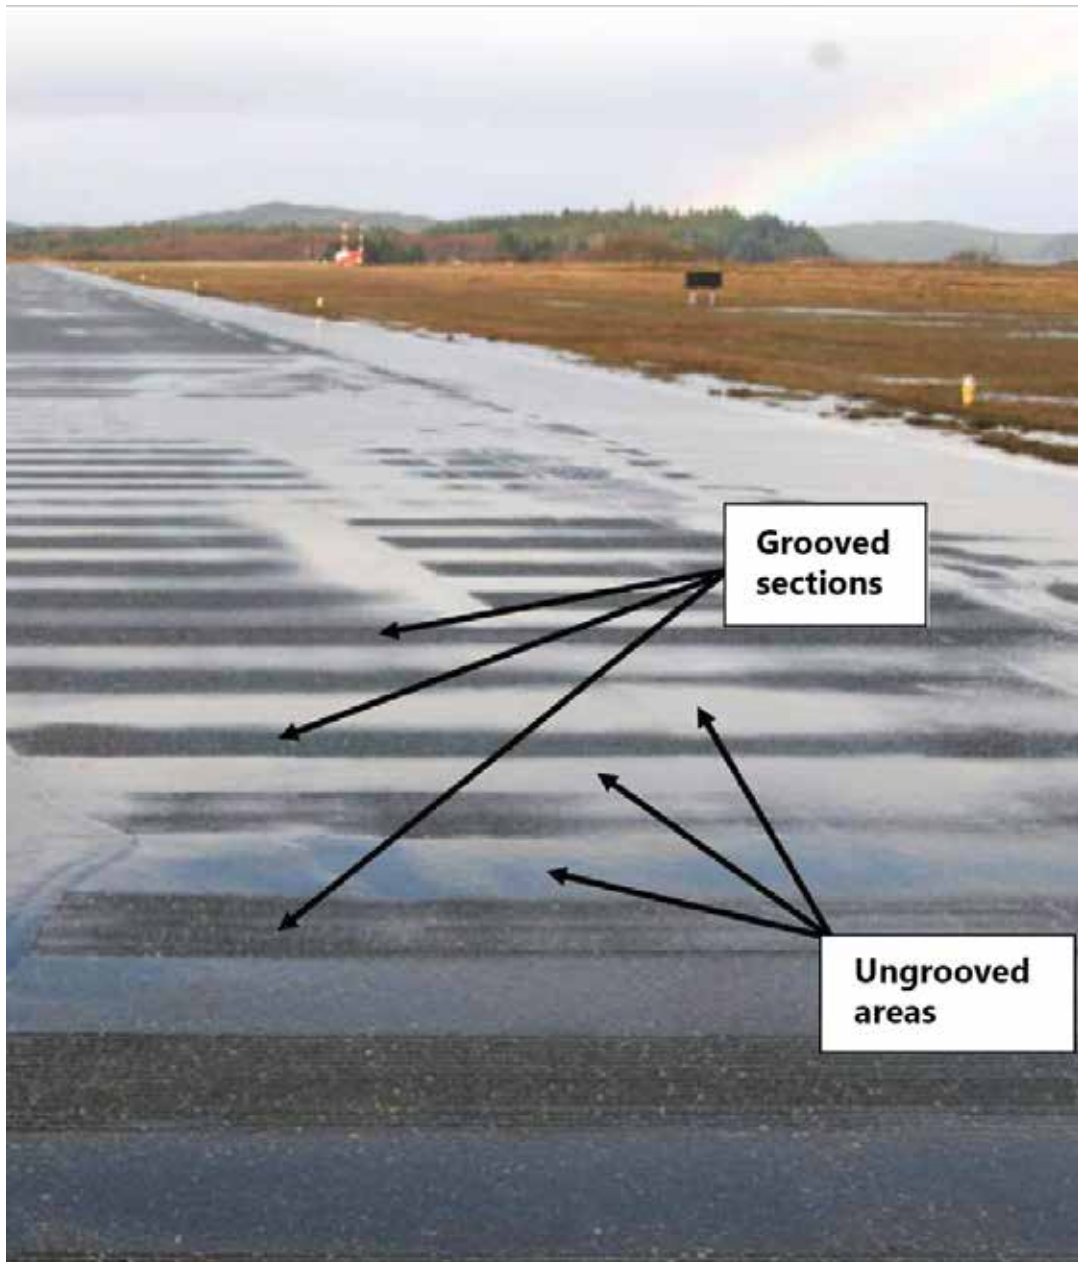
A non-standard grooving pattern on Runway 11/29 at Port Hardy, BC, shows the effect of drainage of water on grooved and ungrooved areas.
