**AVIATION INVESTIGATION REPORT
A10Q0117**

LOSS OF CONTROL AND COLLISION WITH TERRAIN

**NORDAIR QUÉBEC 2000 INC.
DE HAVILLAND DHC-2 MK 1 C-FGYK
LA GRANDE-RIVIÈRE, QUEBEC
24 JULY 2010**

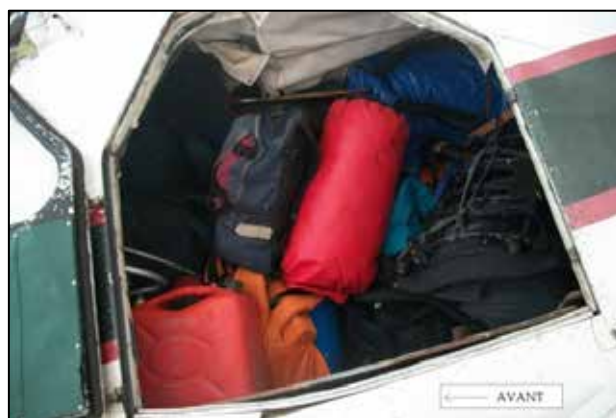
The cabin floor was not severely damaged. However, the aluminum legs of the triple seat were broken and the seat was completely separated from its attachment fittings, propelling the passengers forward. The seatbelts were anchored directly to the seats. Although baggage tie-down fittings were installed in the aircraft, the baggage was not secured to the floor, and it shifted forward (Photo 1).

Photo 1. Baggage shifted toward the front of the aircraft
