**AVIATION INVESTIGATION REPORT
A10W0155**

LOSS OF CONTROL AND COLLISION WITH TERRAIN

**CIRRUS DESIGN CORPORATION SR22, C-FGLA
SUNDRE, ALBERTA, 5 NM NW
24 SEPTEMBER 2010**

Report Number A10W0155

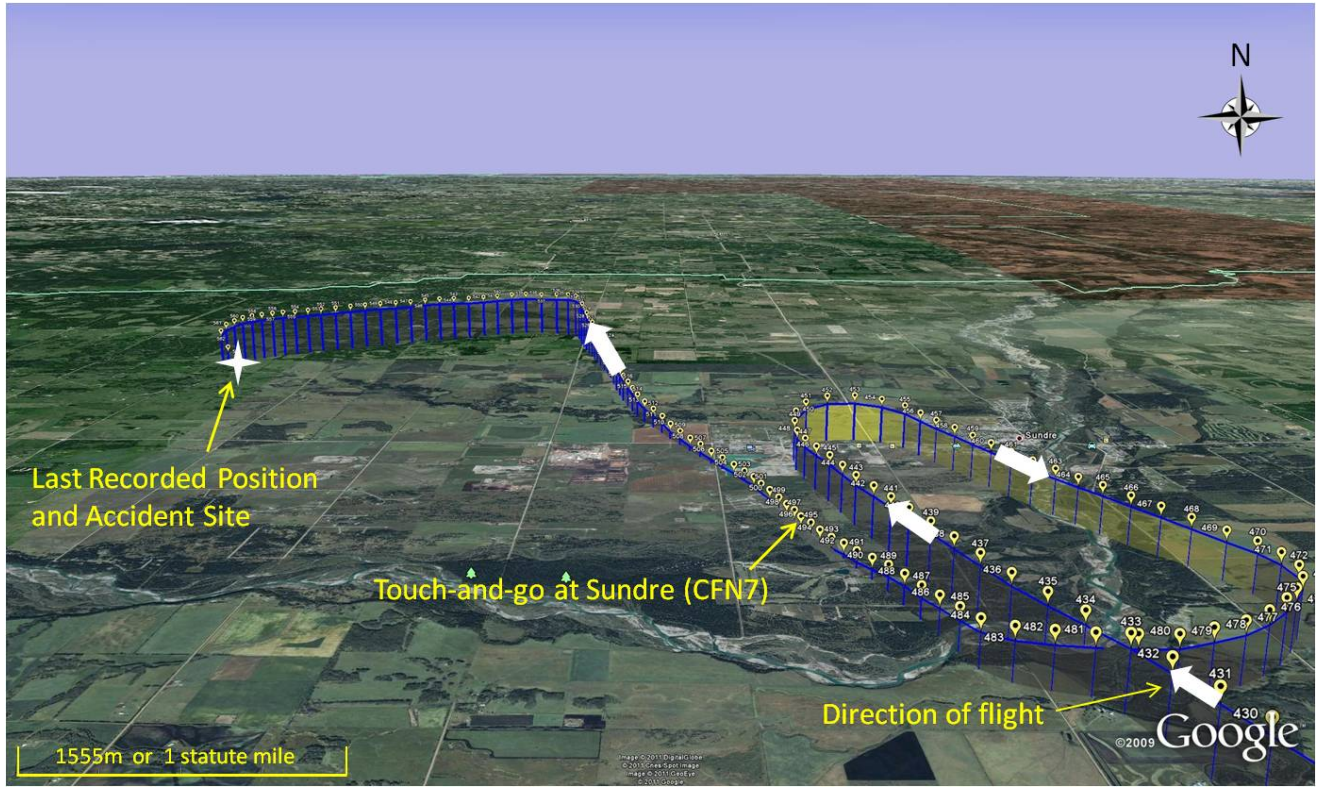
Appendix A – Map of Last Nine Minutes of Flight

The aircraft departed Springbank (CYBW) at 1319, ¹ for a planned 1.5 hour flight. The aircraft travelled northwest toward the Sundre Airport (CFN7), 40 nautical miles (nm) north of Springbank, at a maximum altitude of 6500 feet above sea level (asl), and a maximum ground speed of 160 knots. A descent was commenced 21 nm southeast of CFN7. Due to terrain masking, the last air traffic control radar return produced by the Calgary radar source, at 1336, showed C-FGLA descending through 5700 feet asl.

C-FGLA overflew CFN7 and conducted a right hand circuit, followed by a touch-and-go landing on Runway 32 at 1341. After the touch-and-go, as the aircraft crossed the departure end of the runway, it oscillated slightly in the pitch axis.

The aircraft then climbed to approximately 5600 feet asl, on a north-westerly heading, between 105 knots and 109 knots indicated airspeed (KIAS). At 1343:50, the aircraft turned left to a heading varying between 220° and 227° magnetic (M). The aircraft maintained a relatively stable attitude with the bank angle varying between 5° left and right, and a pitch angle of approximately 5° nose up. At 1344:21, the aircraft began to pitch to a maximum of 15° nose up with no increase in either vertical speed or normal acceleration ² and gradually descended to 5500 feet asl, or 1650 feet above ground level (agl). ³ During this time, the airspeed gradually decreased from 130 KIAS to 67 KIAS.

At 1345:35, the aircraft entered a right turn which increased in rate to a maximum of 11° per second. Airspeed increased to 98 KIAS, accompanied by an 80° nose-down pitch and a rapidly increasing rate of descent. Characteristics of this turn were consistent with the early stages of a spin. ⁴ When the turn reached 329° M at 1100 feet agl, the aircraft rolled to the left. At 1345:48, the onboard recording quality was compromised due to extreme attitudes, resulting in loss of valid pitch and roll information. At that time, the heading was decreasing to 120° M, an airspeed of 103 KIAS and a vertical descent rate over 5000 feet per minute (fpm) with a positive loading in the vertical axis of 2.4 g. At 1345:51, the last recorded data showed the aircraft 160 feet laterally from the impact point, with airspeed increasing through 132 KIAS, vertical descent rate increasing through 6900 fpm and vertical acceleration reaching approximately 3.5 g. The engine was running throughout the descent to the ground.

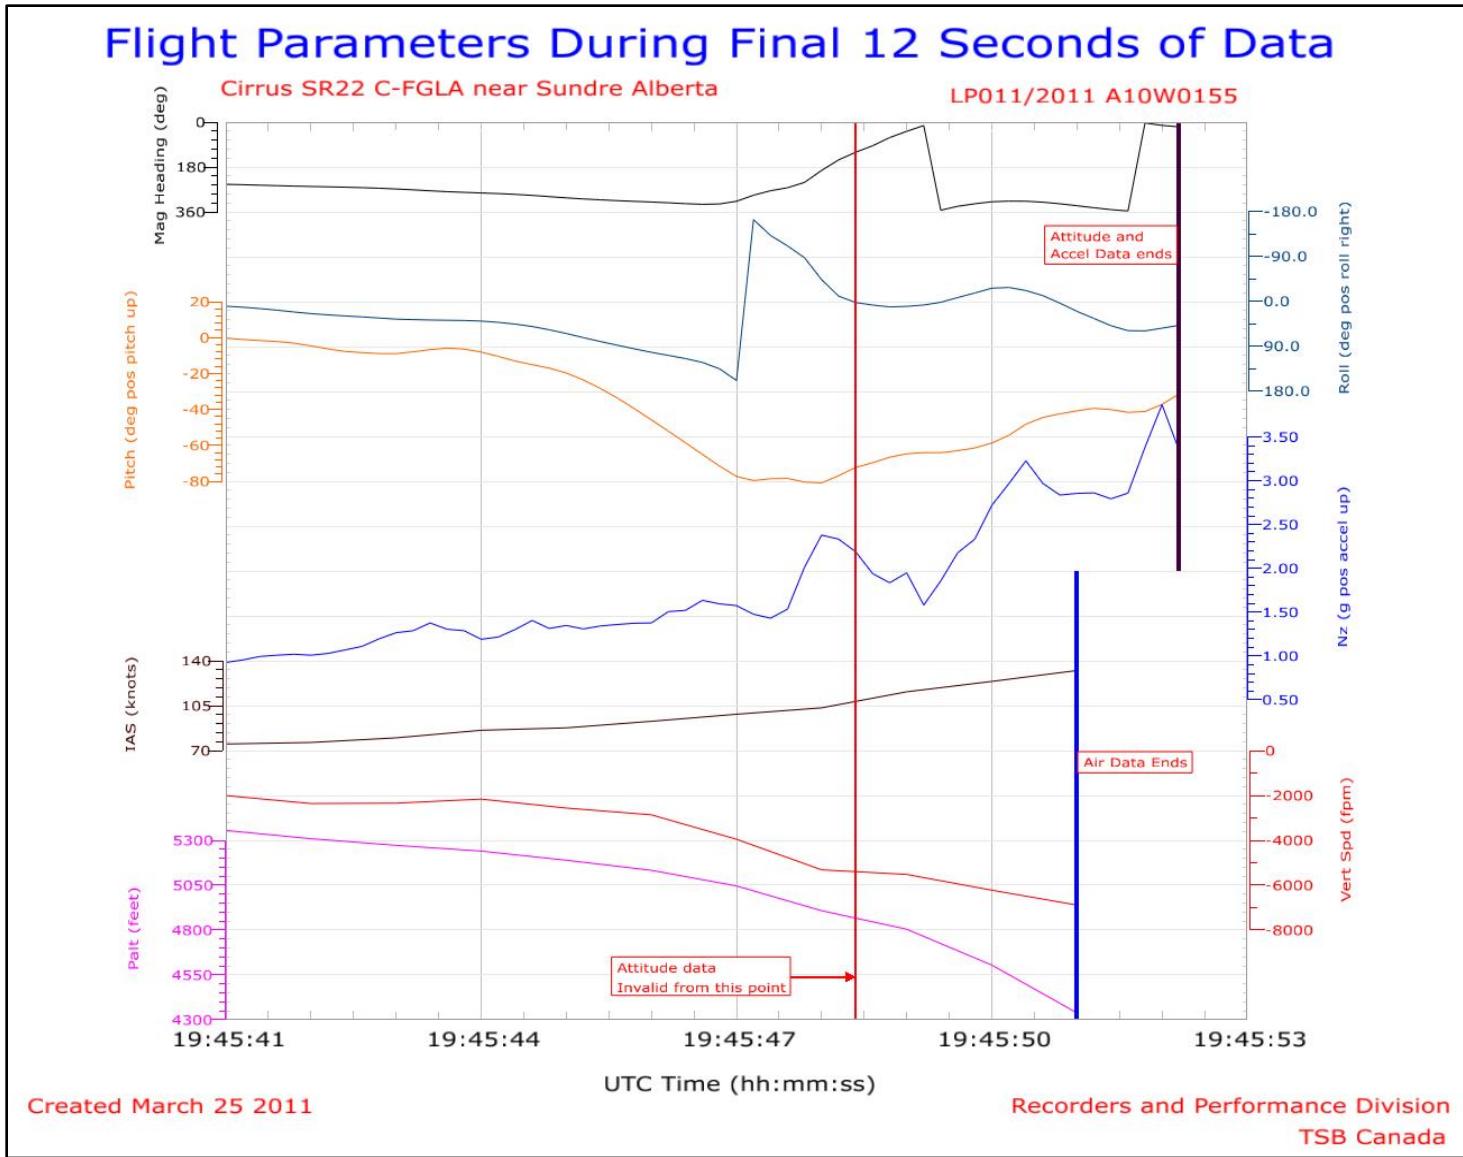
Appendix B – Primary Flight Display Recorded Data

The PFD and MFD are capable of holding non-volatile memory after aircraft electrical power is removed. Data was extracted from the non-volatile memory of the PFD from which some details of the aircraft's last flight could be reconstructed. The MFD sustained substantial impact and fire damage which obliterated information related to engine operation.

The deceleration of C-FGLA after the turn to the southwest, accompanied by a slight descent, is consistent with the engine operating at a reduced power setting, and with the pilot attempting to maintain a more or less constant altitude. The slight loss of altitude and variation in heading suggests that the autopilot was disengaged.

The airspeed deteriorated to the point of aerodynamic stall, which was followed by entry to a spin to the right with a heading change of 90°. The aircraft behaviour in the continued descent indicates an over-recovery into a spiral dive in the opposite direction which featured rapid rotation, speed build-up and increasing positive vertical g loading. Insufficient altitude remained for recovery. The debris field and ground scars indicate that most of the rotation was stopped and a pull-up had begun immediately before the aircraft struck the ground at high speed in a nose down, slight left wing down attitude.

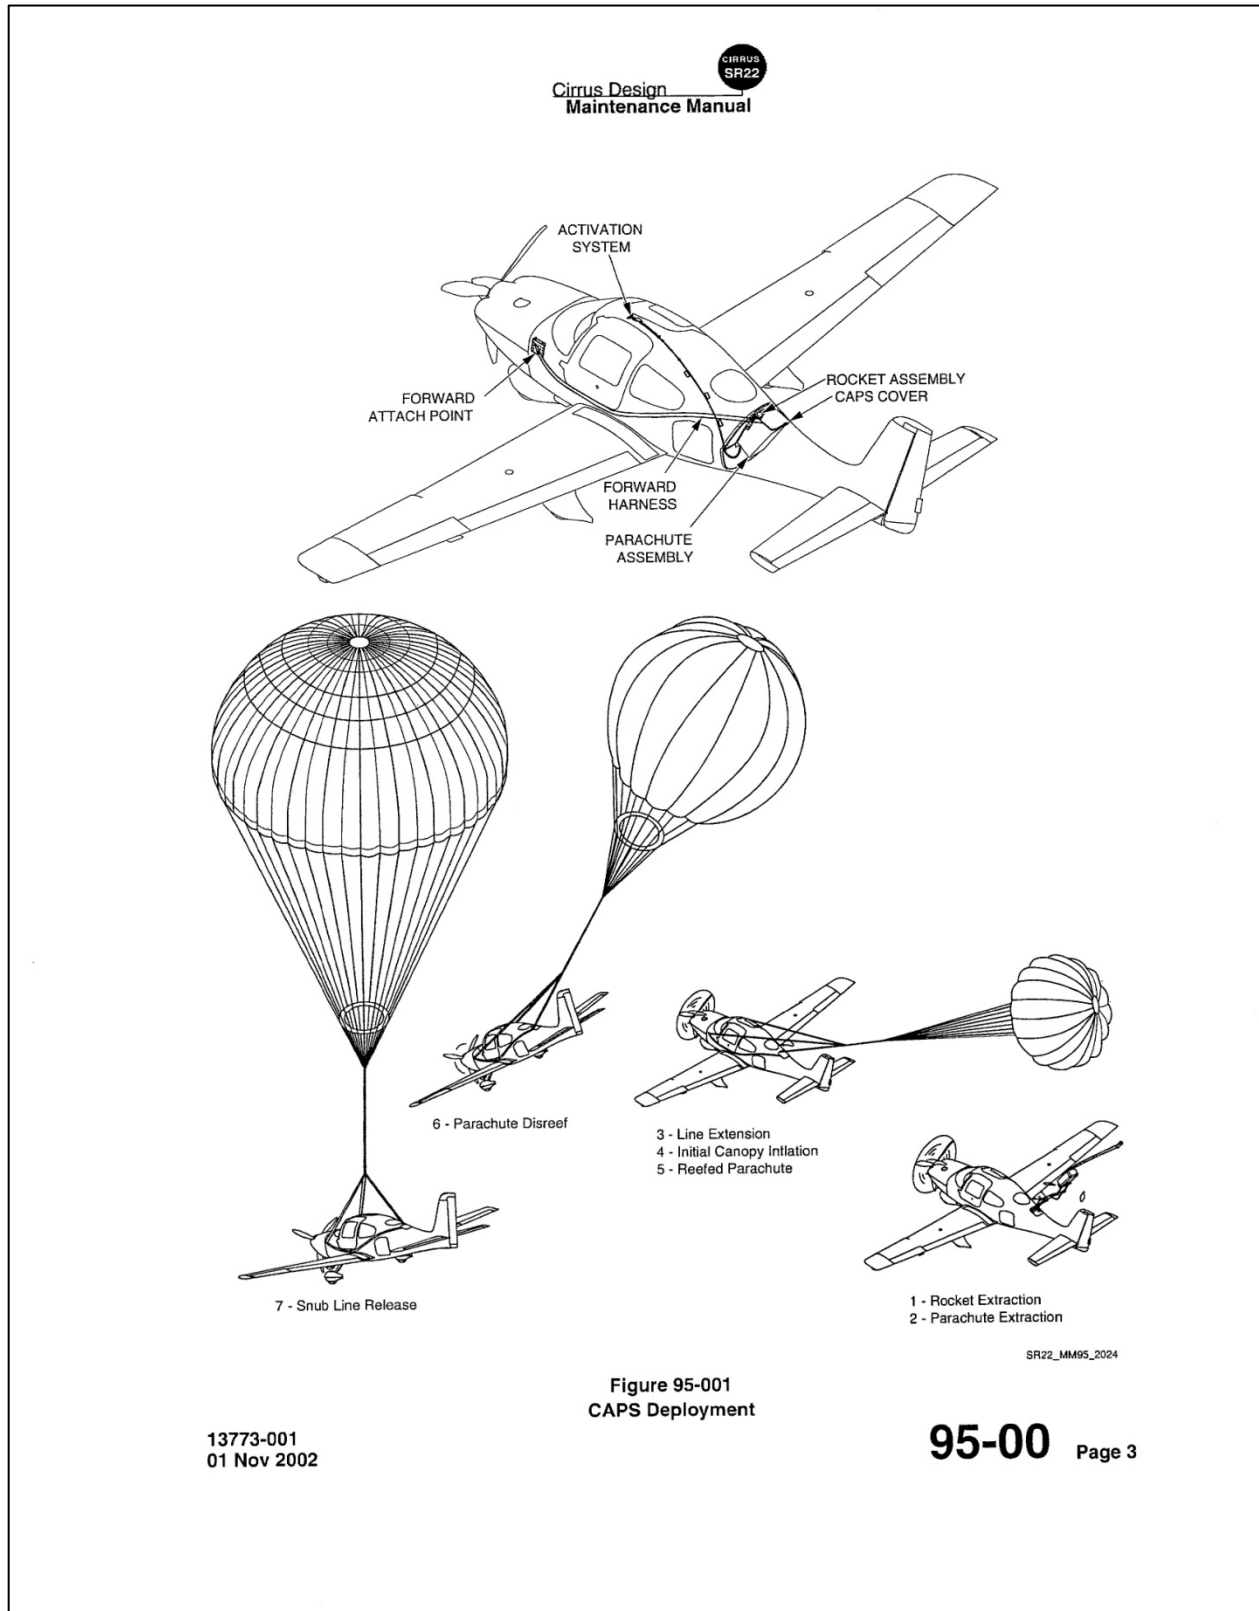
Appendix C – CAPS Deployment Sequence

During rocket deployment of the CAPS system, the T-handle is gripped and forcefully pulled downward, resulting in the deformation of an aluminum bracket which attaches the cable and handle assembly to the cabin roof. In the wreckage of C-FGLA, the T-handle was found to be fully stowed and there was no deformation of the bracket. No deformation of the bracket is an indication, although not always reliable, that the T-handle had not been pulled.

Although the rocket had launched from the aircraft, the parachute lines were grouped together and draped over tree branches forward of the main wreckage. The parachute lay on the ground, neatly folded, adjacent to its containment bag, thus indicating that the system had activated on impact. The safety pin was not in place and was not found in the wreckage. The pilot was in the habit of removing the pin prior to flight which was in accordance with the normal procedures section of the SR22 Pilot's Operating Handbook.

Early recognition of situations justifying the use of CAPS, and subsequent activation, has been very effective in reducing the severity of injuries and damage to aircraft. When C-FGLA entered the initial spin at least 1600 feet agl, there was adequate height for a successful deployment as demonstrated by Cirrus research and past occurrences. In this occurrence, the condition of the T-handle retention bracket, combined with the location and condition of the deployed parachute in the wreckage indicates that the system did not activate until ground impact. It could not be determined why the system was not activated.
