**AVIATION INVESTIGATION REPORT
A11O0222**

COLLISION WITH TERRAIN

**GREAT LAKES HELICOPTER CORP.
ROBINSON R22 BETA (HELICOPTER) C-GVAR
REGION OF WATERLOO INTERNATIONAL AIRPORT,
ONTARIO
28 NOVEMBER 2011**

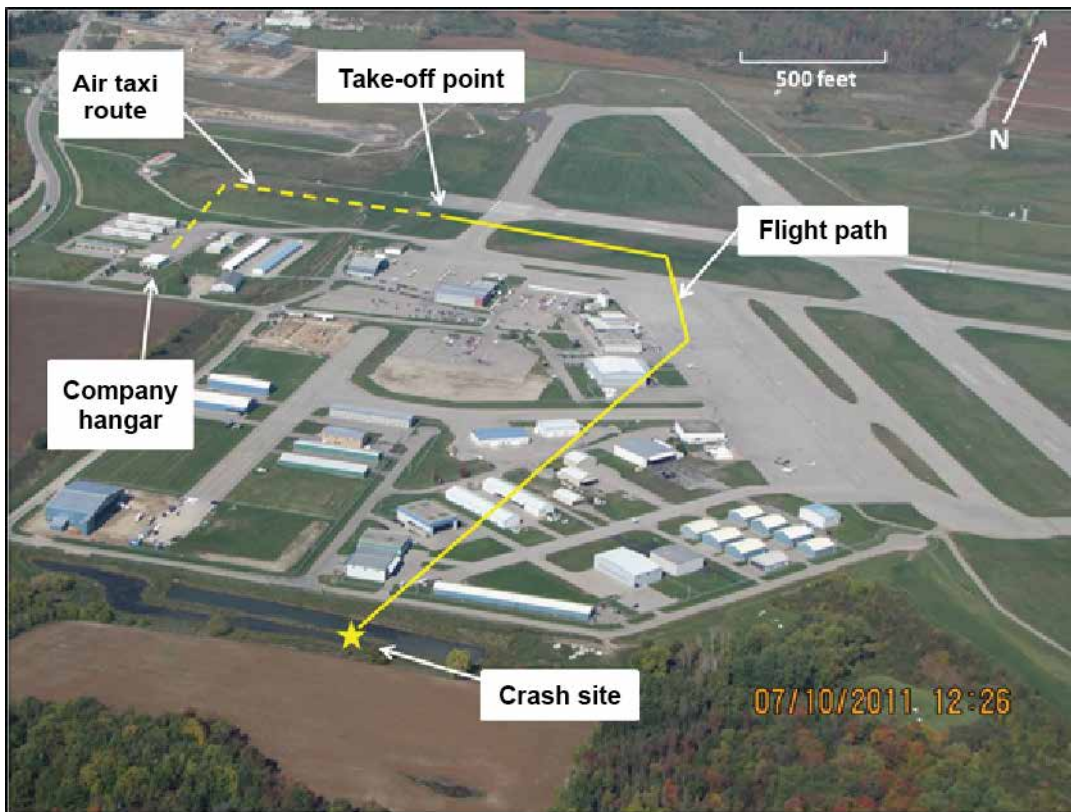
After C-GVAR repositioned to the grassy departure area there was a short delay due to tower frequency congestion. During this 5-minute time period the crew decided to practice touchdowns and lift-offs from the hover. At 1130, the air traffic controller instructed C-GVAR to lift off at the crew's discretion and make a turn around the control tower for a southbound departure (Figure 1).

Figure 1. Flight path

C-GVAR lifted off from the grassy area with the student pilot in control and proceeded as instructed by the air traffic controller. After reaching approximately 200 feet above ground level (agl), at a typical departure speed, southbound over an area of multiple hangars and overhead wires, the instructor instructed the student to apply carburetor heat. It is not clear whether this instruction was actioned; however, shortly thereafter the engine shuddered, the engine rpm (revolutions per minute) decreased, and the instructor assumed control. The helicopter yawed

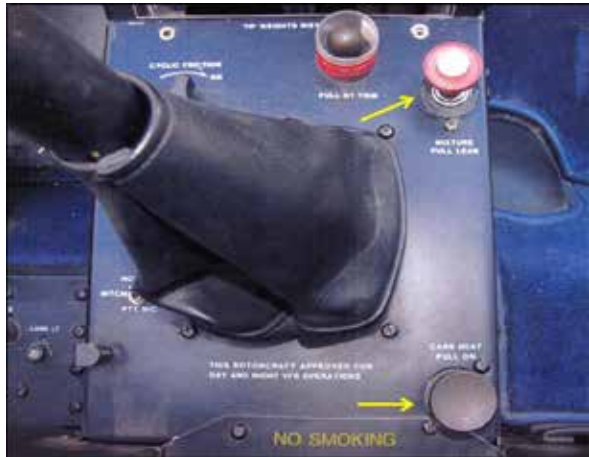
The fuel mixture and carburetor heat controls are located on the centre pedestal in close proximity to each other. To aid in identification, the control knobs are shaped differently. Furthermore, the fuel mixture control knob is red while the carburetor heat control knob is black (Photo 1). To prevent the inadvertent deployment in flight, the manufacturer's checklist directs the pilot to place a removable cylindrical plastic guard over the mixture control knob before starting the engine (Photo 2). This guard is not to be removed until engine shutdown

Photo 1. Mixture control top right and carburetor heat control bottom right

not found at the crash site. The fuel mixture control was found in the full rich position. The carburetor heat control knob was found in the cold position. Examination of the cable-operated guillotine valve in the carburetor air box confirmed that the carburetor heat was selected to cold prior to impact.

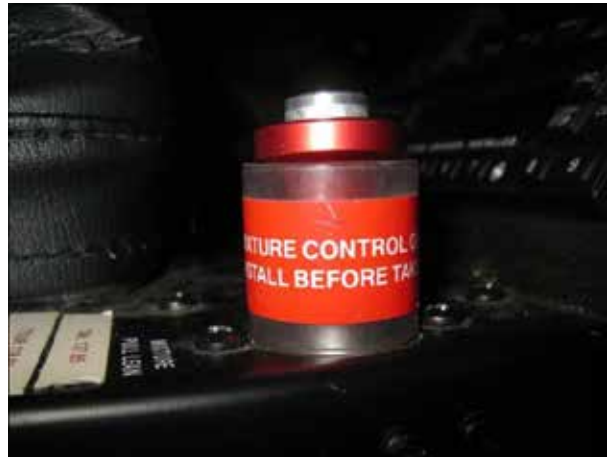
Photo 2. Mixture control with guard installed

There were no pre-impact mechanical failures or system malfunctions that would have contributed to this accident. A teardown of the engine and accessory gearbox revealed that although they were serviceable, they were not turning at impact. The plastic mixture guard was

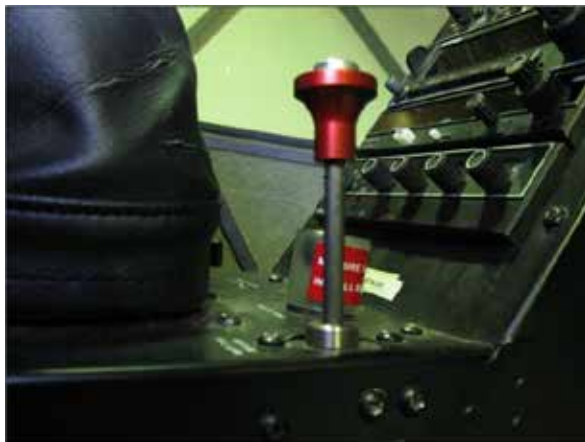
when the mixture control knob is pulled to the idle cut-off position (Photo 3). This plastic guard is not permanently attached to the control panel.

Photo 3. Mixture control in idle cut-off position

An instructor flying with a relatively new student would likely be carefully monitoring the student's actions, particularly during the critical take-off phase. The possibility that the mixture control was inadvertently selected to idle cut-off was considered to be unlikely as the student would have had to remove the mixture guard, pull the mixture control to idle cut-off and return it to full rich without the instructor's intervention. In addition, the fact that the carburetor heat, which would have been required given the conditions, was found in the cold position would further suggest that this scenario is unlikely.

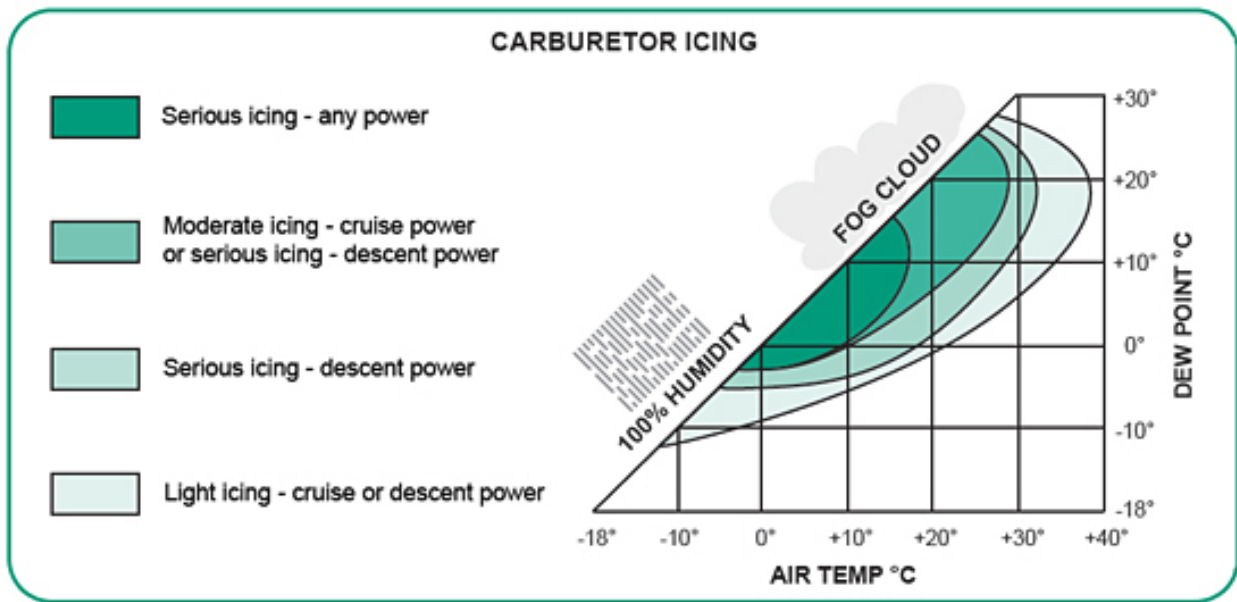
Appendix C – Carburetor Icing Probability Chart

To help determine whether flight conditions are more or less susceptible to carburetor ice, charts based on a knowledge of dry (ambient) air and wet (dew point) air temperatures have been produced (Appendix C). The temperature and dew point at the time of the occurrence when referenced against these charts describe the conditions as the most severe or "Serious Icing – Any Power". In addition, the likelihood of accumulating ice can be exacerbated by operations in cloud, fog, rain, areas of high humidity, or in this case, ground operations over wet surfaces, especially wet grass.²

The weather conditions at CYKF were highly conducive to carburetor icing. In addition to the temperature/dew point spread, the operation conducted over the wet grass would have intensified the rate of ice accumulation.
