**AVIATION INVESTIGATION REPORT
A11P0117**

MAIN-ROTOR STRIKE AND COLLISION WITH TERRAIN

**VIH HELICOPTERS LTD.
BELL 407 (HELICOPTER), C-GNVI
STEWART, BRITISH COLUMBIA 14 NM N
31 JULY 2011**

Report Number A11P0117

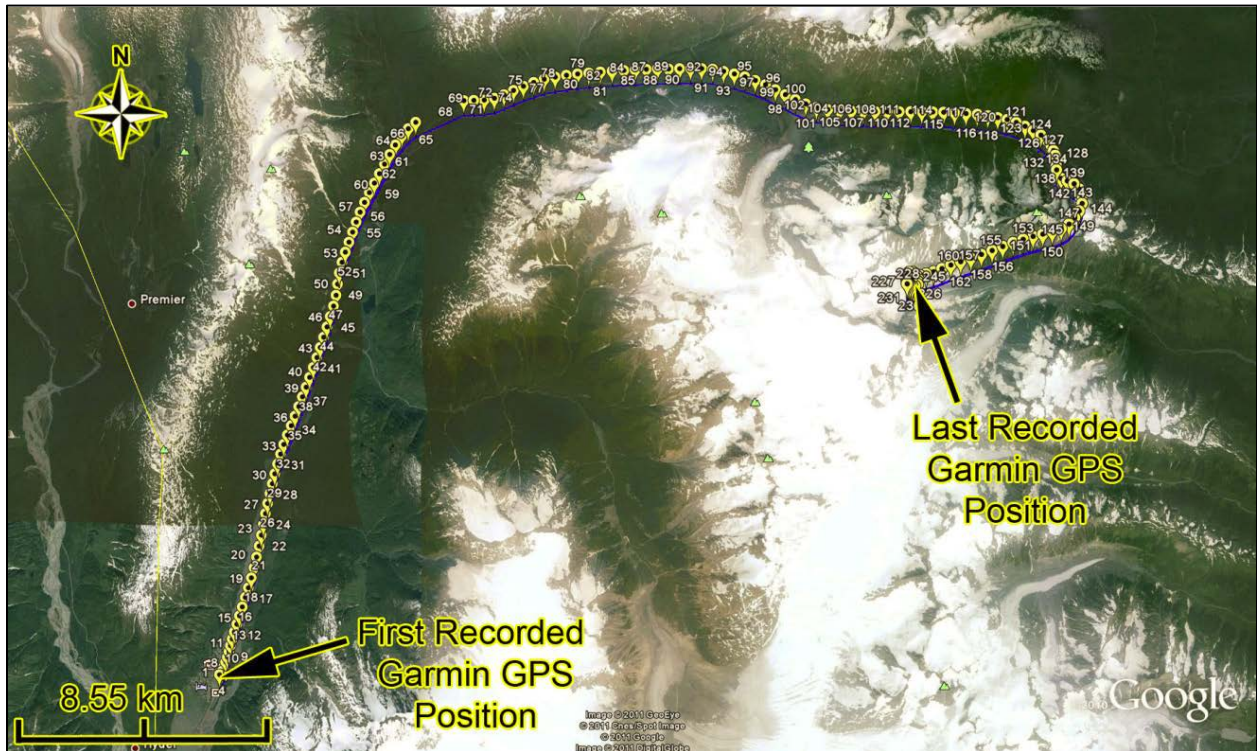
Figure 1. Plot of GPS data showing the flight track (Image: Google Earth; diagram added by TSB)

The last 2 minutes of recorded handheld GPS data showed that the helicopter came to a stationary position and altitude for 54 seconds before electrical power was interrupted or the GPS signal was lost. The next position report would have been recorded 6 seconds later.

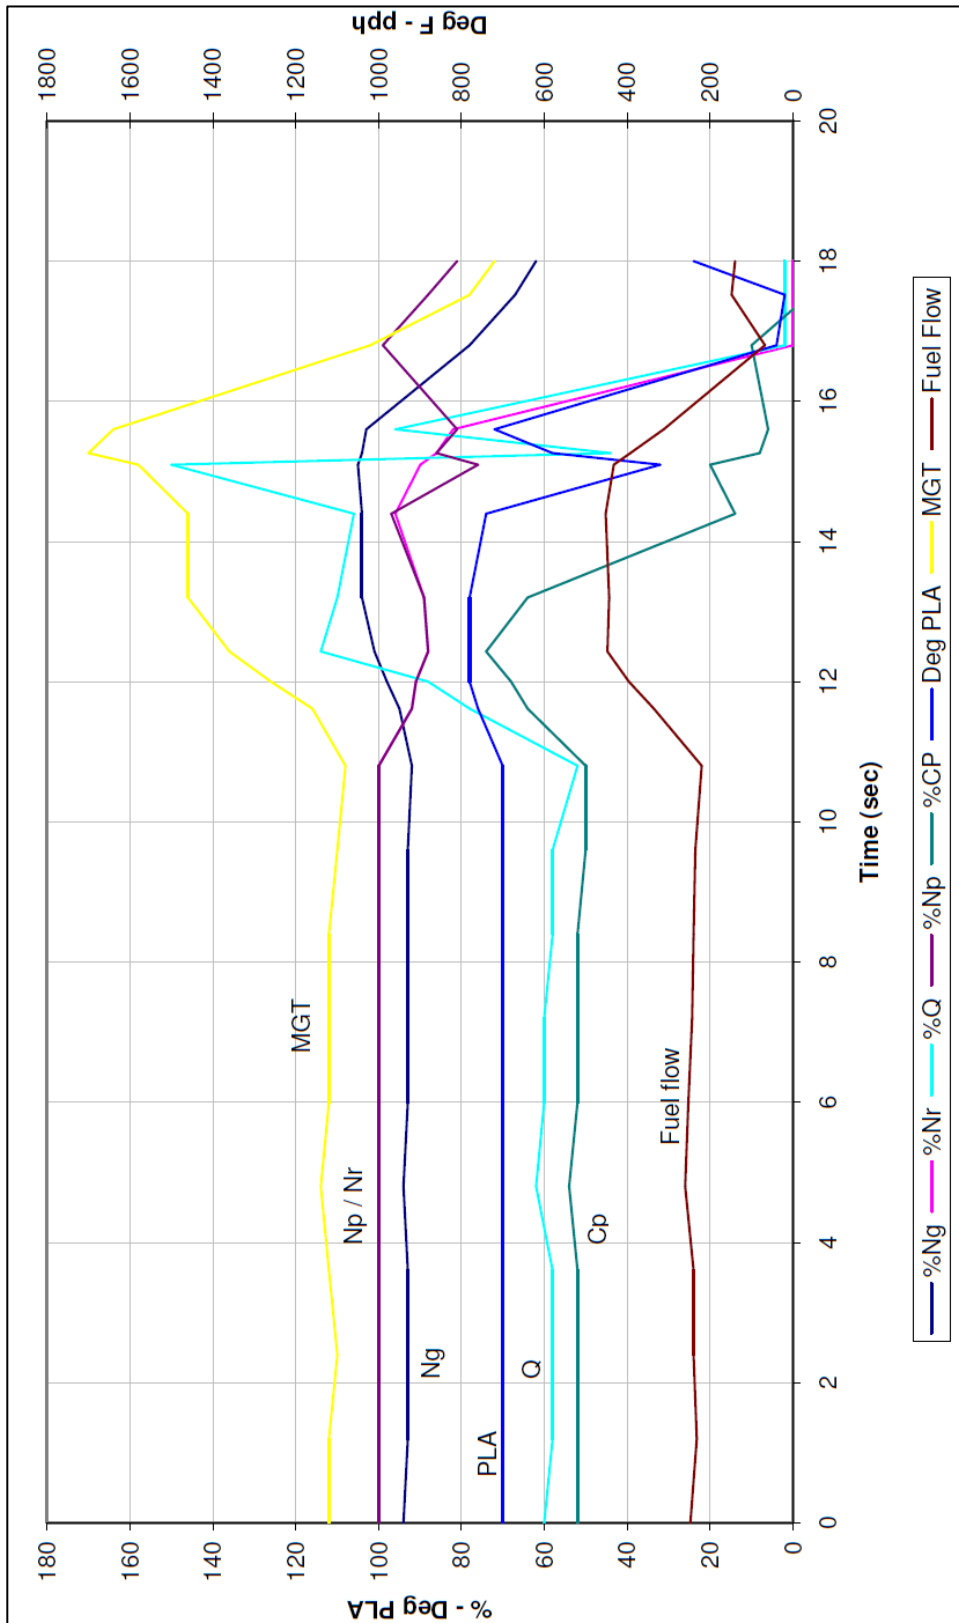
Appendix A: ECU Recorded Data

at least 11 seconds before the torque declined to 52%. The decline was accompanied by a reduction of fuel flow and gas generator speed. Immediately thereafter, an incident recording was triggered by a loss of 9% main-rotor speed. The data showed that both the ECU and the pilot responded with control inputs that commanded the engine to accelerate at its maximum allowable rate. The engine did respond, and it reached its maximum fuel flow, during which time 5 consecutive torque exceedances were recorded. A subsequent sharp spike in torque reached 150%, and was followed by a divergence of power turbine and main-rotor speeds. Torque spikes are characteristic of rotor blades striking objects. ⁶

The recorded GPS data showed the helicopter in, or near, a stationary hover for 54 seconds until electrical power was interrupted, or the GPS signal was lost. The ECU data indicated a small, gradual power reduction, followed by a sudden reduction in main-rotor rpm. It is likely that the decrease in main-rotor speed occurred as a result of the main-rotor blades making contact with an obstacle as the helicopter manoeuvred in close proximity to the rock face. Any damage to rotor blades, which provide both a supporting and a control surface, is likely to result in an unstable control condition or a complete loss of control. The sudden increase in torque to 150% is consistent with a significant rotor strike. The subsequent divergence of the main-rotor speed (decreased) and power turbine speed (increased) is indicative of a sudden release of torque due to severing of the driveshaft between the engine and the transmission. While working in close proximity to steep terrain, for undetermined reasons, the helicopter's main-rotor blades made contact with terrain, causing a subsequent loss of control and collision with terrain.
