**AVIATION INVESTIGATION REPORT  
A11W0180**

**CONTROLLED FLIGHT INTO TERRAIN**

**TREK AERIAL SURVEYS  
CESSNA 185E C-FXJN  
FORT ST. JOHN, BRITISH COLUMBIA, 12 NM E  
30 NOVEMBER 2011**

Report Number A11W0180

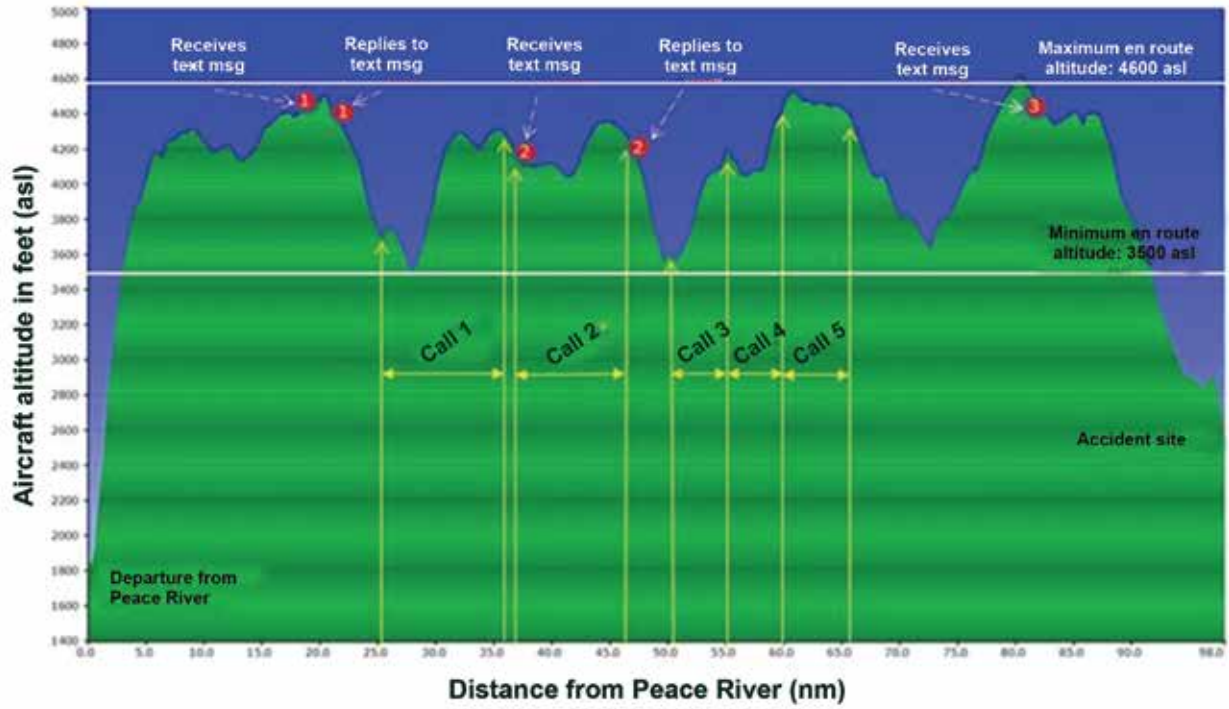
# Appendix A —Pilot's Cell Phone Use, Peace River to Fort St. John

While on the ground at Peace River Airport, the pilot revised his estimated time of arrival at Fort St. John Airport to 1813 with the Edmonton Flight Information Centre (FIC). The pilot then departed at 1706, reporting westbound at 4500 feet above sea level (asl). Between 1719 and 1755, the pilot engaged in 2 text message exchanges and conducted 5 voice cell phone communications totalling 28 minutes.<sup>3</sup> The pilot received a final text message at 1806, 11 minutes before the accident (Appendix A).

In the events leading up to this occurrence the aircraft experienced several large altitude deviations while the pilot was using the cellphone. Cell phone use can distract operators from essential operational tasks. There have been no comprehensive studies regarding the use of cell phones as a distraction in an aviation context. The phenomenon has, however, been extensively studied in the automotive sector. The Canadian Council of Motor Transport Administrators defines driver distraction:

The aircraft had experienced several large altitude deviations while the pilot was using his cellphone. While it did not appear that the pilot was actively engaged in cell phone communications during the last 11 minutes of the flight, this distraction was prevalent throughout the flight and in conjunction with the night conditions encountered, may have contributed to the CFIT event.

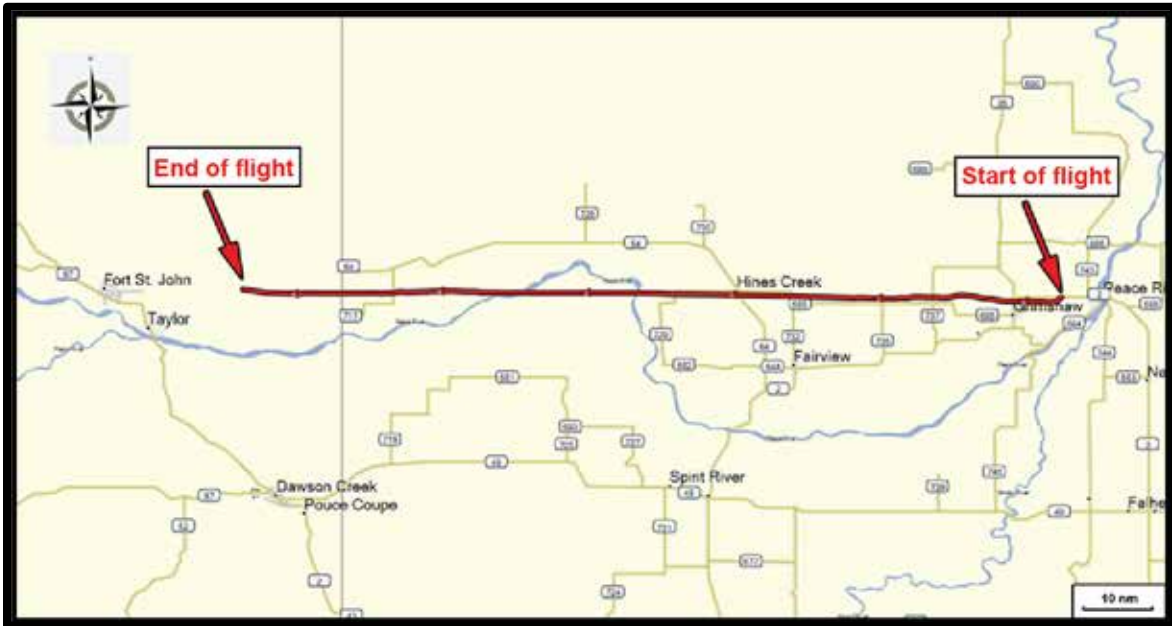
## Appendix B — C-FXJN Flight Path

At 1807, C-FXJN was 26 nm east of Fort St. John Airport at 4400 feet asl<sup>4</sup> (Appendix B). At 1809, 23 nm east of the Fort St. John Airport, the aircraft began a gradual descent of approximately 170 feet per minute, with a ground speed of 90 knots. (Ground elevation was approximately 2400 feet asl at the accident site.) The aircraft was 18 nm east at 3200 feet asl at 1813 when the pilot was in contact with the Fort St. John Flight Service Station (FSS). The pilot was advised that the winds were 210° magnetic (M) at 15 knots, the altimeter setting was 30.31 inches of mercury (in Hg) and that the preferred runway was 20. The pilot acknowledged this information. There were no further communications with the FSS.

From 1815 to 1816, the pilot momentarily leveled off at 2900 feet asl, 15 nm east of the airport, before resuming the descent. The descent continued uninterrupted until the last radar contact at 1817, 12 nm from the airport at 2400 feet asl.
